COLLINS RADIO COMPANY

30S-1 RF LINEAR AMPLIFIER

SERVICE BULLETIN NO 3

REDUCE EXCESSIVE ALC CONTROL

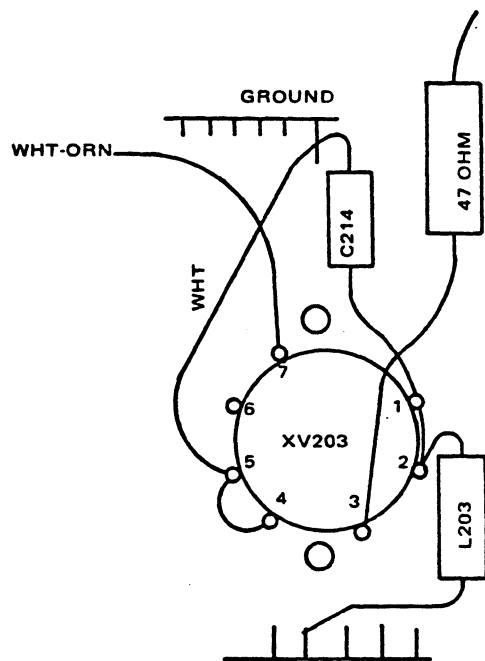
BEFORE MODIFICATION

In order to determine if your unit has this modification installed, observe the top side of relay shelf to locate the tube and socket for V203 which is adjacent to CR205 and CR207 on the right and toward relays K203 and K202. If type 12AL5 tube V203 is present the 30S-1 has not been modified.

1. Remove all power to the unit and remove and position relay shelf to allow access to underside of shelf. It might be necessary to loosen R207 to allow room for movement.
2. Remove and discard 12AL5, V203 tube from socket XV203.

3. Remove and discard white wire from XV203 pins 4 and 5 to terminal strip ground.
4. Remove securing hardware and lift socket XV203 out of the way.
5. Install two terminals A and B (306-0234-000) in removed XV203 socket mounting holes with screws (343-0285-000) and washers (373-8010-000).
6. Disconnect white-orange wire (from J202) at XV203-7 and reconnect it to terminal A.
7. Disconnect L203 lead from XV203-2 and reconnect to terminal B.
8. Disconnect C214 lead from XV203-1 and reconnect to terminal B. Discard XV203 that is now free of circuit.
9. Install 1N457 diode CR218 (353-0204-000) from terminal A to terminal B (banded end).
10. Install 1N457 diode CR217 (353-0204-000) from terminal B to terminal strip ground (banded end).

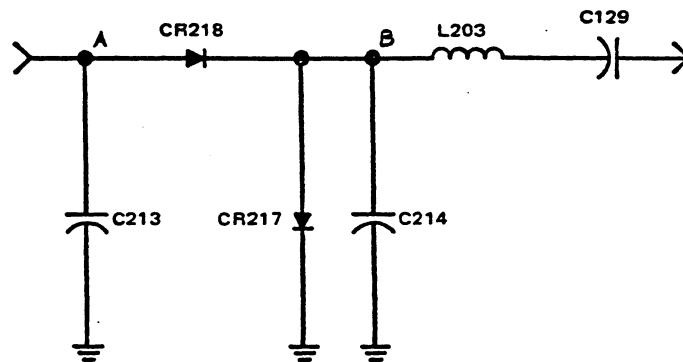
30S-1 SB 3 Modification, Schematic Diagram, Partial View
Figure 2

30S-1 units originally employed a 12AL5 dual-diode as the alc rectifier, V203. Some production runs of this tube exhibited high space-charge characteristics resulting in objectionable high standoff voltage on the alc line. The method recommended to ensure proper alc operating voltage is to substitute 1N457 silicon diodes for the tube.

NOTE: Figure 2 is a schematic presentation of the modification.
