TECHNICAL INFORMATION

Engine Harness Routing

No: 86/05/00/NAS
Ref:
Issue: 1
Date: 10/27/00

Discovery Series II (LT)

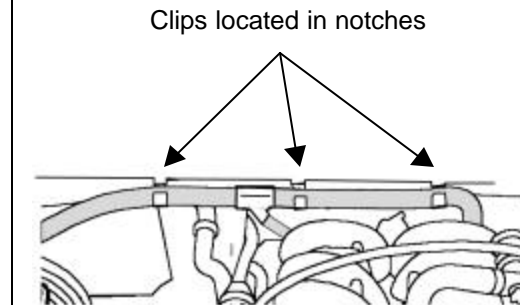
Figure 1

1. Remove the rubber seal from the edge of the cowl.
2. Refer to Figure 1. If clips are all located in the firewall notches, the right clip must be relocated as described below:

- Unclip the harness from the three securing clips.

**CAUTION:** The right clip must *not* be located in the notch to the right of the brake pipe clip.

- Relocate the clip on the passenger (right) side of the vehicle to a location directly above the brake pipe clip. (Figure 2)
- Verify that the remaining two clips are located in the cowl notches to the drivers side (left) of the brake pipe clip.

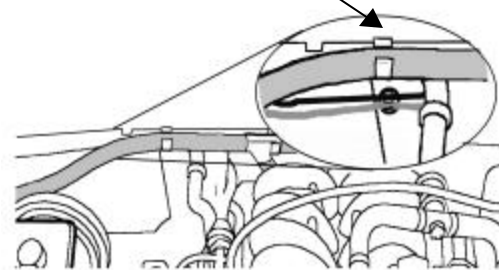
Figure 2

Correct Clip Location

**NOTE:** There is no notch in the new right side clip location
