TECHNICAL INFORMATION

No: 76/20/03/NAS
 Ref:
 Issue: 1
 Date: 10/31/03

Interior Squeaks and Rattles

Discovery Series II (LT)

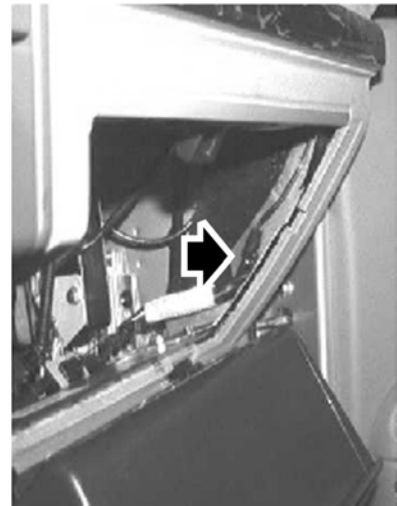
Figure 1

PROCEDURE 3 - TAPPING NOISE FROM THE GLOVEBOX

1. Open the glove box, align stops with cutouts in fascia and remove the glove box.
2. Ensure the light harness clip is fitted to appropriate hole in fascia frame (Arrowed in Figure 1).
3. Ensure the aerial coaxial lead is fitted as shown ('A' in Figure 2).
4. Ensure the airbag harness is fitted in the 'Y' frame ('B' in Figure 2).
5. Raise the glove box, align stops with cut outs in fascia and close the glove box.

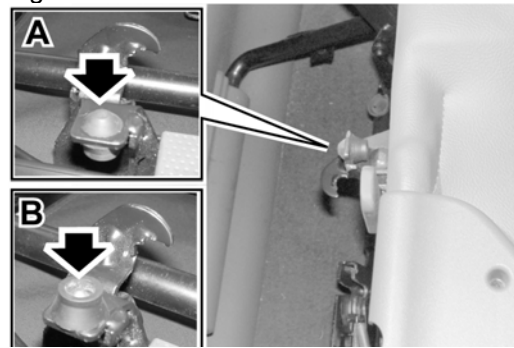
Figure 4

PROCEDURE 5 - THIRD ROW SEATS RATTLES AND CREAKS

1. Release the 3rd row seat from the stowed position.
2. Remove the rubber buffer and refit in reversed position (from 'A' to 'B' in Figure 4)
3. Remove backing from tape (STC3118K) and fit pad to the top and the underside of the hook on seat frame (See Figure 5).
4. Fully deploy the seat and apply Krytox to seat piping (Arrowed in Figure 6).
5. Stow seat.
6. Repeat procedure for the other side.

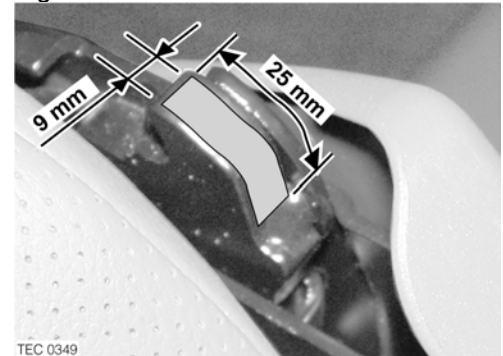
Figure 7

PROCEDURE 6 – SECOND ROW SEATS RATTLES AND CREAKS

1. Fold the LH and RH rear seat squabs forward.
2. Apply Krytox to the upper area on the LH side of the LH rear seat squab.
3. Cut two velour pads (STC3118K) to the dimensions detailed in Figure 7.
4. Remove backing from the velour pads and install one pad to the LH seat cam ('A' in Figure 8) and one pad to the RH seat cam ('B' Figure 8).
5. Secure seat squab into fixed position.
6. Lower center armrest and apply Krytox to areas between armrest and seat bolsters (Figure 9).
7. Fold center armrest back into position.

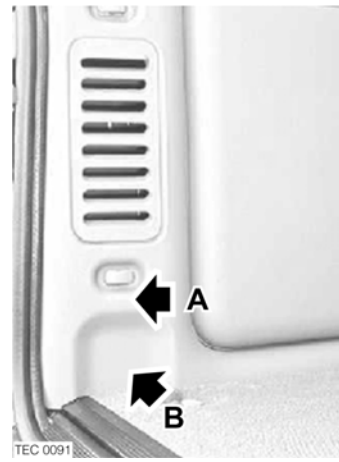
Figure 9

PROCEDURE 8. CREAKING NOISE FROM REAR LEFT HAND CORNER OF VEHICLE

1. Check for slight discolouration on the rear quarter trim ('A' in Figure 9).
2. Carefully push on the bottom of the rear quarter trim ('B' in Figure 9) to create a clearance gap between the subwoofer and the rear quarter trim.
3. Release six clips securing the tail door aperture upper trim casing and remove the upper trim casing.
4. Remove the backing from the tape (STC3118K).
5. Install the tape to both ends of the trim casing. (Arrowed in Figure 10)
6. Remove two trim studs ('A' in Figure 11) from 'D' post upper trim casing and ease casing away from the glass.
7. Remove backing from velour pad (Available in kit STC4006).
8. Install pad to edge of trim casing ('B' in Figure 11).
9. Install studs to trim casing and secure casing.
10. Install and secure the tail door aperture upper trim casing.

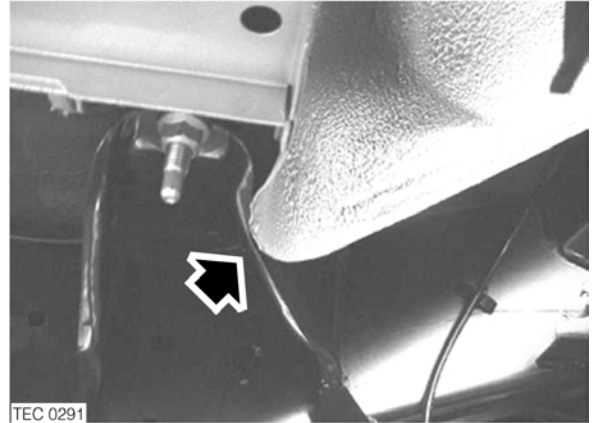
Figure 12

PROCEDURE 10 - CREAK FROM REAR SEAT AREA THAT IS HARD TO TRACE.

1. Ease the wheel arch away from the chassis outrigger to create a 2-3mm gap (Arrowed in Figure 12).
2. Apply underbody sealer to the damaged area.

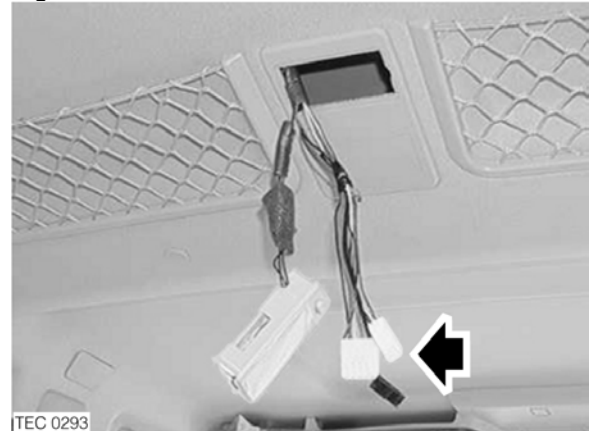
Figure 13

PROCEDURE 11 - TAPPING NOISE FROM THE CENTRE OF THE HEADLINING.

1. Remove the lens from interior lamp.
2. Remove two nuts securing interior lamp to roof.
3. Release the interior lamp from the headlining and locate the unused loose connectors (Figure 13).
4. Wrap all connectors and harnesses with foam tape available in kit STC4006.
5. Position connectors behind the headlining and under the other harness running along the headlining.
6. Install the interior lamp and lens
7. Tap the headlining to verify noise has been eliminated.

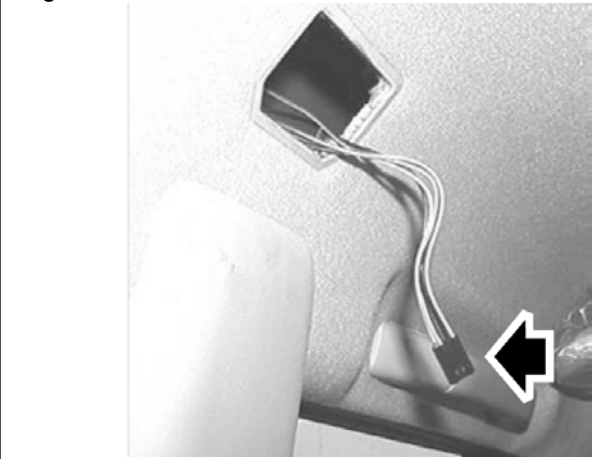
Figure 14

PROCEDURE 12 - TAPPING NOISE FROM HEADLINING ABOVE LH SIDE 'B' POST.

1. Remove the blanking panel from headlining,
2. Locate the unused alarm ultrasonic sensor connector (Arrowed in Figure 14).
3. Wrap foam tape available in kit STC4006 around the connector.
4. Position the connector behind the headlining.
5. Install the blanking panel.

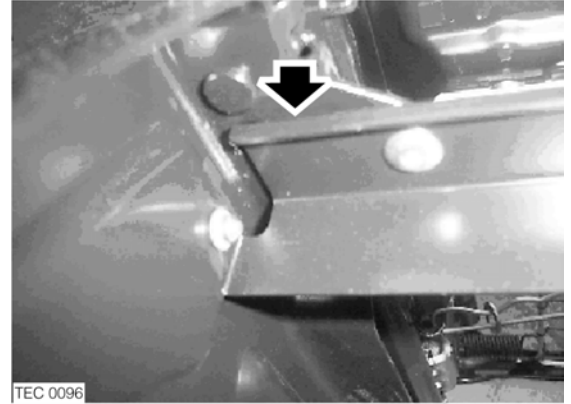
Figure 15

PROCEDURE 13 - NOISE FROM FRONT CROSS MEMBER

1. Slide seat fully forward.
2. Apply non silicone based grease available in kit HAK000010 to the mating surfaces of the cross member and outboard plinth bracket. (Arrowed in Figure 15)
3. Return seat to original position.

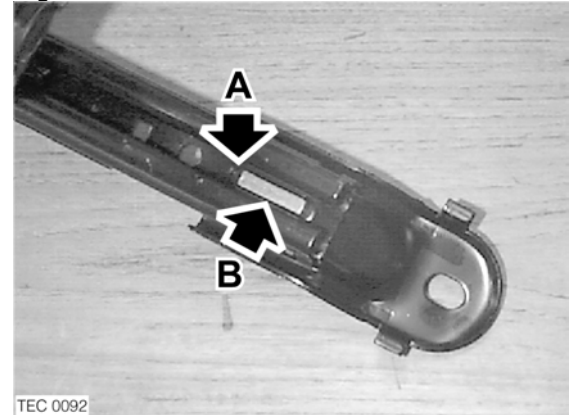
Figure 16

PROCEDURE 14 - METAL TO METAL NOISE FROM REAR TRACK END-STOP WHEN SEAT IS FULLY REARWARD.

1. Switch ignition to the on position.
2. Slide seat fully forward and apply grease available in kit HAK000010 to both slide end-stops. (Arrowed in Figure 16)
3. Return seat to original position.
4. Switch off ignition.

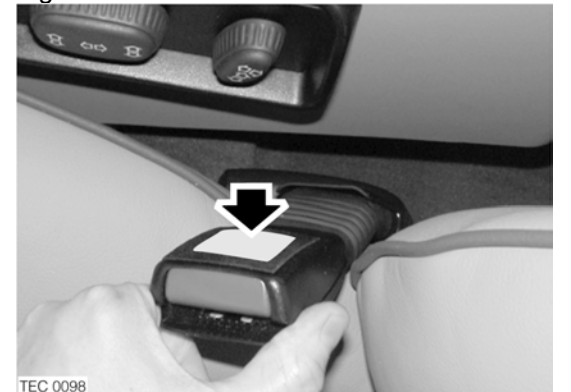
Figure 17

PROCEDURE 15 - NOISE FROM SEAT BELT PRE-TENSIONER

1. Trim and fit velour strips (STC3118K) to the seat belt stalks. (Arrowed in Figure 17)

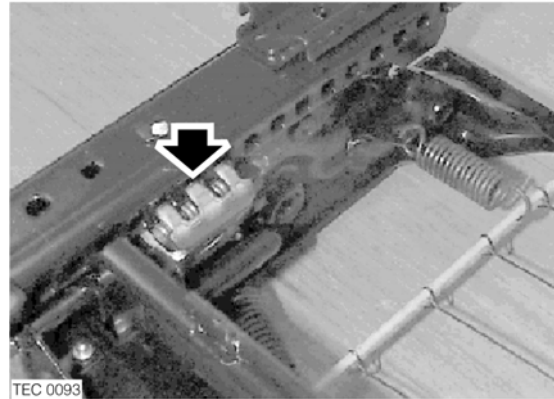
Figure 18

- NOISE FROM THE SUSPENSION MAT AREA FROM CONTACT WITH REAR TUBE
 - CREAK FROM SLIDE LATCH CONTACTING FRAME WHEN SEAT OCCUPIED.
 - CORNER BRACKET CREAK FROM REAR OF FRONT SEAT.

8. Secure the recline motor harness with a cable tie.
 9. Hold the release catch fully open and apply grease to the teeth on both latches (arrowed in Figure 18).

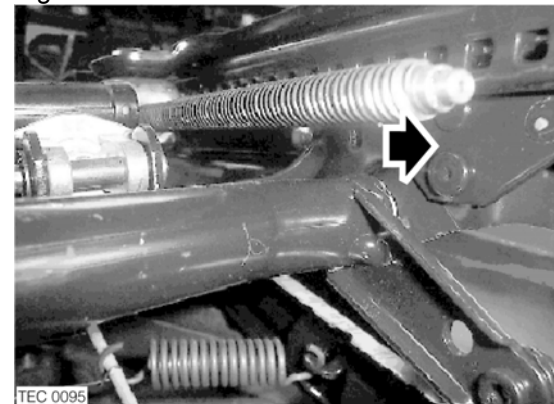
Figure 20

- NOISE FROM THE HEIGHT-ADJUST CROSS-TUBES.
 - NOISE FROM CUSHION SIDE CHANNEL.
 - A CONSTANT HIGH PITCHED SQUEAKING NOISE FROM THE UPPER PART OF THE FRONT SEAT SQUAB FROM TRIM WIRE CONTACT WITH THE RETURN

12. Apply grease to both mating surfaces of the rear cross-tube and wipe off excess. (Arrowed in Figure 20)
 13. Replace nut and washer (supplied in kit HAK000010), and torque to 19 Nm.
