AR7030 technical bulletin 003

J309 FET Change and SD5400 Clamping Diodes

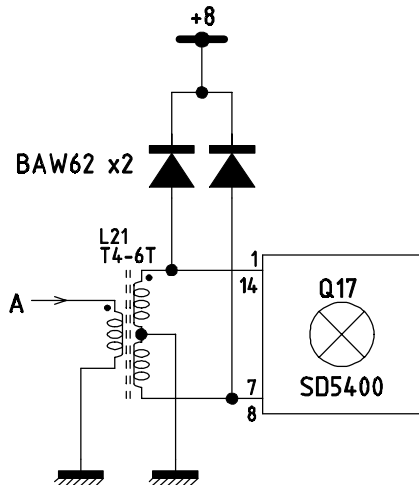
Replace the SD5400 if it's failure is suspected and in all sets add two diodes between the input transformer L21 and an 8V supply as shown below

We suggest that two silicon low capacitance diodes such as BAW62 are used. Twist the diodes together at the cathode end, solder and cut short. Cut both anodes short and solder each to one leg of the secondary winding of L21 on the underside of the board. Close proximity of the diodes to the SD5400 should be avoided, the diodes should therefore point towards the rear of the set being careful to insulate the cathode connection to avoid contact with the middle primary leg of L21 which is at +B potential. An insulated length of wire should be connected from the cathode connection pair to an 8V supply. A convenient point to pick up the 8V supply is at the top end of VR1 mixer bias preset.
