SB-928

## SERVICE BULLETIN AMATEUR RADIO

SUBJECT	DATE
TS-140S INTERMITTENT LOSS OF TRANSMIT POWER	4/11/88

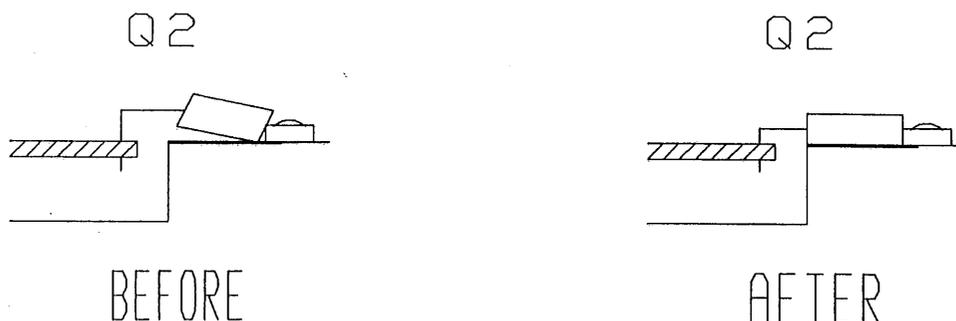
In some TS-140S transceivers, the drive transistor Q2 is not firmly mounted to the radiator plate. This can cause a loss of transmit power after the unit warms up. The following modification will correct this condition.

1. Disconnect the TS-140S from the antenna and power supply.
2. Remove the top and bottom covers. Open the subchassis. Refer to the instruction manual for step by step instructions.
3. Remove the shield plate from the subchassis (12 screws) to expose the Filter and Final units. Do not loose the 2 springs that are secured by the right side screws.
4. Resolder Q2 so that the transistor makes firm contact with the radiator plate on the Final unit. Tighten the transistor's mounting screw (see the diagram below).
5. Assemble the transceiver by reversing steps 1 through 3.
