# SERVICE BULLETIN

from: TRIO-KENWOOD COMMUNICATIONS, INC.

SUBJECT: TS-180S DFC INSTABILITY

DATE 7/13/79

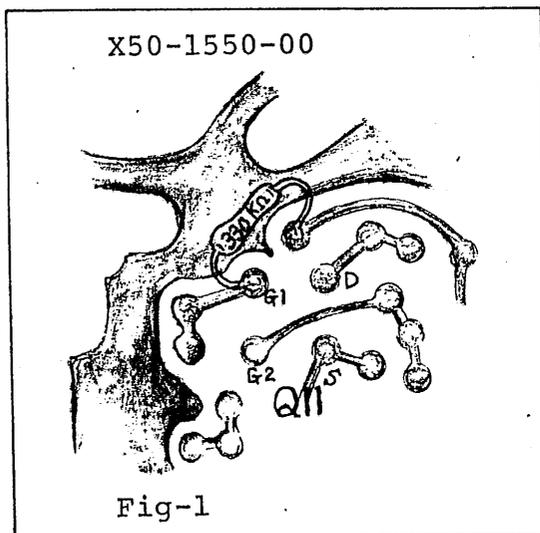
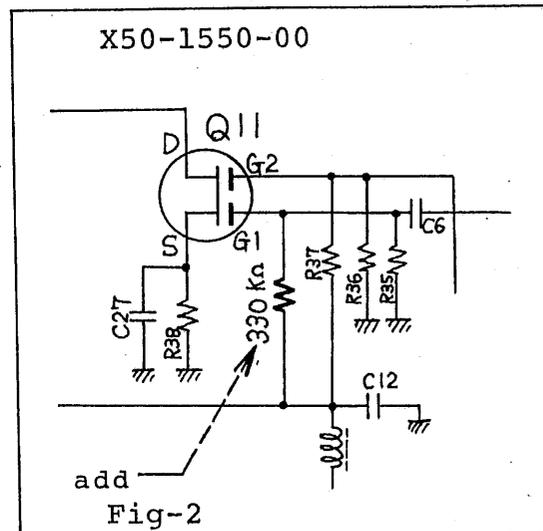
TS-180S operators may report intermittent DFC instability, especially at 10Khz even points. This may be characterized in some cases as FM'ing.

On page 37 of the Service Manual, the Board view of the VCO unit contains reversed callouts for Q11 & Q15 FET's. D & S, and G1 & G2 are transposed.

On the VCO unit X50-1550-00, install a 330K ohm resistor between Q11 G1, and the 8V line. Connect from L7 at C12 to Q11 G1, at R35.

No adjustments are necessary.
