Circuit Improvements for the TS-440S

by Richard L. Measures, AG6K

Updated December, 2002

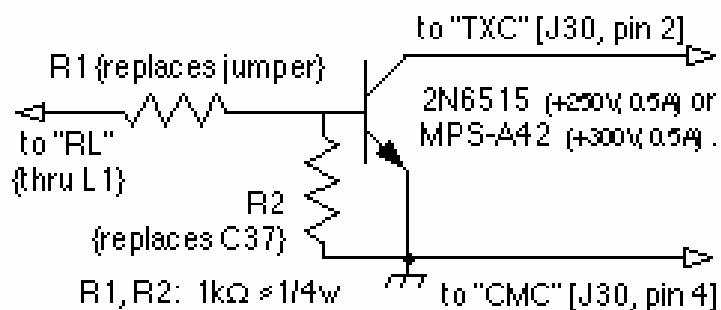
*Amplifier-control-relay (RY2) replacement for
TS-440S SWITCH UNIT, (N41-1610-00) (N-14)*

PROBLEM: The amplifier-keying-relay, RY2 on the (N/14) Switch Unit, makes too much noise, or the contacts on RY2 have burned and pitted, or all of the above. Another problem with RY2 is that it is too slow to use with a full-QSK amplifier. This needless make-delay can cause the amplifier to hot-switch, burning the contacts in its QSK-relays. **FIX:** replace RY2 with an NPN switching transistor and fix the current pulse problem that pitted the relay contacts, which may also damage the transistor. [only works for amplifiers with positive voltage relay control]. If your amplifier uses positive 110V for the relay control, like the SB-220 and the TL-922, the relay pitting is caused by the current pulse from the repeated shorting out of the charged .02 μ F bypass capacitor across the amplifier's relay control jack. The bypass-capacitor can be removed if shielded wire is used for the interconnection cable to the transceiver. Another fix is to install a 150 Ohm to 200 Ohm, 1/4W series resistor at the relay control jack to limit the discharge current to a value that the relay or switching transistor can handle. The bypass capacitor is connected to the relay-side of the resistor.

Transistor Installation Notes: The N/14 Switch Unit is located just behind the ANT RF connector on the rear panel. The small access panel on the bottom, rear of the radio is removed to gain access to the N/14 Switch Unit. Two chassis-ground connections and one center pin connection must be unsoldered from the RF connector before the Switch Unit can be removed. Unplug the three connectors, remove the two sheet metal screws, and lift out the Switch Unit. Unsolder and remove RY2, D16, and the white jumper-wire and the pin that it plugs into. Install one 1k Ohm resistor each in place of D16 and in place of the jumper-wire and its pin. The transistor will solder in place of the relay if its full length leads are bent to fit the available holes. The emitter goes to common-ground, as does the trace to J30, pin4 [CMC], the ground return for the relay control circuit. The base lead connects to the trace that goes to R2 {D16} and C37. The collector solders to the trace that connects to J30, pin 2 [TXC].
