Kenwood TS-830

Survival Guide

Kenwood TS-830 Survival Guide, ed. [Olaf Rettkowski](#), DL9AI, ver.1.2, 03 Dec 2002

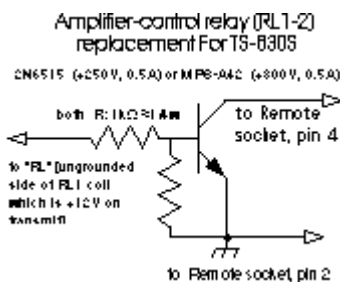
6.1 Excessive delay in relay control signal to external amplifier--which causes hot switching in the amplifier's RF relays

Cause: The RF relay in the TS-830S also switches the external amplifier relay control line. Thus, the amplifier relays can not begin to close until the RF-relay in the TS-830S has closed.

Fix: Install a NPN >200V switch transistor [MPS-A42 or=] in the TS-830S to take over the job of relay control line switching. The input [base] of the switch transistor is driven by the +12V on transmit signal ["RL"] that drives the coil of the TS-830S' RF-relay, RL1. The base-current is limited to approx. 11 mA with a 1 KOhm series resistor. Connect another 1 KOhm resistor between the emitter and the base to drain off the stored charge in the base. The emitter connects to chassis-ground. The collector connects to the wire from pin 4 on the Remote socket. Pin 2 of the remote socket should be connected to chassis-ground or to the emitter of the transistor. The NPN transistor can only switch a positive relay-control line voltage, so this circuit will not work on negative relay-control voltage amplifiers like the SB-200 and the 30L-1. The fix is to convert these amplifiers to [standard] positive V relay control line polarity. A solid-state electronic cathode bias switch [ECBS] is useful in this application. Such a circuit is shown in QST magazine, January 1994, "The Nearly Perfect Amplifier."

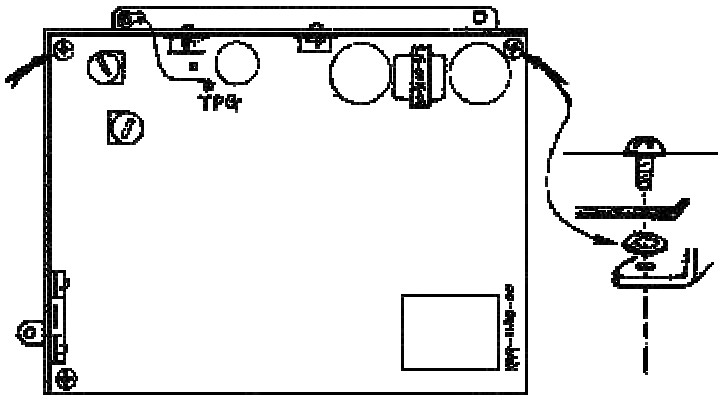
Some users may report an intermittent shift in the display and operating frequency. This may typically be a 1 to 4 KHz random shift. Cause will be a loose grounding screw on the AF/AVR unit heat sink.

1. Remove the top cover (8 screws) and unplug the speaker.
2. Remove the bottom cover (8 screws).
3. Remove 5 screws holding the AF/AVR unit and swing the board over. Leads do not have to be unplugged.
4. Add two tooth-lock washer as shown.
5. Replace the circuit board and heat sink to the chassis, adding the solder lug as shown.
6. Solder a jumper between the TPG wrap post and the added solder lug.
7. Replace the top and bottom covers.

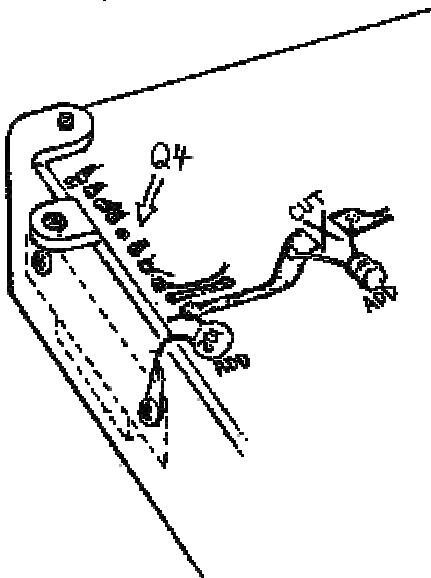
Transmitter "talkback", either with or without a linear amplifier, may be eliminated by adding a filter at the receiver audio power amplifier.

On the AF unit X49-1140-00 at Q4, cut the 12 V DC B+ line between R47 and C28, and add a 1 μ H choke (L40-1092-02) in-line. Add a 0.01 μ F cap (C52-1710-36) from the IC pin 1 to ground, as shown using a 3 mm lug (E23-0015-04) under the IC mounting screw on the heat Sink.
