ASB-1006

Service Bulletin

Subject: TS-850S Low/no Receiver Sensitivity

Date: January 22, 1993

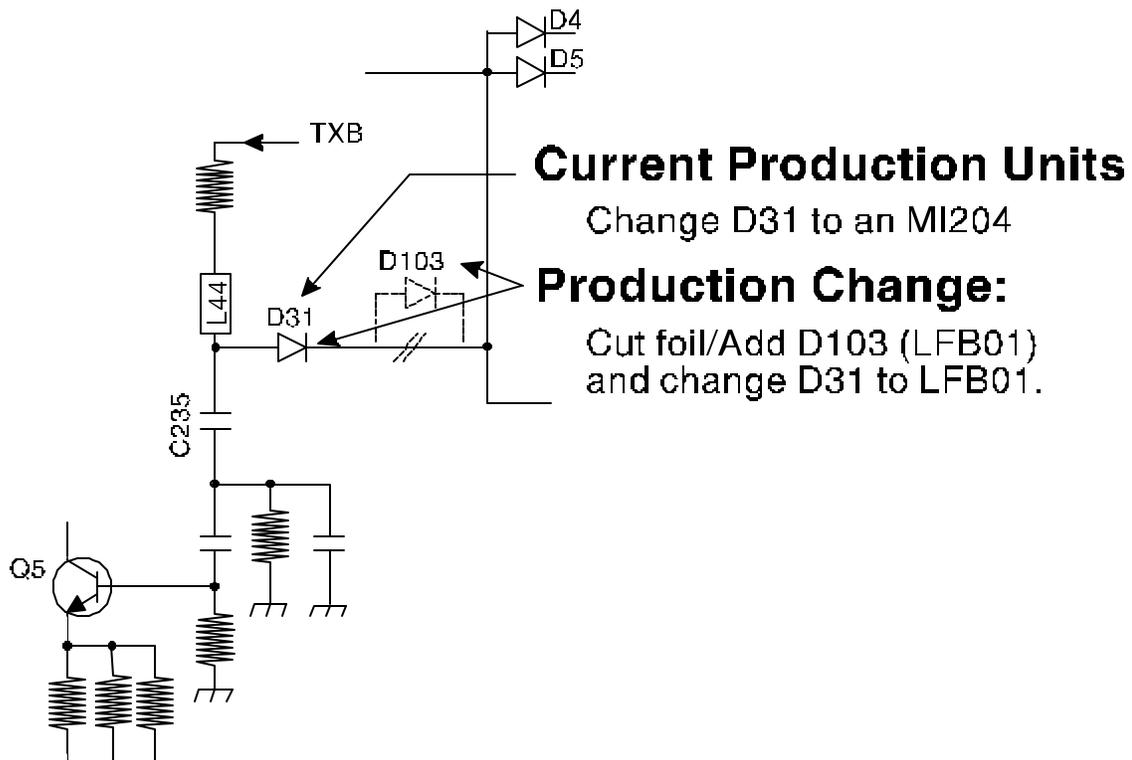
RF Unit (X44-3120-00)

Reports of low or no receiver sensitivity accompanied by a lack of audio from the speaker during CW or SSB modes might be caused by improper RXB voltage levels. Normal RXB voltage is +8 vdc during receive and 0 vdc during transmit. If you find approximately +2 vdc during receive you might suspect a problem with a leaking diode, D31 on the RF unit (X44-3120-00.)

D31 is used as the transmit switching diode. Leakage of this diode is most probably caused by electrostatic surge or discharges from the antenna.

A temporary cure for units that have already been manufactured is to replace D31 with an MI204 diode. Future production radios will change D31 to an LFB01 diode and incorporate a change in the printed circuit foil pattern to allow addition of a series diode, D103 (LFB01).
