SUBJECT : PARTS SUPPLY OF THE CONNECTOR FOR TS-850S

SERVICE TECHNICAL REPORT

MODEL TS-850 Series DATE Aug. 08 '91

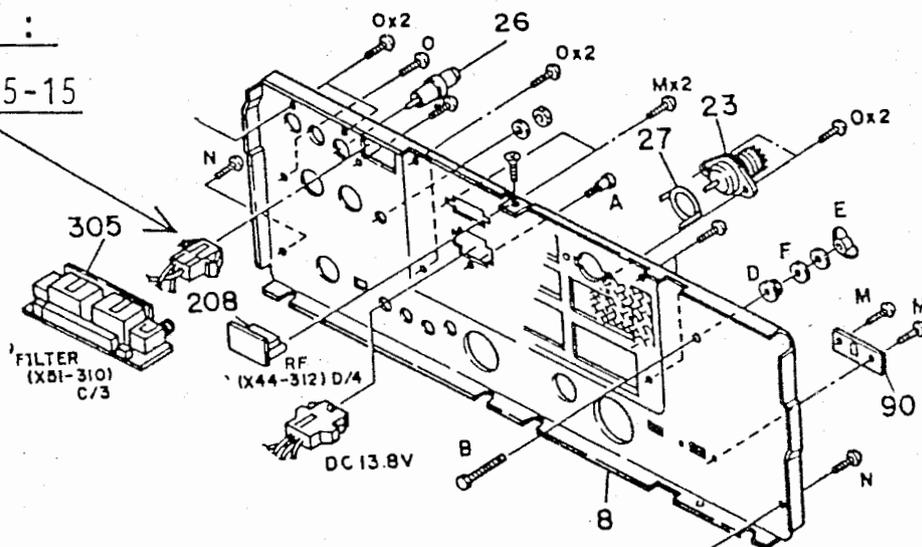
E37-0115-15

The connector of following part is in stock now.

The part has been registered as a new part.
 Please record it your service manual. (on page 93 B51-8098-00)

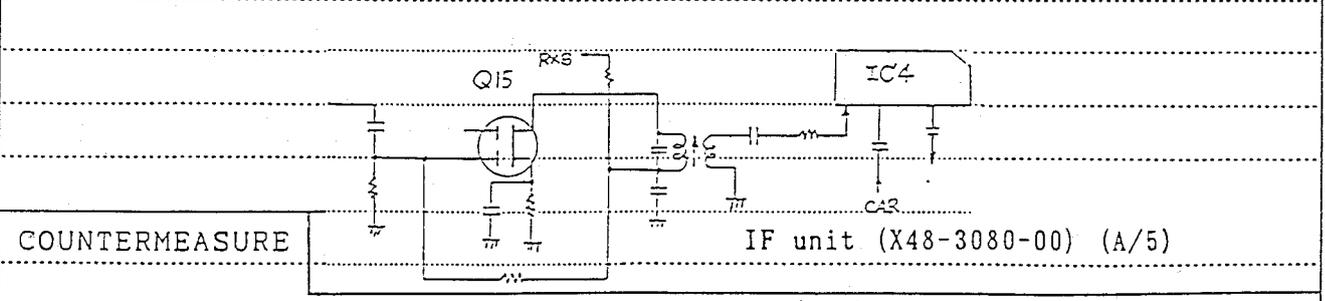
I finally found out that Q15 in the IF unit was the cause of the failure. When this failure occurs, the drain voltage of Q15 is lowered. I recall that a similar failure occurred when the D31/Q5 of the RF unit became faulty. When the volume was turned up, a slight reception could be confirmed.

COUNTERMEASURE IF unit (X48-3080-00) (A/5)

Replace Q15 (3SK131M).

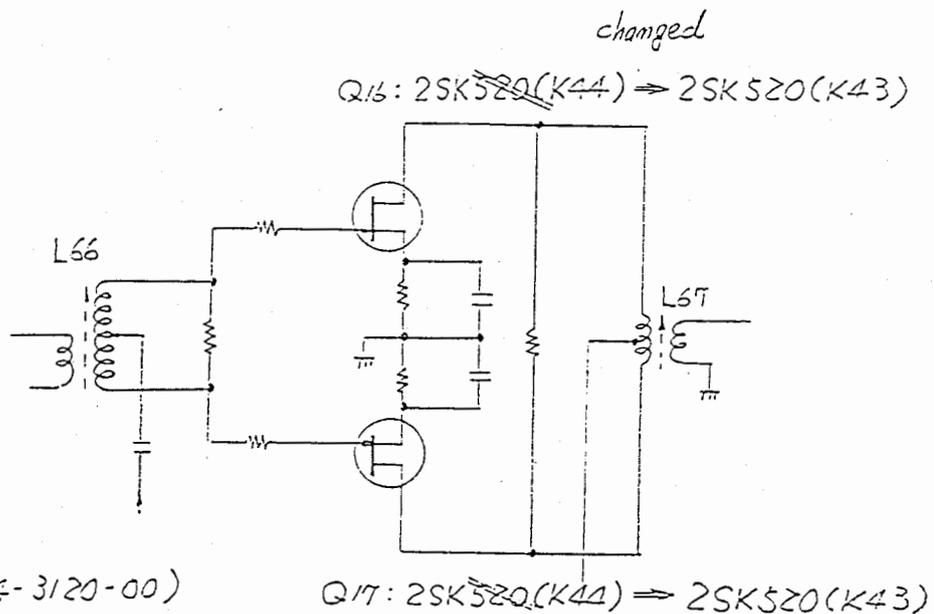
Phenomenon: TS-850S that could not adjust S-1 (reception, S meter starting point level) and could not determine the SSB gain were found during production. The information serves as a tip for repairs.

Cause: Variation of Q16 and Q17 gain in the second mixer (73.05MHz to 8.83MHz) FET in the RF unit.

Note: In FET, the lower the IDSS (drain breaking current), the greater the mixer conversion gain. As a result, the total gain of the reception circuit gets greater.

Counter- : Replace the Q16 and Q17 with low IDSS types in the RF unit (X44-3120-00)
measure Q16, Q17: 2SK520 (K44) → 2SK520 (K43) Changed

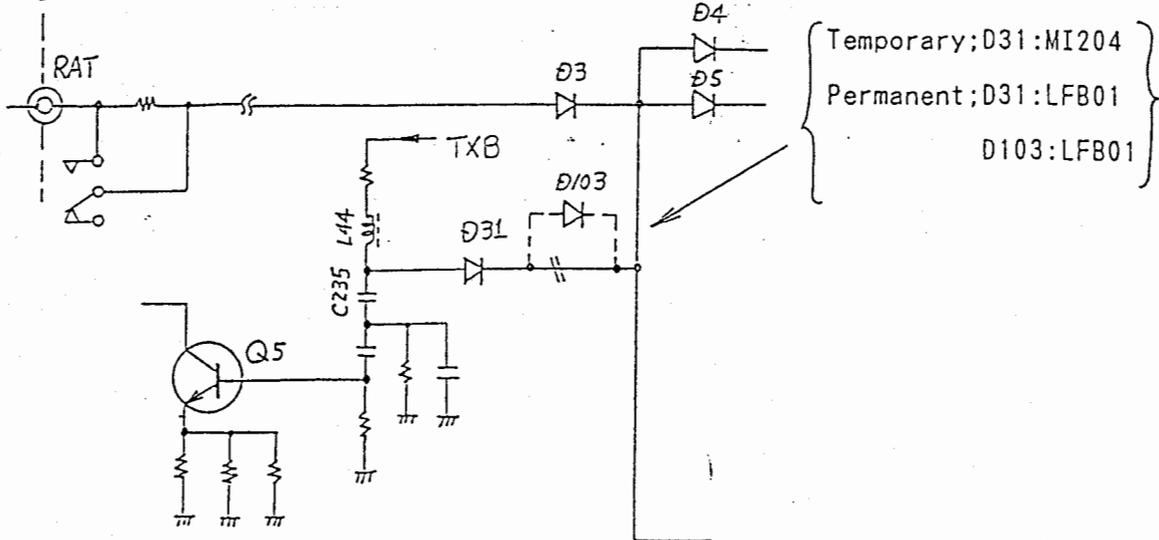
Circuit diagram: RF unit (X44-3120-00)

SUBJECT: Countermeasure against defective RF unit D31:RLS135 (due to destruction by electrostatic surge).

Note: In the permanent countermeasure, the pattern is changed, with D31 and D103 connected in series.

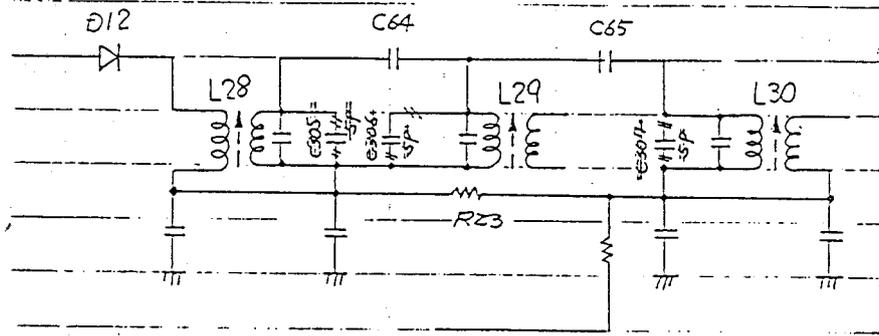
RF unit (X44-3120 -xx)
Address E-5 in circuit diagram.

The ceramic capacitors, C305 to C307: 5 pF (CC45CH1H050C), were added to solve the problem of a failure to tune B.P.F. due to a matching capacitors connected to the tuning coils.

New tuning coils have a built-in 5 pF capacitor and so do not require C305 to C307.

Name	Ref. No	Old part number	New part number
Tuning coil	L28 ~ L30	L34-4268-05	L34-4289-05 (new part)

Remove ceramic capacitor C305 ~ C307 (5 pF)

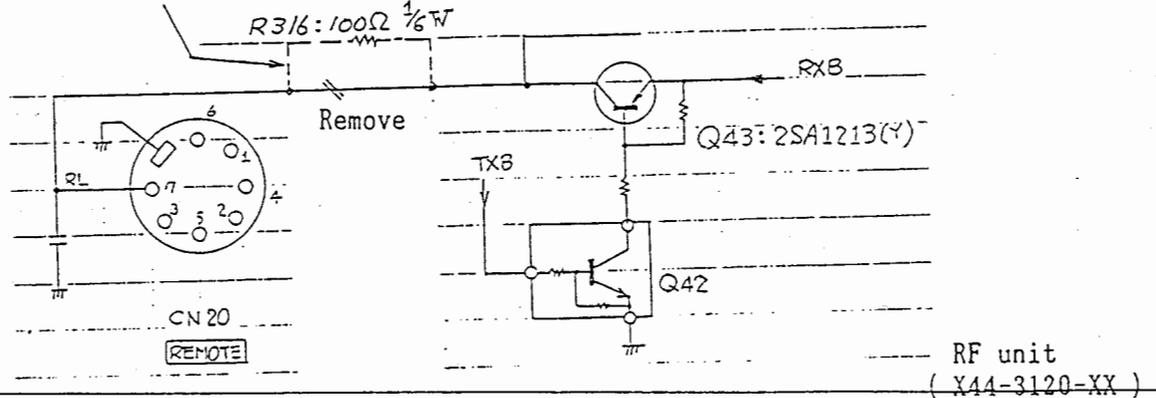
SUBJECT Defective of Q43 in RF unit when other external accessory equipment (e.g. Linear amplifier) is improperly connected.

Cause : Pin 7 (RL line) is directly connected to Q43:2SA1213(Y) (TXB-RL DC SW Tr) on the RF unit. If pin 7 (RL line) of the REMOTE socket is grounded, the emitter and collector of Q43 short circuit in a quick time and consequently defective.

Countermeasure : A protection resistor is installed against the defective of Q43 on the RF unit in case pin 7 of REMOTE socket is grounded.

Carbon resistor 100 Ω : RD14BB2C101J 1/6 W
Resistor to be added.

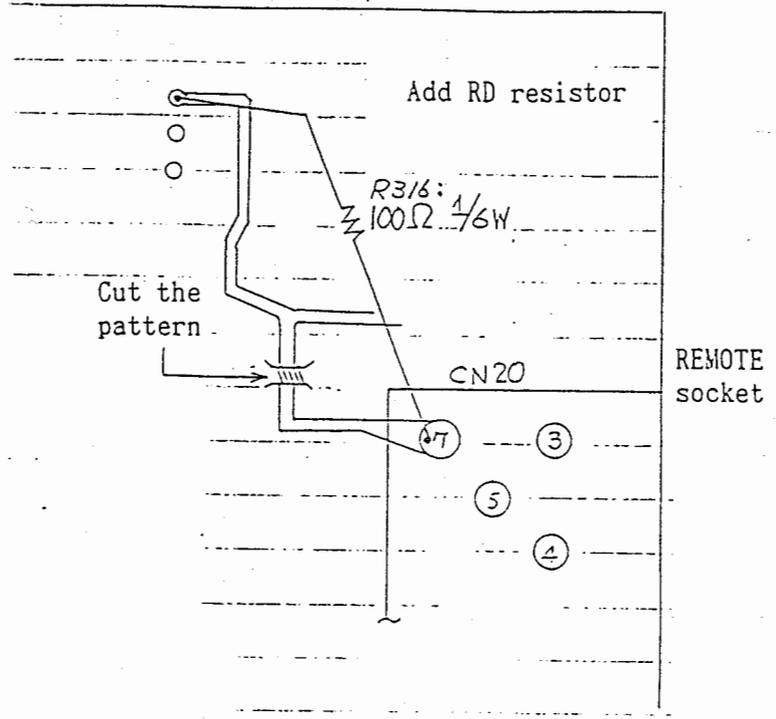
RF unit (X44-3120-XX)
 (Foil side view) PC Board
 address T-2,3

SUBJECT Defective of Q43 in RF unit when other external accessory equipment (e.g. Linear amplifier) is improperly connected.

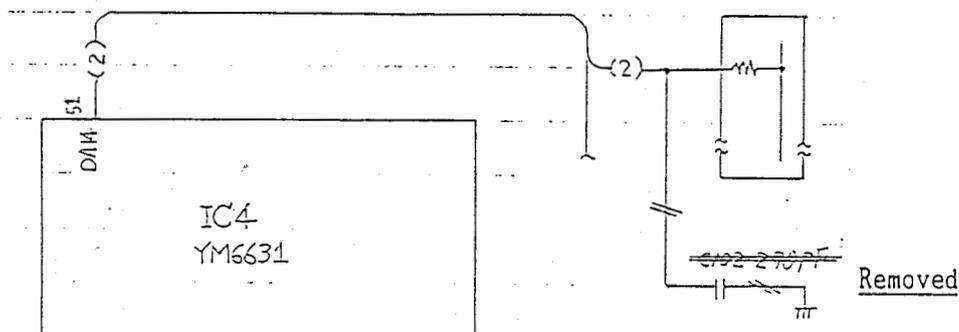
Phenomwnon : A internal beat is produced from the internal speaker when knobs are operated under certain conditions. The internal beat level is low, but is offensive to the ear when the radio is used in a silent room. However, there has been no complaint about this internal beat although the radio has been on the market for two months. (The phenomenon was reported from a new-product monitoring check.)

Cause : The capacitor C102: 270pF, was installed by mistake. This pacitor connects to the DDS IC in the CAR unit (X50-3140-00). (The circuit diagram shows that the capacitor connects between IC 4 pin 51 and GND. Actually, however, it was connected between IC pin 52 and GND on the PC Board.

Note: The C102: 270pF, has located on the component side of PC Board (it is on the upper-left corner of IC 4: PC Board address: B-6.) Removing this C102 improves the level of DDS produced spurious radiation from -60dBm to -75dBm, so there is no more beat at all. The improvement is from 3.5 mV to 1.5mV rms.

Countermeasure:
The chip capacitor C102: 270pF, will be removed from the CAR unit (X50-3140-00).

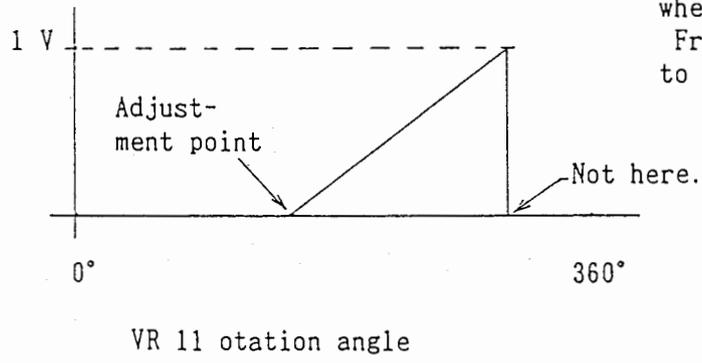
Phenomenon: When the antenna tuner is started in the 10 MHz band in the high temperature (about +50 °C) condition, the tuner cannot tune (the variable capacitor : VC continues moving, unable to find the tuning point forever.)
This failure was discovered during production. The information may be useful for services.

Cause : ALC meter misadjustment (RF unit : VR 11). VR 11, which is an endless semi-fixed variable resistor, is adjusted to the point that has no carbon (no resistance value).
To match the meter indication, the gain of the meter amplifier must be at the maximum. Then, the meter amplifier output exceeds the input range of the A/D converter.

Counter-measure : The adjustment procedure of the ALC meter (Item 34, on page 105 of the Service Manual) will be changed as follows :

Method	Rated value
At present : RF unit VR 11	Adjust immediately before the voltage indicator moves.	0 V
After change : RF unit VR 11	Turn the VR 11 clockwise at around the 1 V range to lower the voltage until the point where no change is observed. From that point, fine-adjust to the starting point.	Approx. 10 mV

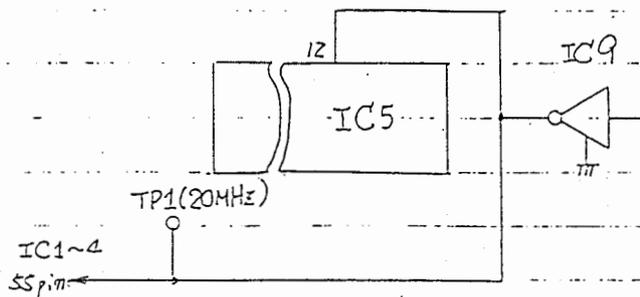
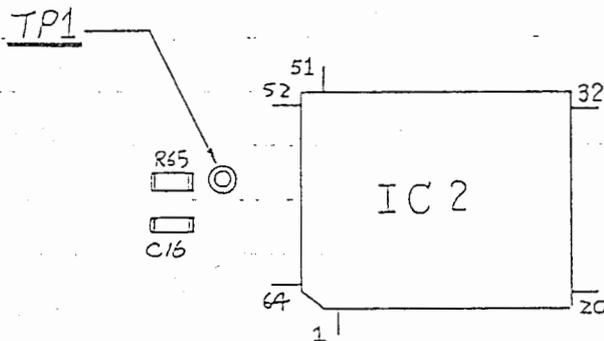
CAR unit
(X50-3140-00)

Background : The adjustment point of the 20 MHz Ref. OSC, which used to be in the PLL unit, had low oscillation level and showed incorrect display on the connected frequency counter.

So the adjustment point (TP 1 terminal) is moved to the CAR unit side on which the 20 MHz Ref. OSC, has a increase oscillation level; address B-3 (on the left side of the IC 2) on page 161 of the printed circuit board diagram of the Service Manual. (Also, the TP 1 terminal is not found in the circuit diagram address F-3 in-between the IC 5 pin 12 and IC1-4 pin 55).

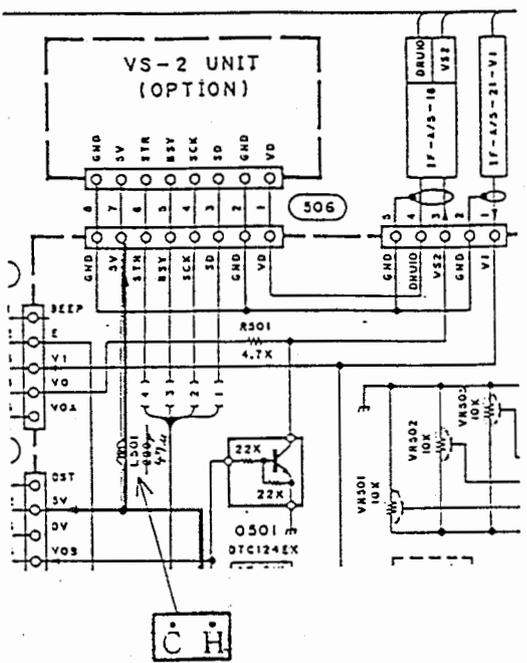
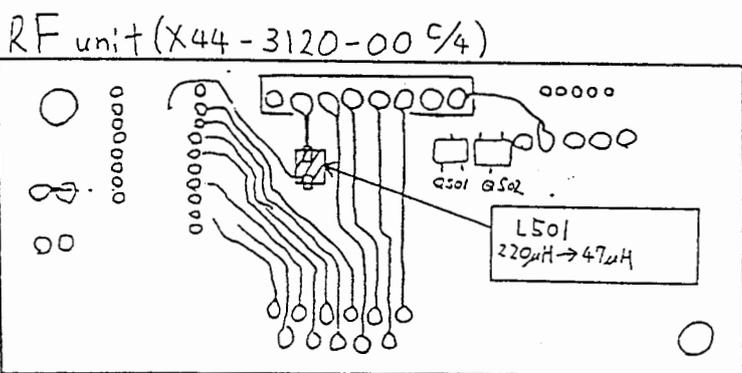
Cause: When connect VS-2, then 5C voltage drop down to 4.5V.

Countermeasure: RF unit (X44-3120-00 C/4) L501 change from 220 μ H to 47 μ H.

Old L40-2211-48 \Rightarrow New L40-4701-48

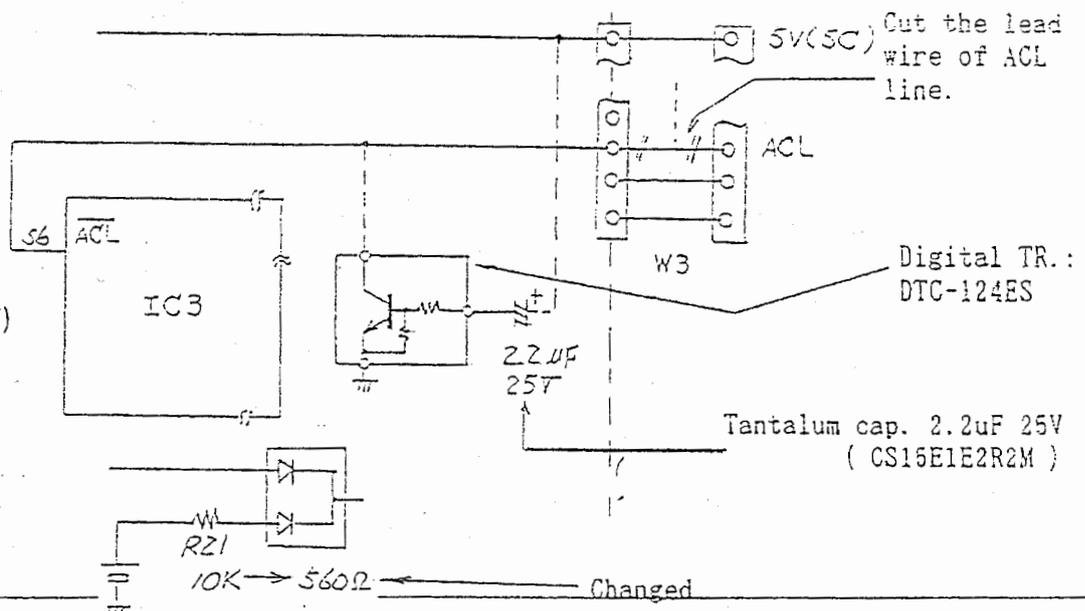
Cause: The lithium battery that back up data in the TS-850 containing the DRU-2 has dried up. When the TS-850 power switch is turned off, the lithium battery in the DRU-2 backs up recorded data, but it dries up much earlier because more than 100uA backup current flows (as compared to normal current of 1-2uA).
 When the DRU-2 is kept in storage by itself, the backup current is normal. Only when the DRU-2 is installed the TS-850 does the trouble occur.
 When power to the TS-850 is turned off with the DRU-2 connected to the TS-850, excessive backup current flows from the DRU-2's ACL line to the TS-850's reset line.

Modification parts kit.
 (W05-0379-00)

- o Lithium BAT. (W09-0326-05)
- o Insulator (UP) (F20-0520-04)
- o Insulator (DWN) (F20-0521-04)
- o Digital TR: DTC-124ES
- o Tantalum cap. 2.2uF 25V: CS15E1E2R2M
- o Tube: 10mm (212-1016-05)
