KENWOOD

ASB-1049

Service Bulletin

Subject: TS-850S "Click Noise" with Notch On

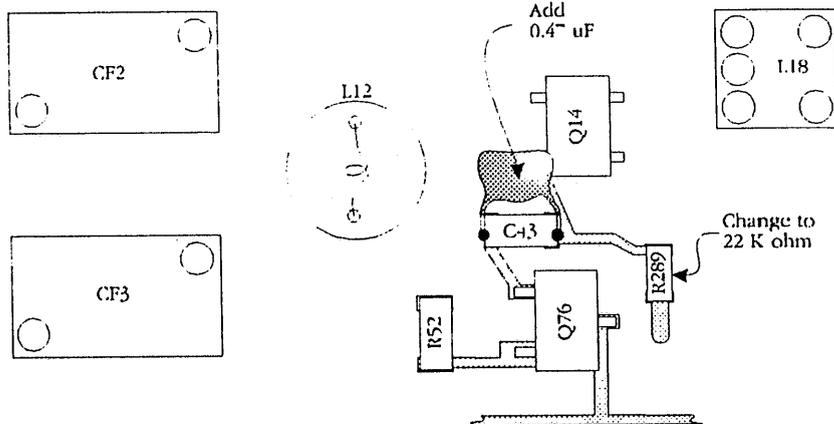
X48-3080-00 Foil Side View

When a strong signal of S-9 or greater is received at the antenna terminal with the NOTCH circuit ON a "clicking" noise might be noticed. This is caused by excessive response in the AGC loop circuit.

The changes detailed below will add additional delay to the AGC circuit and reduce or eliminate this tendency.

Qty	Description	Old Part No.	New Part No.	Circuit Description
1	22 k Ohm chip resistor	RK73FB2A103J	RK73FB2A223J	R289
1	0.47 uF capacitor	NA	CQ92M1H474K	NA
