SERVICE BULLETIN

SERVICE BULLETIN NO. 1

EQUIPMENT TYPE: 30L-1 R-F LINEAR AMPLIFIER

SUBJECT: WIRING CHANGE REQUIRED BEFORE CONVERSION FROM 115 TO 230-VOLT OPERATION IS MADE, USE OF 8-AMPERE LINE FUSES, AND CORRECTION TO INSTRUCTION BOOK DRAWINGS.

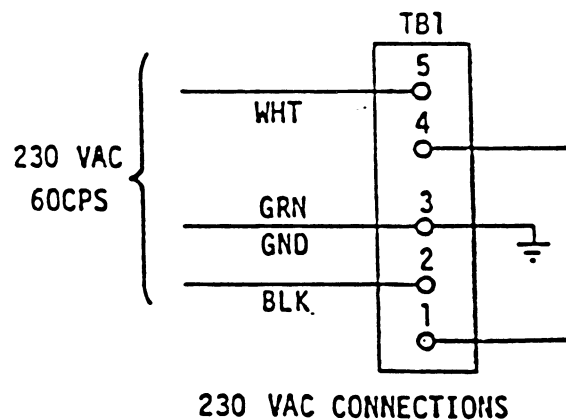
Figure 1

The procedure and schematic for converting operation of the unit from 115 to 230-volts, as detailed in the 5th edition of the 30L-1 R-F Linear Amplifier Instruction Book, dated 15 June 1962, is in error. These errors are corrected in the 6th edition of the above referenced instruction book, dated 15 June 1964. Before conversion is attempted the wiring changes detailed below must be made. After these changes have been made, the conversion can be made by changing the jumper wires on TB1 as shown in figure 1.

Termination of AC Power Cord at Terminal Strip TB1

1. Remove a-c power cord from the primary power source.
2. Lift the cabinet lid and remove the two Phillips-head screws located on the front panel rim.
3. Remove the four feet and the Phillips-head screw that is located between the rear feet.
4. Remove amplifier chassis from cabinet. The easiest way to do this is to place amplifier panel down on a padded surface.
5. Remove the screws from the bottom panel and both end panels of the amplifier. Lift out the bottom shield.
6. Move the white wire from the power cord from terminal 1 to terminal 2 on terminal strip TB1.
7. Move the lead of capacitor C4 from terminal 1 to terminal 2 of TB1.
8. Reassemble unit and return to operation. (Conversion from 115 to 230-volt operation and vice versa now can be made by connecting the jumper units on terminal strip TB1 as shown in figure 1.)
