TECH NOTES

TECH NOTE # TN 97-5

Vibro-King

Unit has excessive hum in reverb.

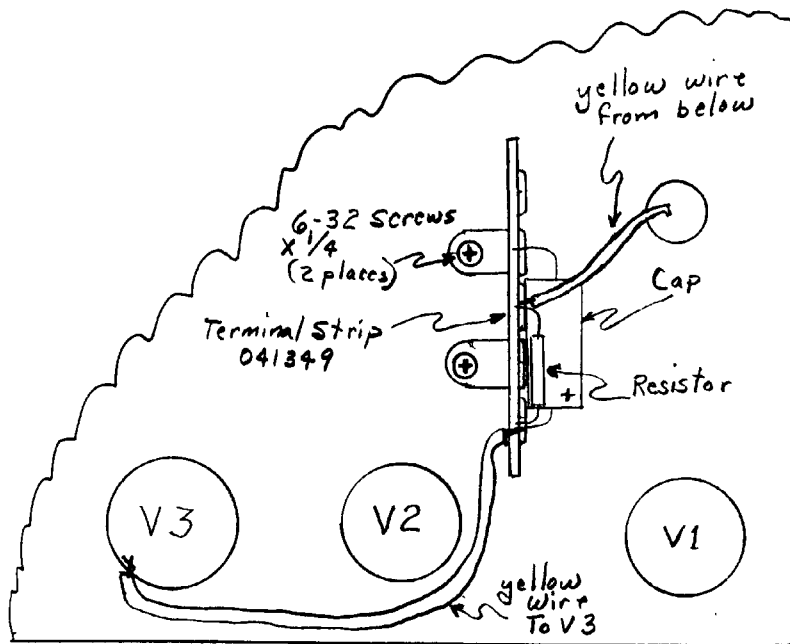
fig. 1

The screen grid of the 6V6 reverb driver tube is being modulated by 120 Hz ripple from the power supply. This can be reduced by adding decoupling components, R & C

- 1) Drill 2 holes to accomodate 6-32 screws, 3/4" spacing, in the approximate position shown in fig. 1; mount the terminal strip as shown.
- 2) Cut the yellow wire that runs through the hole in the chassis to V3, at a point that will allow the ends to be connected to the terminal strip as shown.
- 3) Attach positive end of C401, one end of R401, and the yellow wire attached to V3 to the end terminal.

- 4) Attach the negative end of C401 to the terminal that connects to chassis.
- 5) Attach the other end of R401 and the yellow wire to an unused terminal.
