APPENDIX A. RUNNING DESIGN CHANGES/FIELD SERVICE BULLETINS

The factory provided these ten Field Service Bulletins to 8X32 dealers and customers. Each Bulletin describes a remedial procedure for a specific problem, or a hardware change necessary to implement an improvement in the machine's design.

8X32 FIELD SERVICE BULLETIN #1

TITLE: PANEL BOARD CONNECTOR

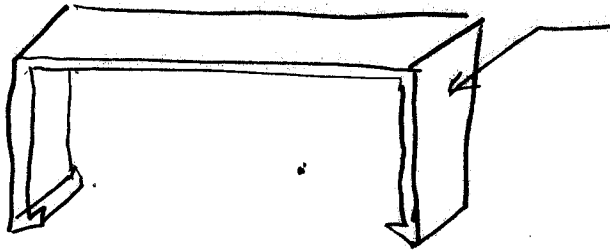
PROBLEM: J5 DIP connector from panel board to CPU board may vibrate loose in shipping, resulting in failure of front panel display or control functions.

HOW TO CORRECT THE PROBLEM: Unplug the unit from power. Set it right side up with front panel facing you. Protect the front panel with a soft cloth. Remove the top cover with the screws around the perimeter. Locate the ribbon cable at the front left of the unit and unplug the 24 Pin plug from J5 on the CPU-1 PC board. Gently bend it back, out of the way, toward the front of the unit and locate the tie wrap securing the large bundle of 6 wires passing underneath the cable, and cut the tie wrap securing these wires to the mother board. Redress that 6 wire group so that the wires are underneath the mother board and out of the way completely of the ribbon cable as it passes toward J5. Using a file, put 2 small notches (roughly 3/16" wide by 1/32" deep) 1 at each end of the plug that goes into J5. Attach the short piece of foam tape on top of the plug that goes into J5. Reinstall the plug into J5 and snap the new plastic clip down in place to secure the connector. Screw the cover back in place.

- 1.) 1 piece foam self stick tape, 1/2" x 3/4" x 1/8".
- 2.) 1 eby 24 Pin DIP clamp.

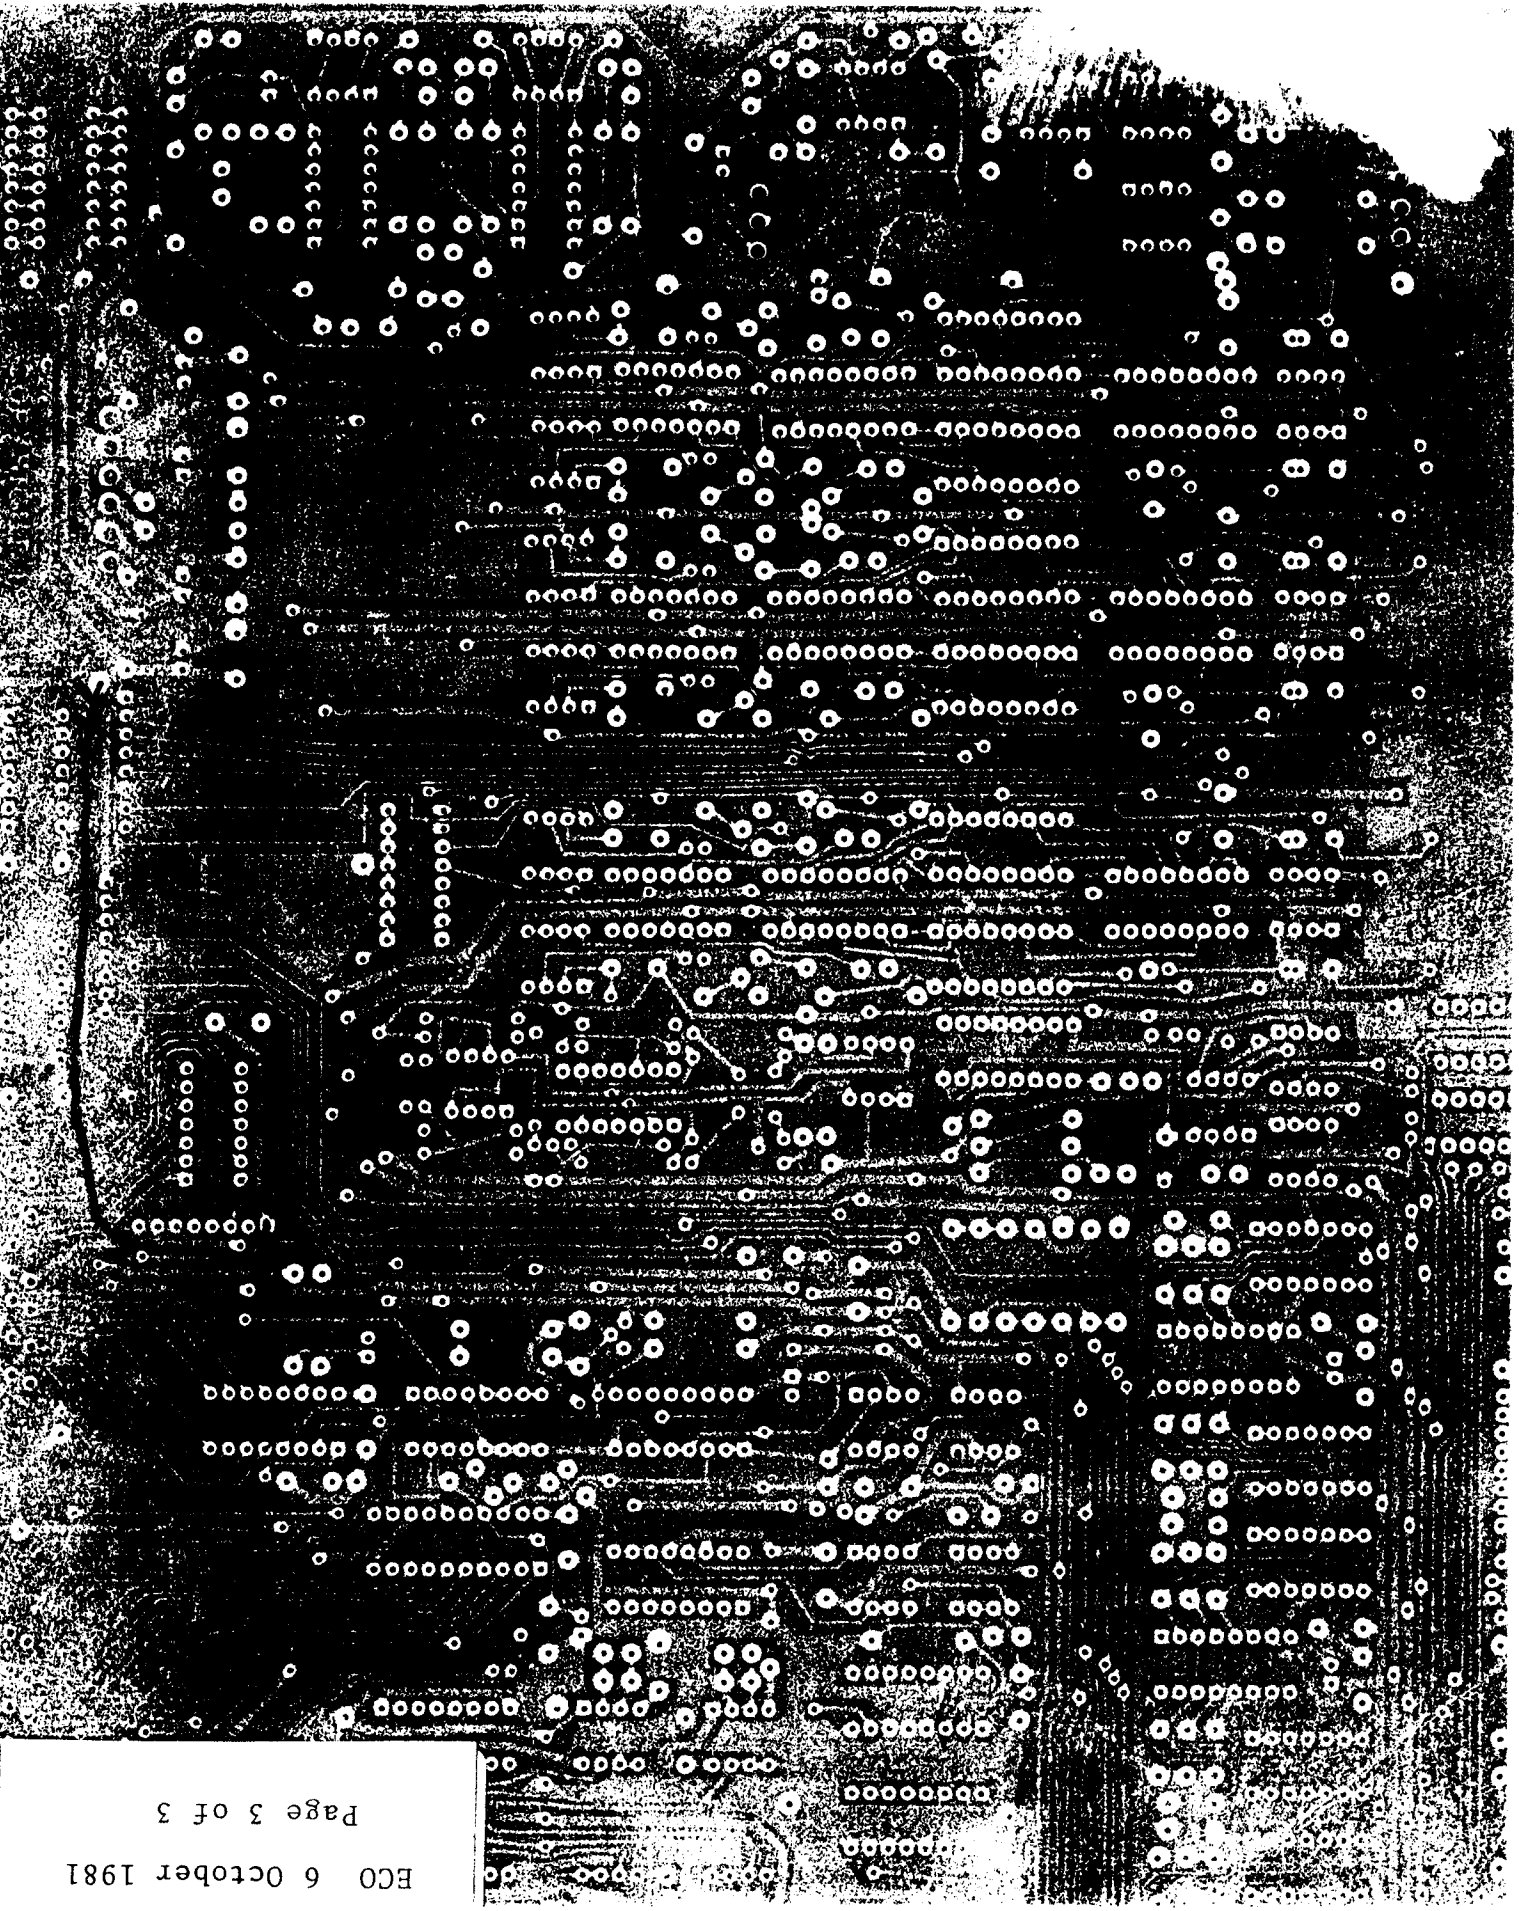
PROBLEM: SIP resistor network RN34 on ANA-2 PC board has its pin 1 connected in error to +5V. It should be connected to +7.5V. This may result in premature failure of IC's U2, U4, U5, and U6. These are Fairchild or Motorola MC14051B CMOS IC's.

The symptom would be improper operation of the early reflection level controls and/or initial reverberation level controls. Improper operation could take the form of the levels not changing equally in both channels, or not changing smoothly in monotonically increasing or decreasing steps. Another symptom could be pops or clicks as the level is nudged up or down.

HOW TO CORRECT THE PROBLEM: Disconnect the 8X32 from power. Turn it upside down, with the front panel facing you. Protect the front panel with a soft cloth. Remove the screws holding the bottom cover in place and set the bottom cover aside. Unplug the 2 input connectors, the connector from the potentiometer on the rear panel and connectors going to the output connectors on the front left side. Unsolder the 3 green wires, having made a note in advance where they were soldered. Remove five number 6-32 screws around the perimeter of the board. DO NOT remove the 2 screws at the very front edge of the board. Remove the 3 hexagonal standoffs. Carefully bend the wires out of the way at the left rear, and hinge the analog board upward. Locate resistor network RN34, near IC65 and, on the etch side of the board (the

solder side, the side without components), find Pin 1 (noted by a square pad) of RN34. With a sharp knife cut the edge going to Pin 1 of RN34. Referring to the attached diagram, run a small insulated wire from RN34, Pin 1 to the pad near RN36 Pin 1. Verify with an ohm meter that this RN34 Pin 1 is now connected to +7.5V and not to +5V. If the unit had developed a problem leading to carrying out this change, locate the defective IC U2, U4, U5 or U6 by normal trouble shooting techniques and replace as necessary.

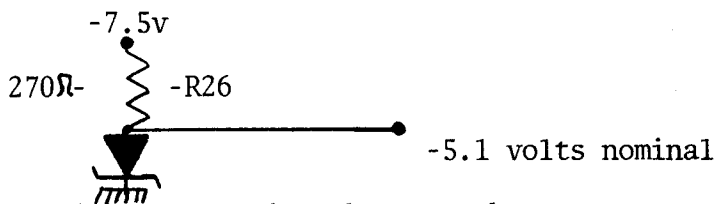
PROBLEM: It has been discovered that a few URSA MAJOR 8X32's may have been shipped with a resistor of the wrong value. The unit should probably still function properly, but under severe heat stress it could blow the resistor and this would shut down the memory.

To avoid this failure, we ask if you would please check the resistor in question - R26. This resistor is the voltage dropping resistor in series with zener diode D17. The resistor should be of value 270Ω $\frac{1}{2}$ watt. The color code for this value is red, purple, brown, gold. Some units may have a 27Ω $\frac{1}{2}$ watt resistor with color code red, purple, black, and gold. The circuit looks like this:

HOW TO CORRECT THE PROBLEM: If it is the wrong resistor:

- 1). Remove the top cover.
- 2). Carefully unsolder the resistor from the top side.
- 3). If necessary, use a solder sucker to carefully remove old solder.
- 4). Replace with new resistor (also enclosed) of value 270Ω $\frac{1}{2}$ watt.

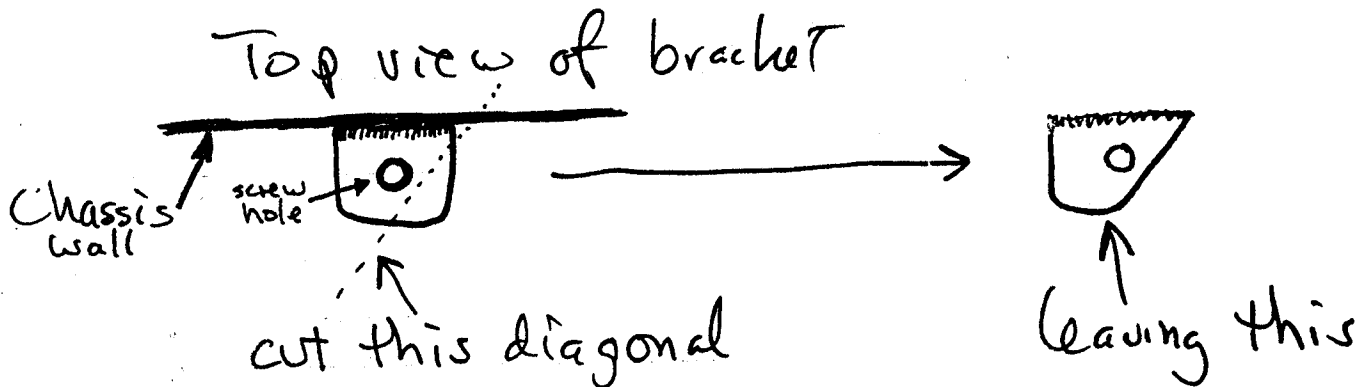
PROBLEM: The Keystone bracket which is mounted on chassis under H17 of ANA-2, sometimes makes contact with R13 of ANA-2.

HOW TO CORRECT THE PROBLEM: Remove AC power and then the bottom cover. Unsolder 3 green wires from connector on ANA. Remove all plug-in connectors from the ANA, except the 3 ribbon cables. Remove 3 standoffs and the perimeter screws, except for the two at the front edge of the ANA. Hinge the board up to reveal the bracket closest to R13. Refer to the figure and clip the bracket.

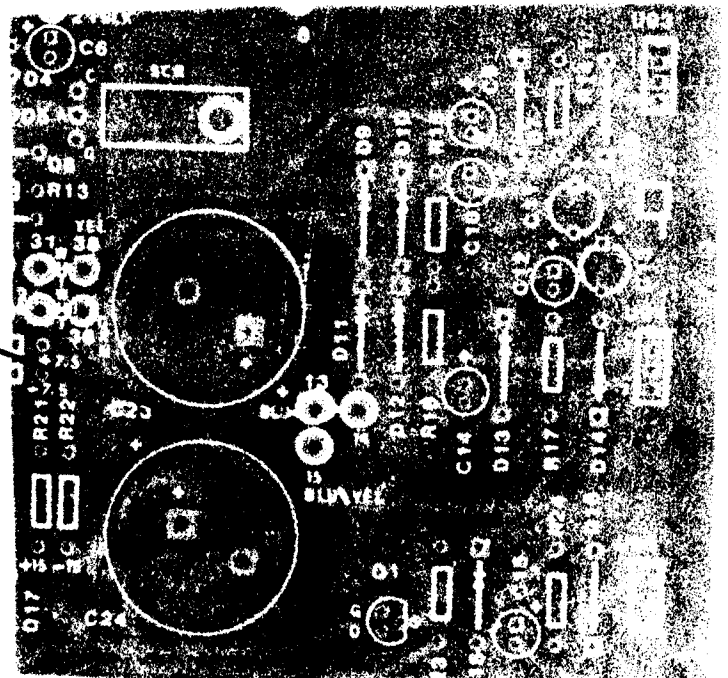
PROBLEM: Units hot to touch on chassis, right hand side. The extra heat is due to a wiring error where the blue-yellow and one of the blue wires were interchanged coming from the transformer secondary.

BLU-YEL wire should go here, in 15.

HOW TO CORRECT THE PROBLEM: Unplug the 8X32 from A/C line. Remove the top cover. Find the blue-yellow wire in the wrong hole. Unsolder the blue-yellow wire from the top side, applying heat to the joint and pulling the wire upward. Also remove the blue wire in hole 15. Reinsert the blue-yellow wire in hole 14 and resolder from the top.

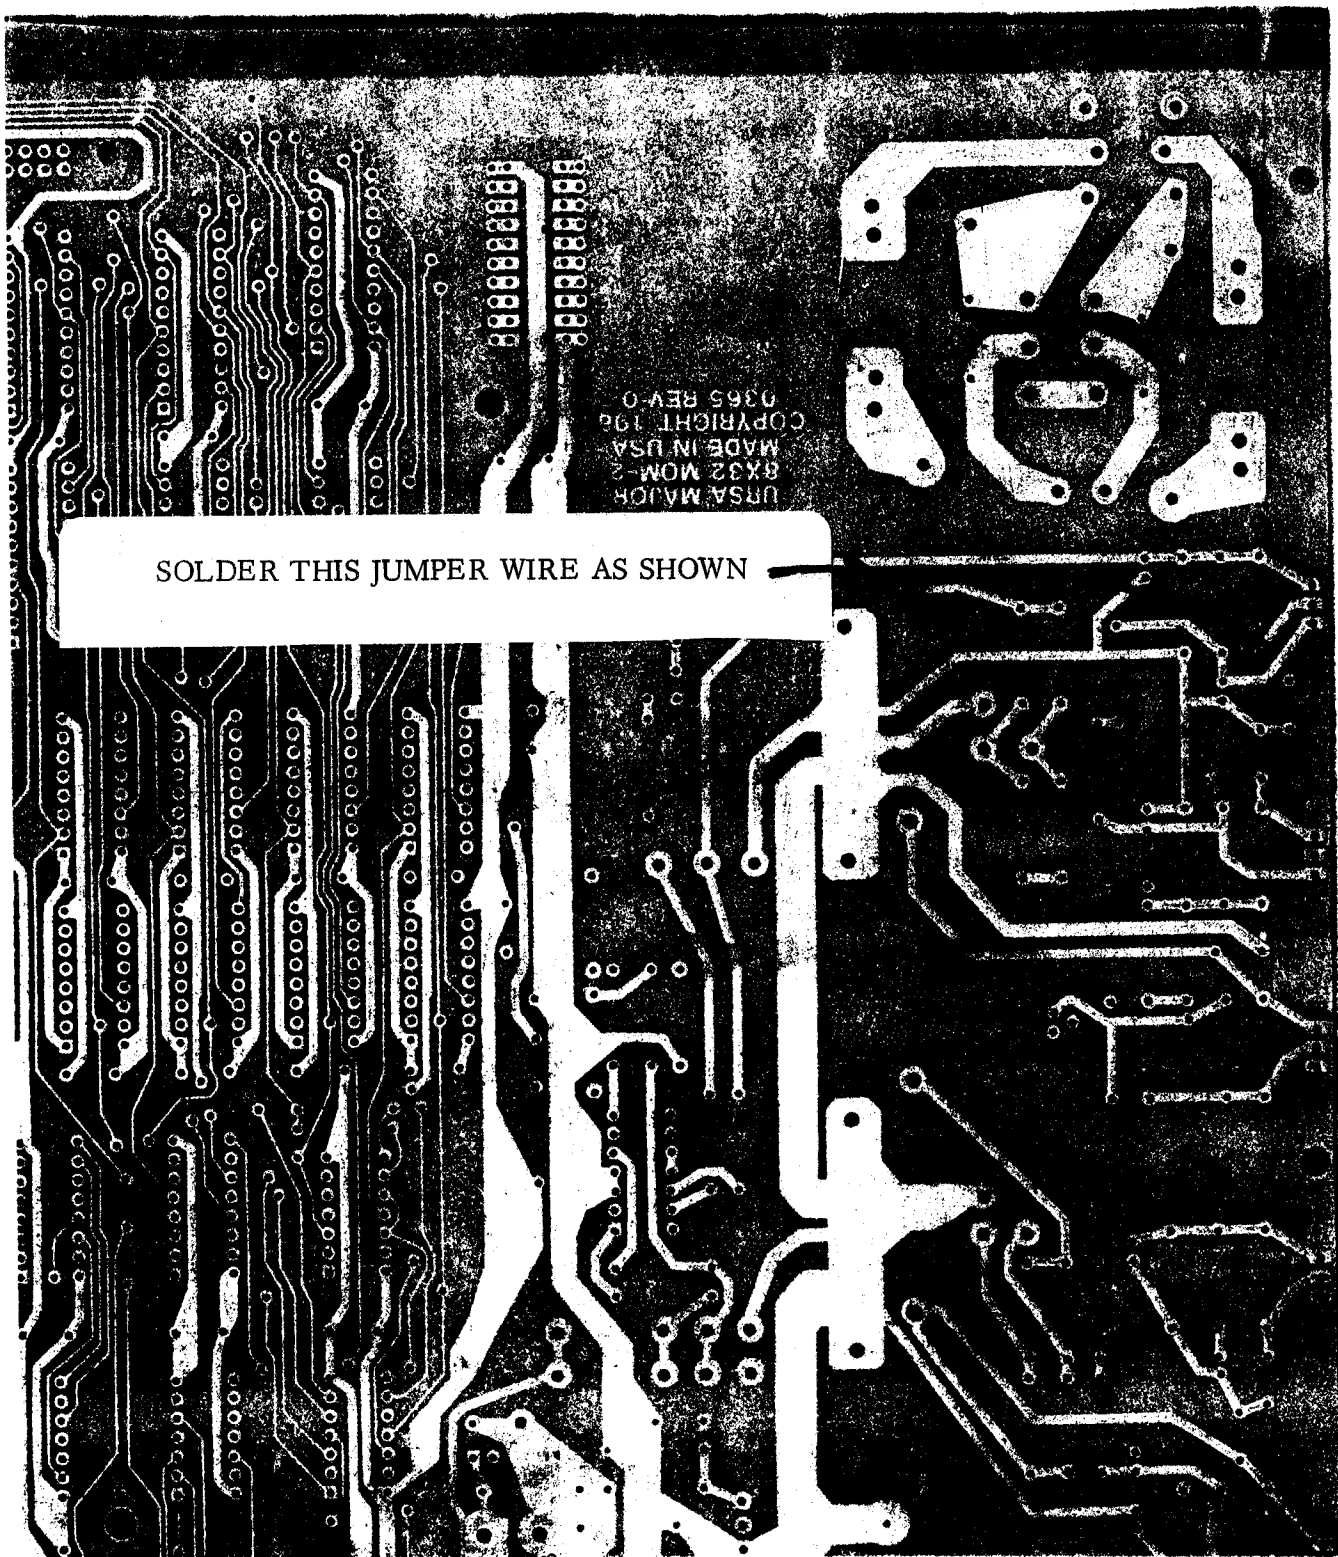
FIGURE:

PROBLEM: The negative lead for capacitor C26 on the mother board (MOM) passes through a hole that is not plated through. Without the plating there is a slight chance that a connection does not exist or could become intermittent from the etch side of the PC board to the component side. In the event that this connection did become intermittent, the -15V power supply would drop to 0. This would result in failure of the audio and other functions of the 8X32.

HOW TO CORRECT PROBLEM: Remove the A/C line cord from the unit. Turn the 8X32 upside down and remove the bottom cover. Remove all the connectors going to the ANA board except the ribbon cables on the front edge. Unsolder the three green wires going to the connector on the ANA board. Remove the three hexagonal standoffs and all the small screws holding the ANA board down except the two at the front of the board. Swivel the analog board upware, revealing the underside of the MOM board, (the "etch side"). Locate C26 minus pad on the etch side of the board and D25 anode on the MOM board by observing from the component side. Solder a short piece of #22 insulated wire from C26 minus lead to D25 anode. Reassemble the unit. It would be wise to verify correct -15V power supply operation before completely reassembling the unit.

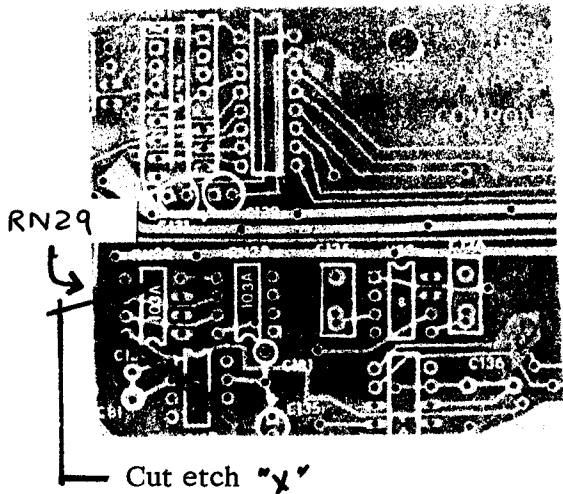
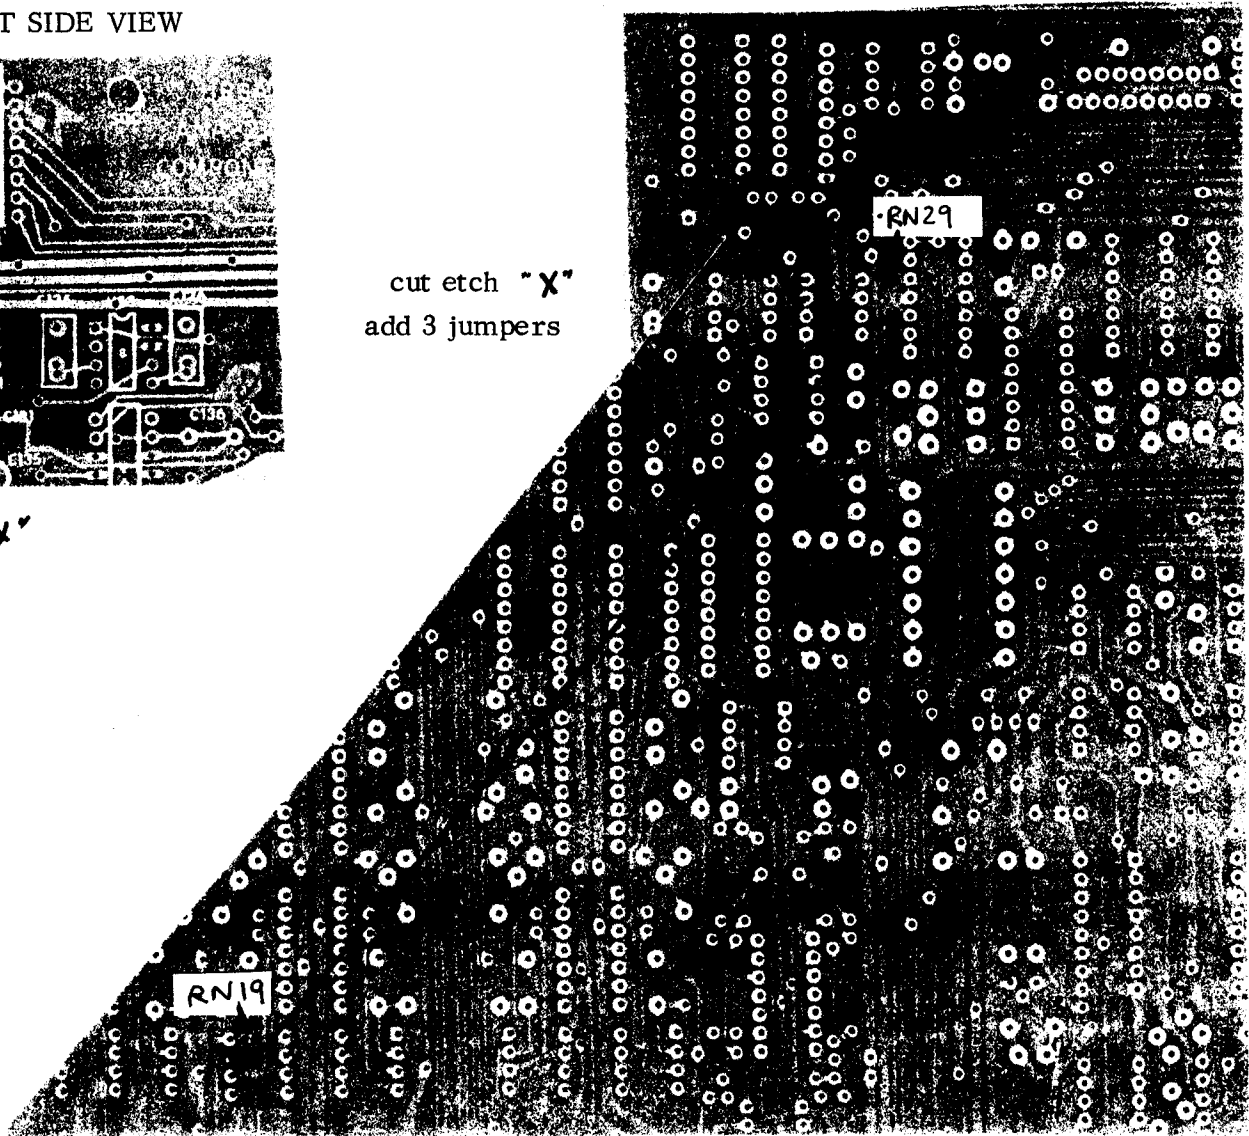
PROBLEM: In some units, the minor DC offsets inevitable associated with linear and A to D components, resulted in the A to D converter for the Ap signal resting with 0 signal at the decision point for mid scale, (the sign decision point). Normal circuit noise under these conditions will permit the build up of a hollow, reedy sounding noise in this converter which would appear at the output. This sounds sort of like a "buzz saw".

Find a connection on the etch side from RN29, pin 4 to ground. Cut that connection. On the etch side, solder a short piece of wire from RN29, pin 4 to RN29, pin 3 (bare #30 wire is ok).

Using #30 insulated wire, connect RN29, pin 5 to RN19, pin 7 some distance away. Put the wire on the etch side of the board.

cut etch "X"
add 3 jumpers

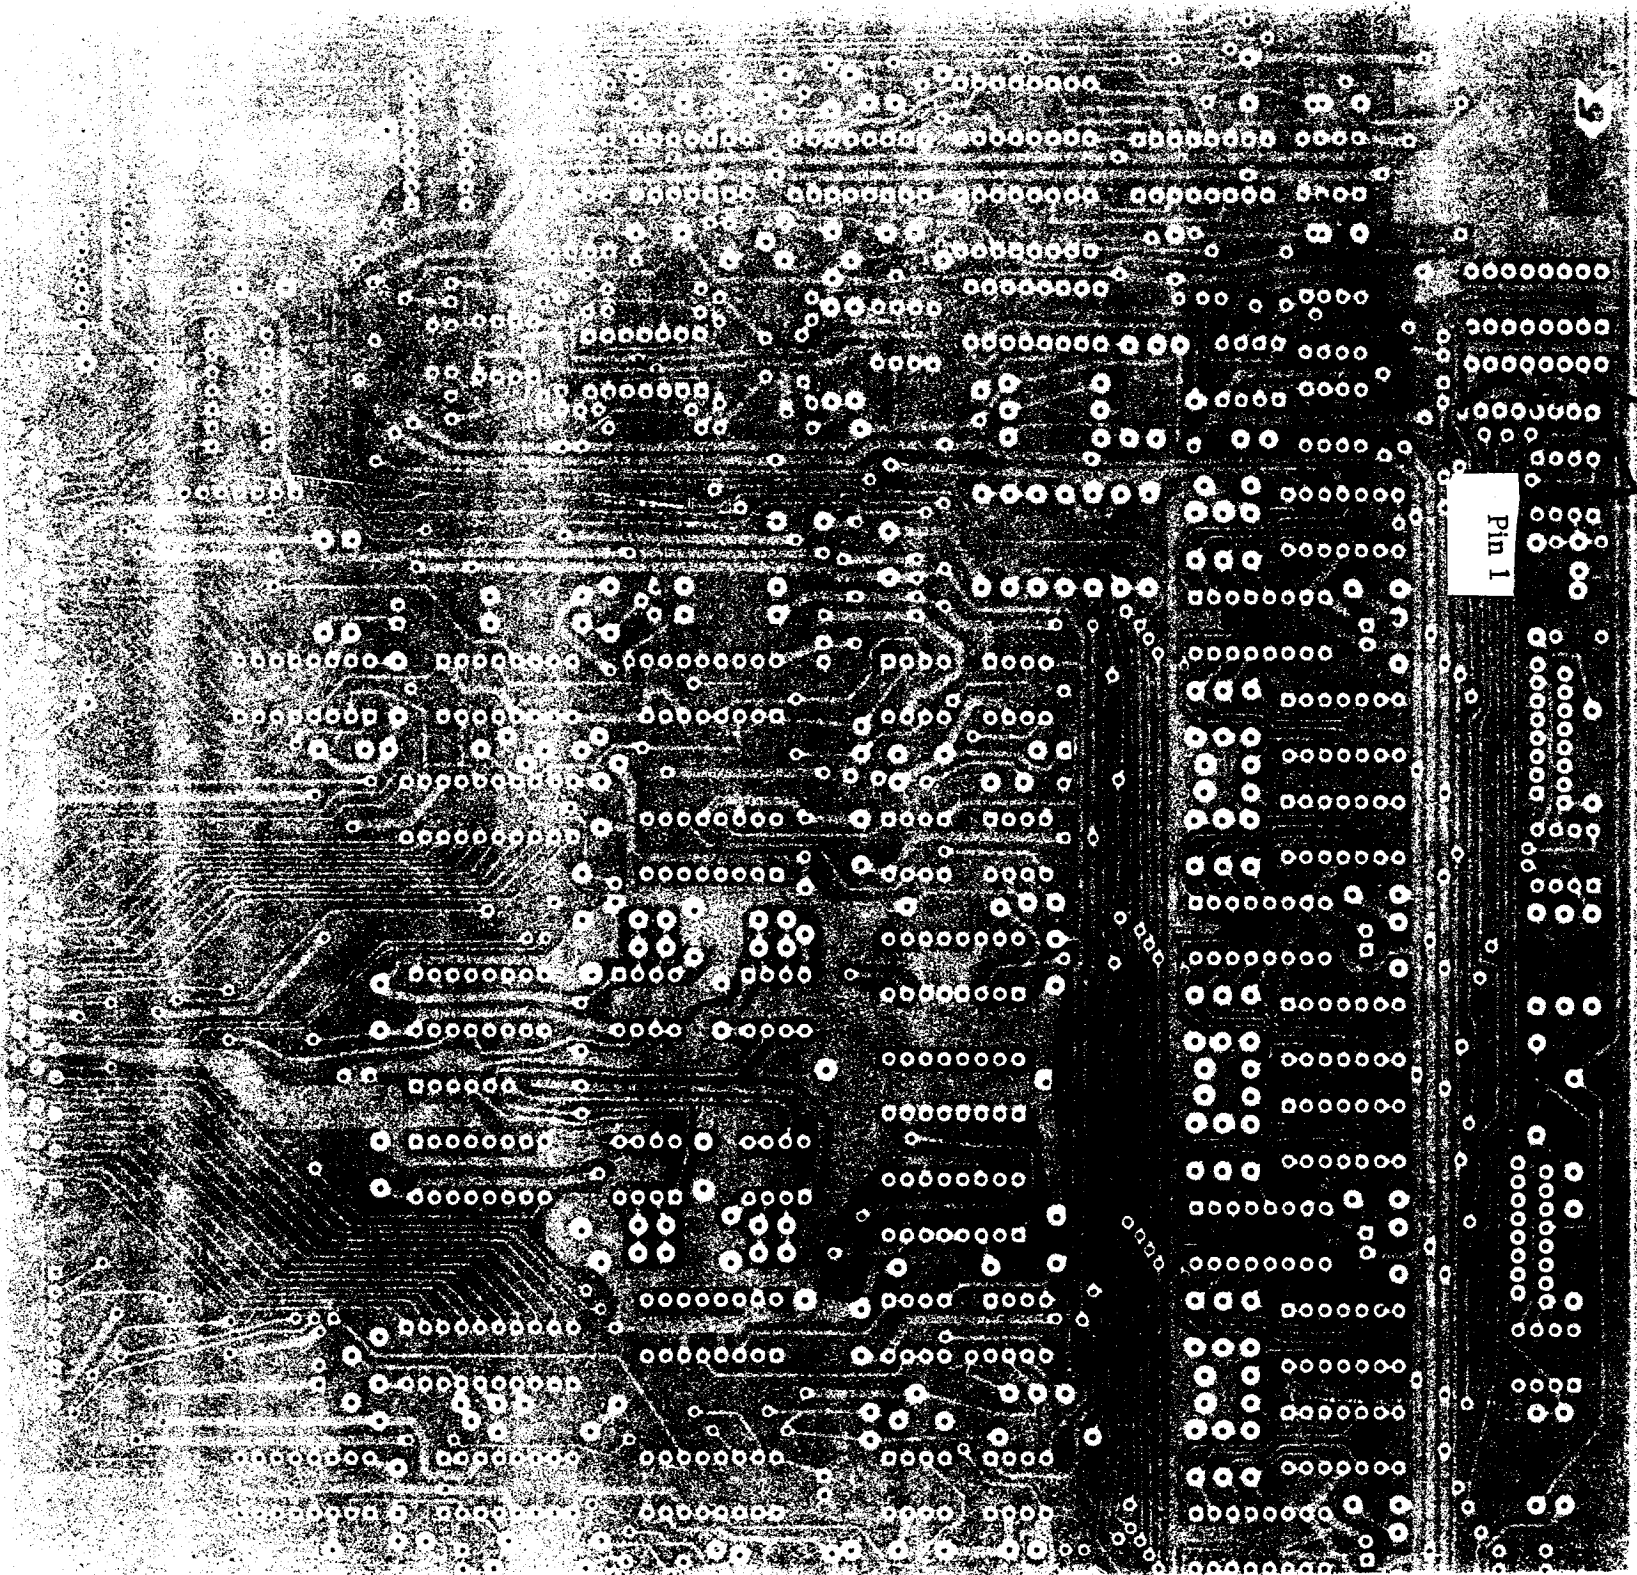
PROBLEM: There is a 3DB gain error in the contribution of three signals going into the reverberator output due to an error failing to ground two resistors.

HOW TO CORRECT PROBLEM: Unplug the power cord. Turn the 8X32 upside down. Remove the bottom cover. Unsolder the three wires going to the connector on the ANA board. Remove all the other ANA connectors except for the three ribbon cable connectors. Remove the three standoffs. Remove the other screws that secure the ANA board except for the two in the front. Carefully hinge the board forward revealing the etch side. At the rear of the board, locate OP AMP U68 and associated components. Right next to U68 is a resistor network labeled RN41. The pin of that network closest to the back of the ANA board is pin 1. Look at the etch side (the back side of the board). At the eight pads for this resistor network, you will notice that pins 2 and 3 are connected to a ground trace. Use #30 solid wire to also connect pin 4 and pin 8 of the resistor network to that same ground point, pins 2 and 3. This will decrease the gain of the stage to signals C2F, C4F and C6F. Refer to the attached figure on following page.

FIGURE: Install jumper from pin 3 to 4 and to 8.
