DISCO ABS FAULT

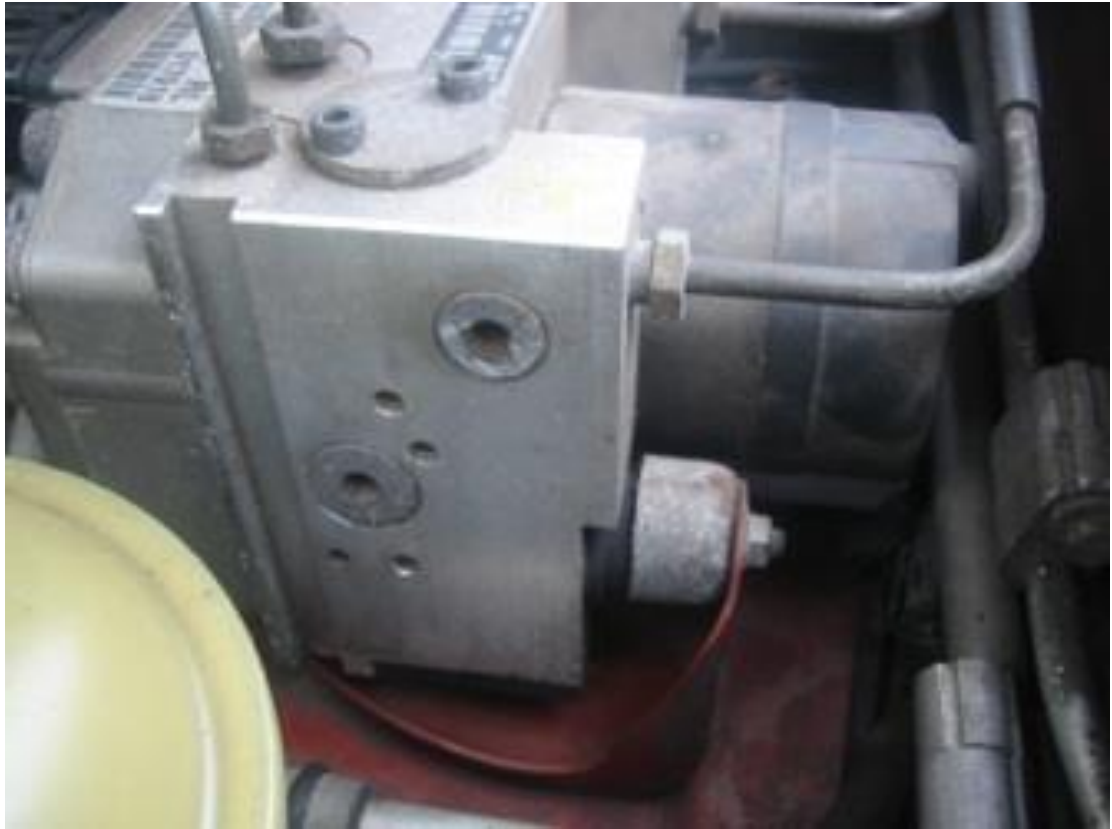
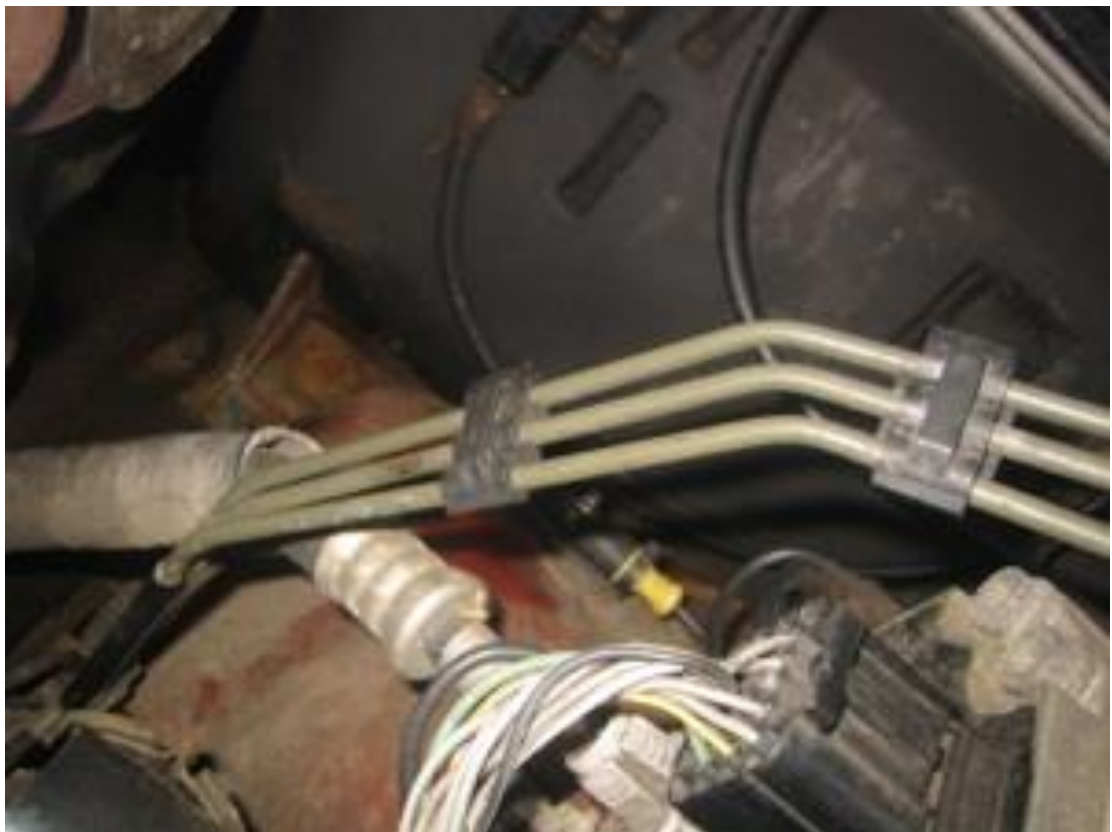
The clips that separated the three pipes in the photo below were removed.

The photos below show the 3 nuts that were removed to undo the abs unit from the mounting bracket.

I started the job by unclipping all the ABS pipes from the clips on the firewall.

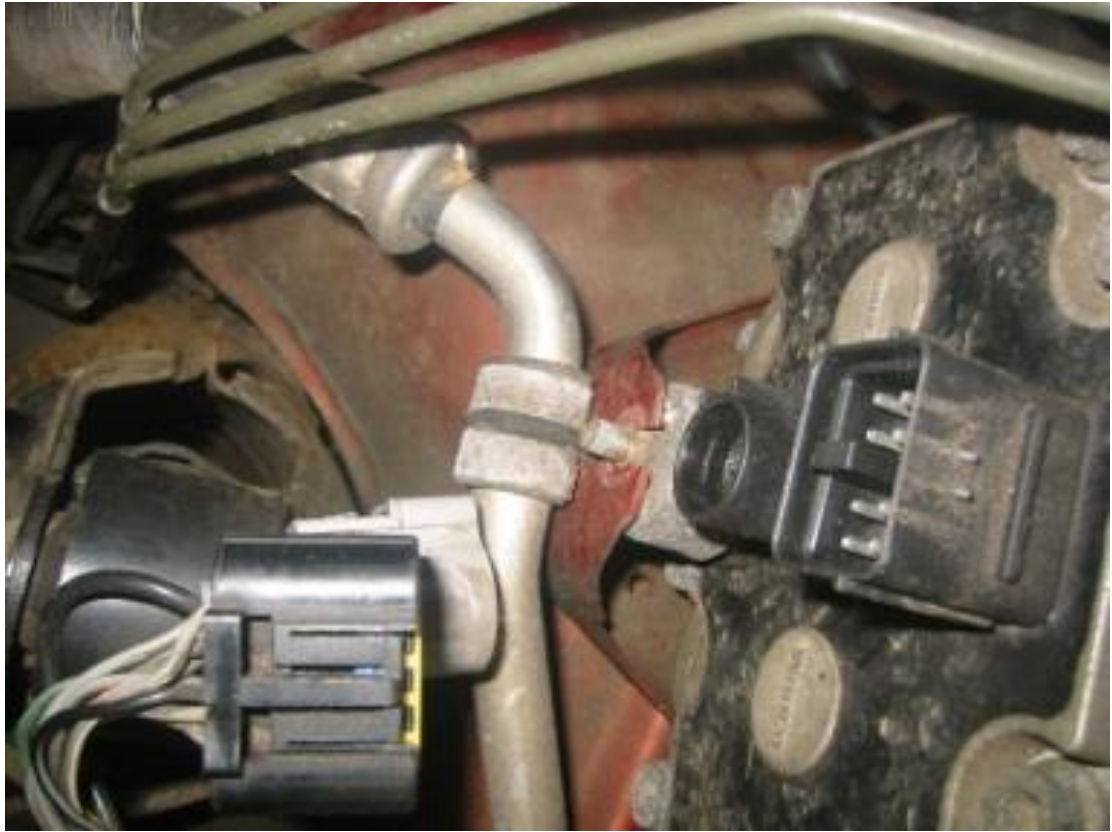
This photo shows two of the connectors unplugged and one of the mounting nuts removed.

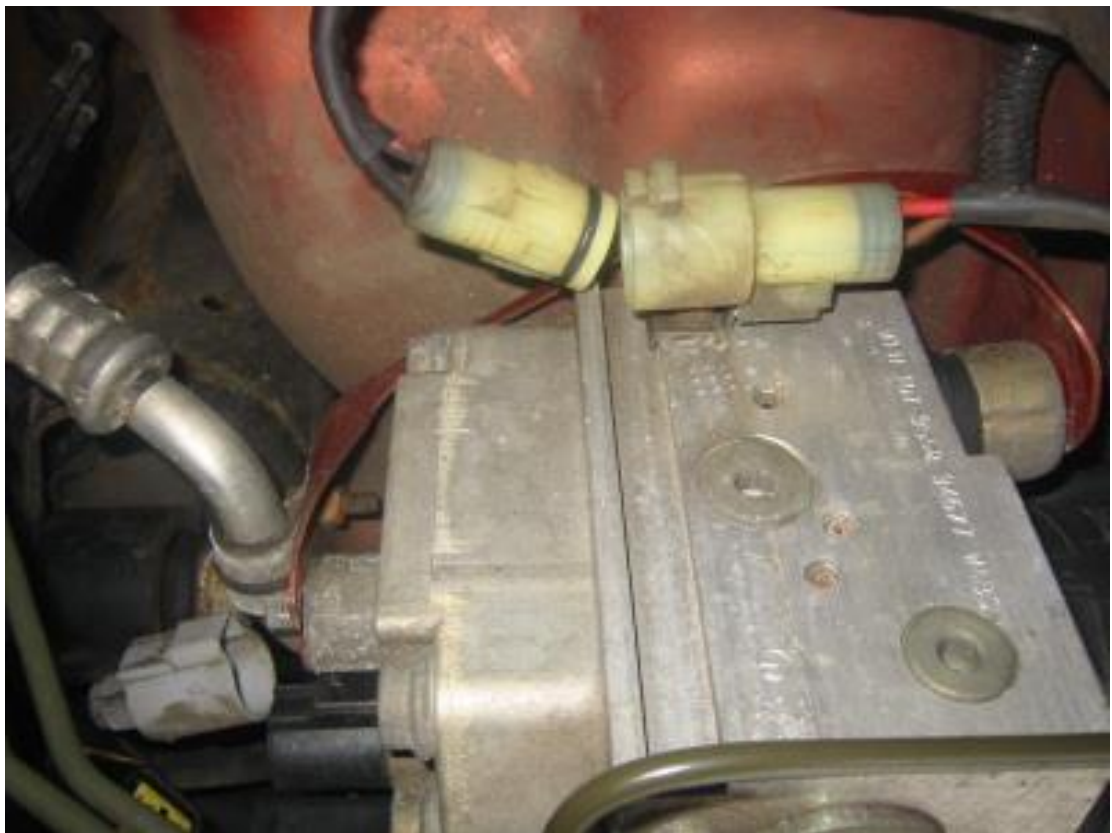
The third connector unplugged.

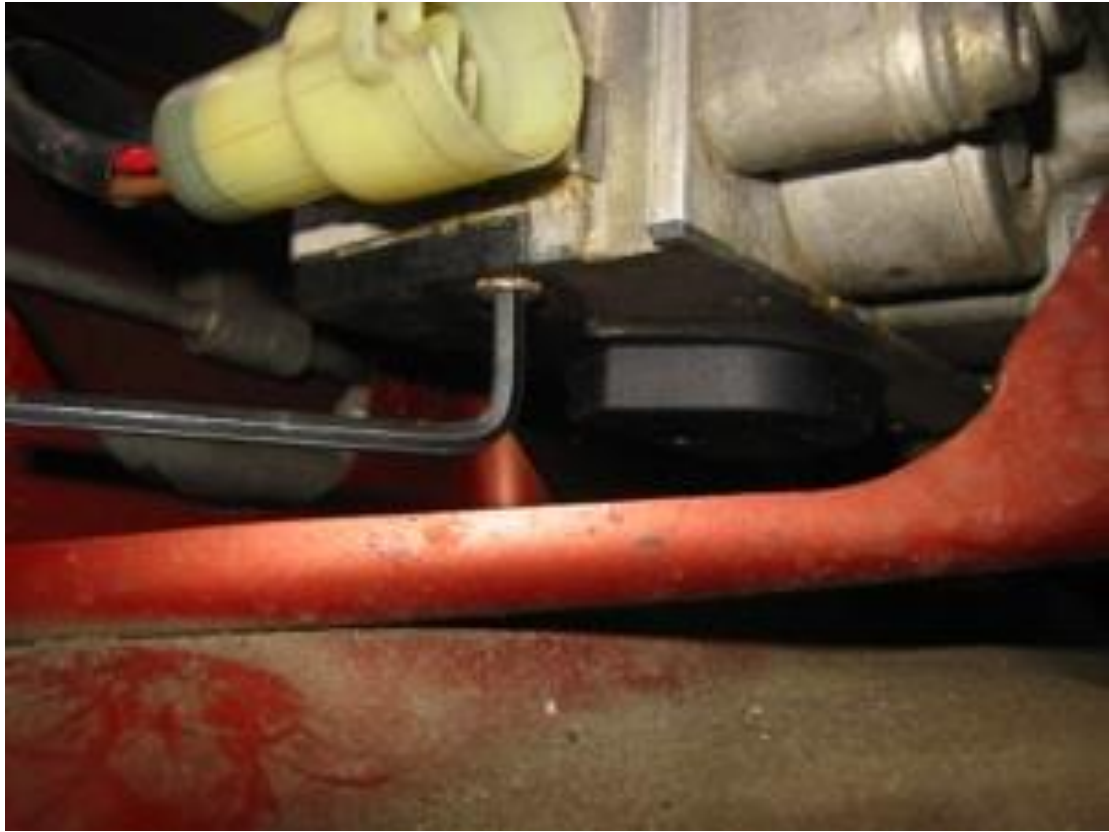
The new shuttle valve switch module and one of its mounting screws being removed using an allen key.

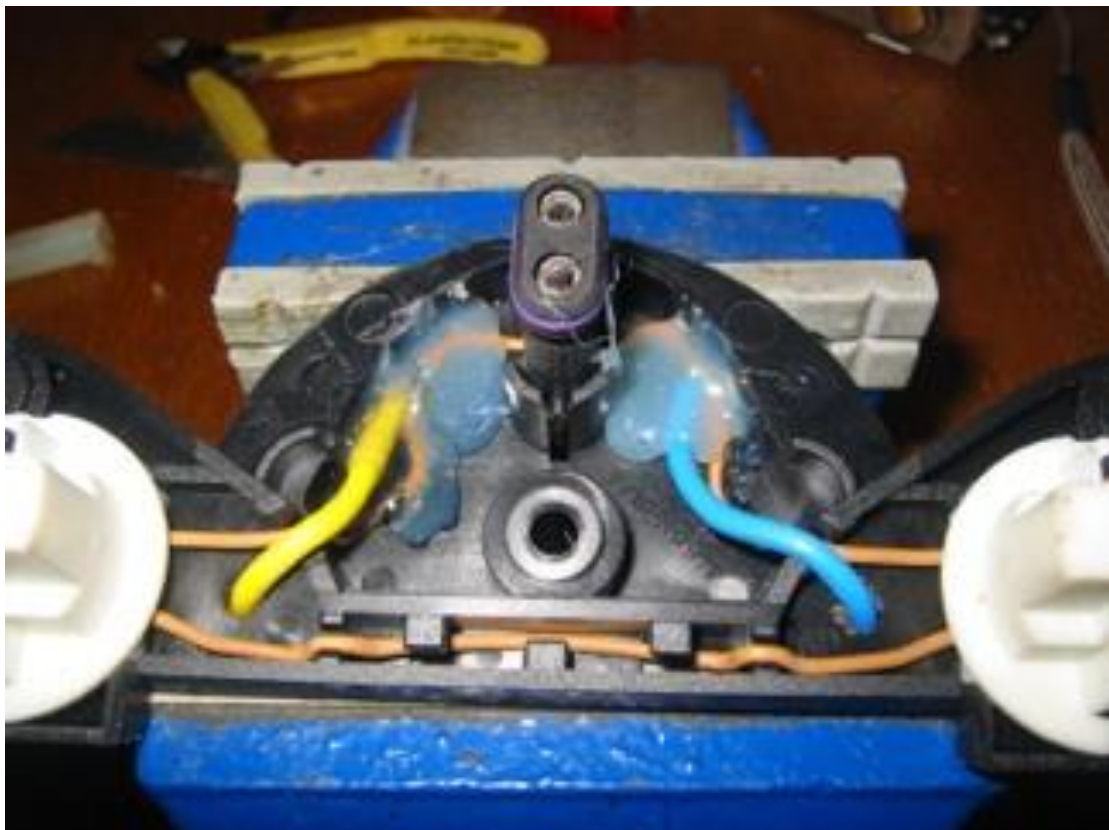
The old switch module. A little grubby, but upon testing with my multimeter, it did appear to be working OK.

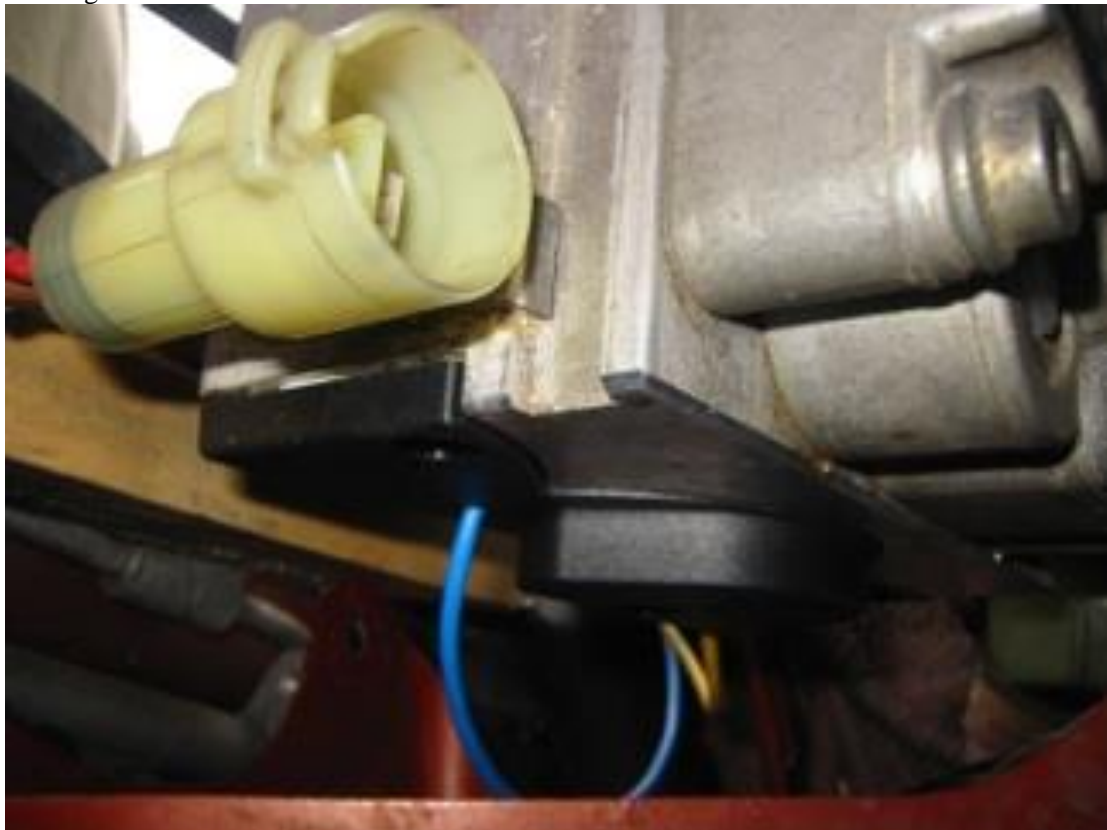
Rather than fit the new shuttle valve switch module, then find that the problem was the internal connections in the ABS unit, I decided to perform the modification to bypass the possibly faulty internal connections.

As can be seen in these photos, I passed a couple of wires through some holes in the module and connected them to the existing wires that go to the connector. I then covered the joints in hot melt glue to insulate them and hold them in place.

The module was then fitted to the abs unit. I removed some of the insulation on the green/yellow wire going to the ABS multi-plug and soldered the blue wire to it. The yellow wire was connected to a suitable earth connection near the abs module.
