Bulletin
Number 5011

1948 LAND-ROVER

1948 LAND-ROVER AND UNIT NUMBERS

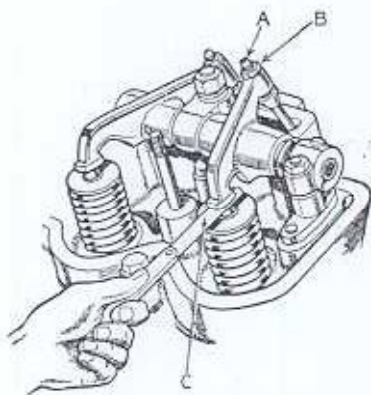
Fig. 1 Inlet tappet adjustment.
A—Tappet adjusting screw.

The correct tappet clearance is .010 in. (0,25 mm.) on the inlet valves and .012 in. (0,30 mm.) on the exhaust valves, with the engine COLD.

Adjustment for this clearance is provided by a set-screw and locknut on the rocker. (See Figs. 1 and 2). When adjustment is required, slacken the lock-nut and rotate the set-screw to give the correct clearance by means of a screwdriver. The lock-nut should be securely tightened after adjustment, great care being taken to ensure that this operation does not upset the clearance.

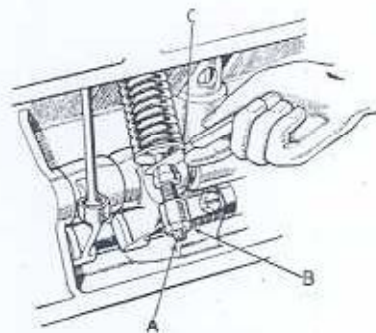
Fig. 2 Exhaust tappet adjustment.
B—Locknut.
C—Feeler gauge.

The tappet clearance should be set with the engine cold and it is essential to ensure that the valve to be adjusted is really closed. To do this, set the valve receiving attention fully open and then move the engine one complete turn, to bring the tappet on to the back of the cam.

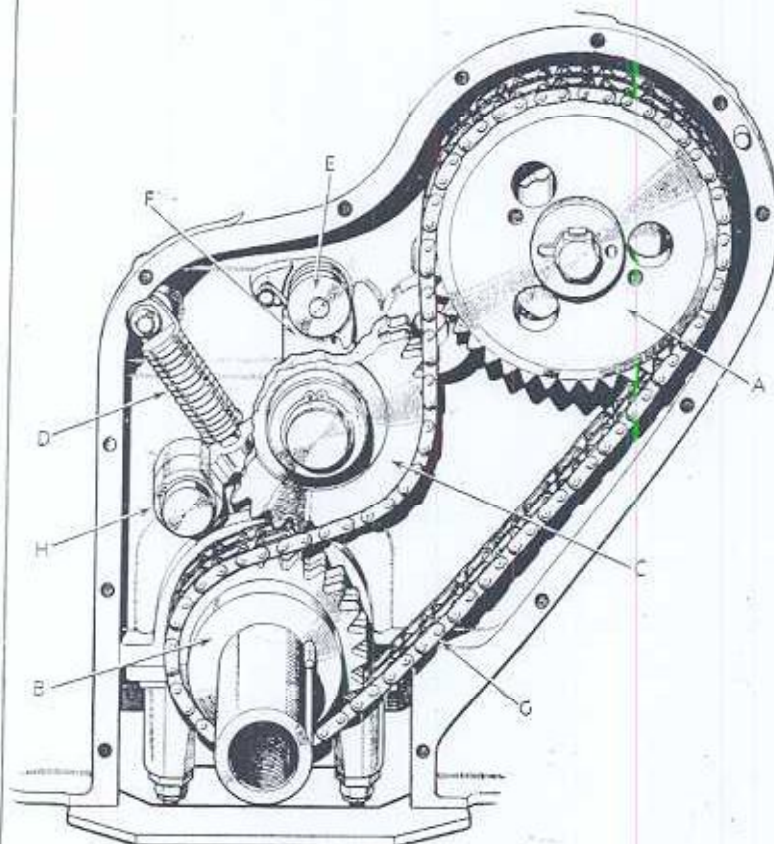
Fig. 3 Timing gears.

- A—Camshaft chainwheel.
- B—Crankshaft chainwheel.
- C—Jockey pulley.
- D—Hydraulic tensioner.
- E—Pawl.
- F—Ratchet.
- G—Timing chain (driving side).
- H—Jockey pulley arm.

4. Fit the timing chain, ensuring that there is no slack on the driving side (G).
5. Hold the ratchet pawl (E) clear and replace the complete jockey pulley (C, F and H), meshing the pulley with the chain.
6. Check the timing and correct if necessary. The camshaft chainwheel (A) is made with three irregularly spaced keyways, so that if the timing will not come correct in the first position tried, alternatives are provided.
7. Replace the hydraulic tensioner (D) comprising cylinder, piston and spring; these items must be assembled dry to prevent the formation of an air lock. Retain at its upper end with a split pin. Fit the circlip at (H), retaining the jockey pulley assembly. Engage the ratchet (E, F).
8. Set the inlet tappets to .010 in. (0,25 mm.) clearance (see Sheet 1 of this bulletin).

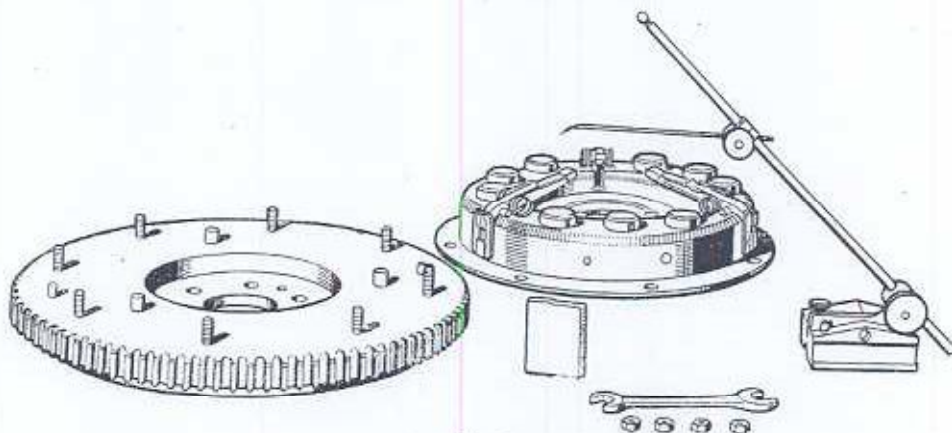
Fig. 1

1. Clutch to be checked.
2. Flywheel.
3. Surface plate.
4. Scribing block.
5. Setting gauge with steps at 1.729 in. (43,90 mm.) and 1.739 in. (44,15 mm.). This can be made from a piece of flat $\frac{1}{2}$ in. (6 mm.) steel plate.
6. Three $\frac{3}{8}$ in. (9,5 mm.) distance pieces. $\frac{3}{8}$ in. (9,5 mm.) Hoffmann rollers are suitable.

Owing to the number of accumulated tolerances affecting this dimension, it is unlikely that the setting will be correct on initial assembly and the following method should be employed to check and rectify any inaccuracy present.

The complete clutch assembly should be bolted down to the flywheel with eight nuts, with the clutch plate replaced by the three distance pieces. The clutch plate is not used for the checking operation as it has an allowable "run-out" of .010 in. (0,25 mm.).
