**THE ROVER COMPANY LIMITED**  
**S E R V I C E   D E P A R T M E N T**

**Rover Service News Letter No. 51**

January, 1955

**TO ALL DISTRIBUTORS AND DEALERS**

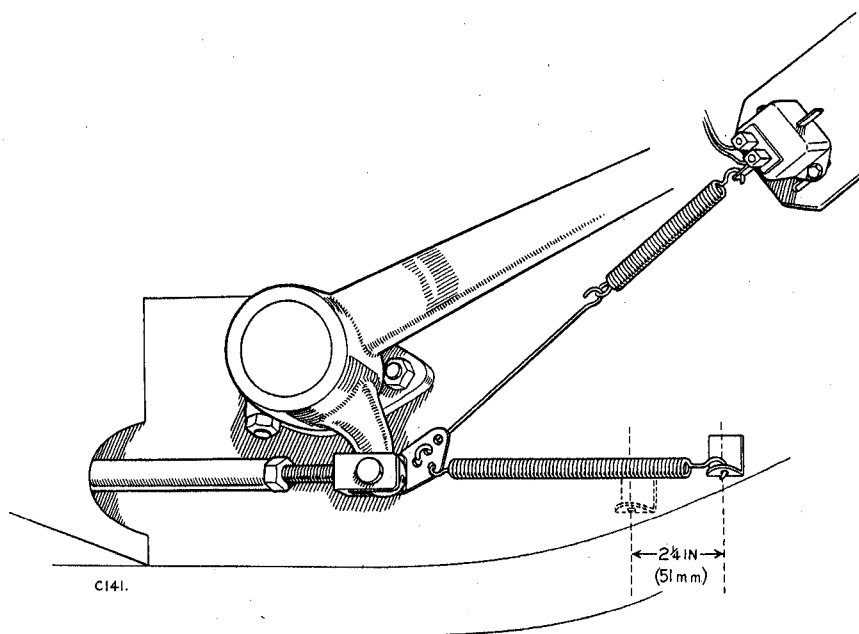
Fig. 1. Layout of brake linkage.

CAUSE: Due to snow lodging between body bracket and bracket for brake return spring.

7. Refit fork end and replace joint pin.
8. Check that master cylinder has  $\frac{1}{16}$  in. (1.6 mm.) free play at the push rod and tighten locknut.

11. Fit bracket for stop lamp switch (266272) using original position on wing valance. Alternatively, the holes in the original bracket can be slotted to give adjustment to the stop lamp switch link.

12. Fit stop lamp switch and connect up link (266271) using a suitable hole in the anchor bracket, adjust link by means of the stop lamp switch.

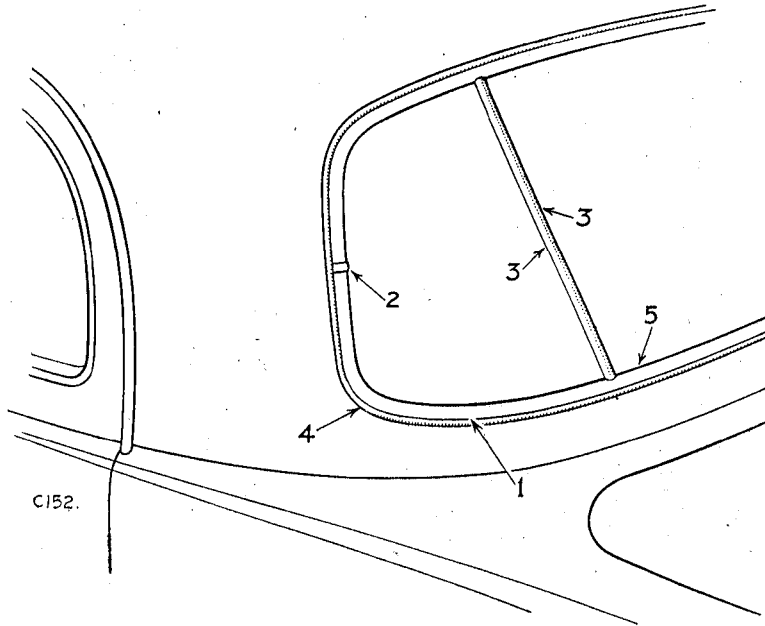
Fig. 2. Backlight from L.H. side.

Water leaks on the 1955 back light are probably the most difficult to locate and seal due to the length and contour of the sealing area. It is particularly important therefore, that a thorough water test is carried out (10 to 20 minutes spray may be necessary) when the back light is suspect or where difficulty is experienced in locating water leaks in the boot; as water entry through any of the points listed below may show up at the rear of the wheel-arch or round the petrol filler, etc.; this is because the water tends to run down inside the boot, thus giving a false impression of the source of entry.

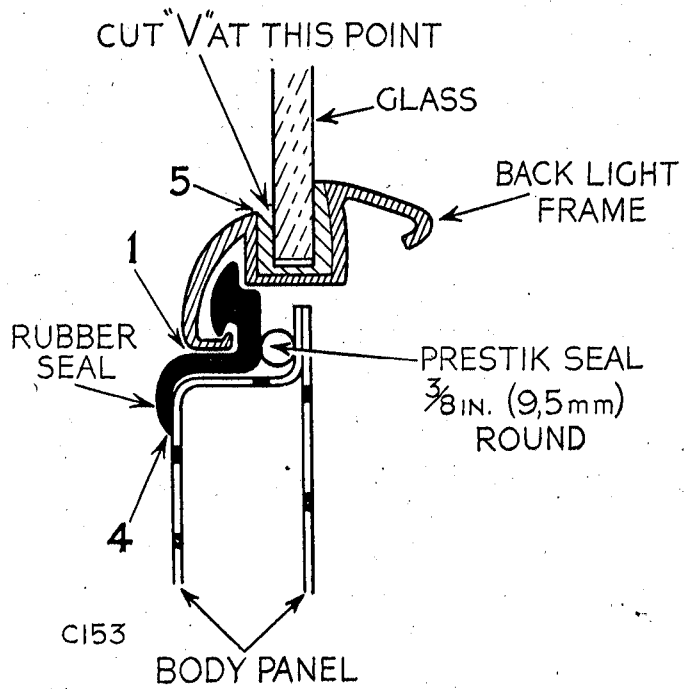
Fig. 3. Cross-section of backlight frame. Full size.

Water may leak between the glass and the sealing rubber.

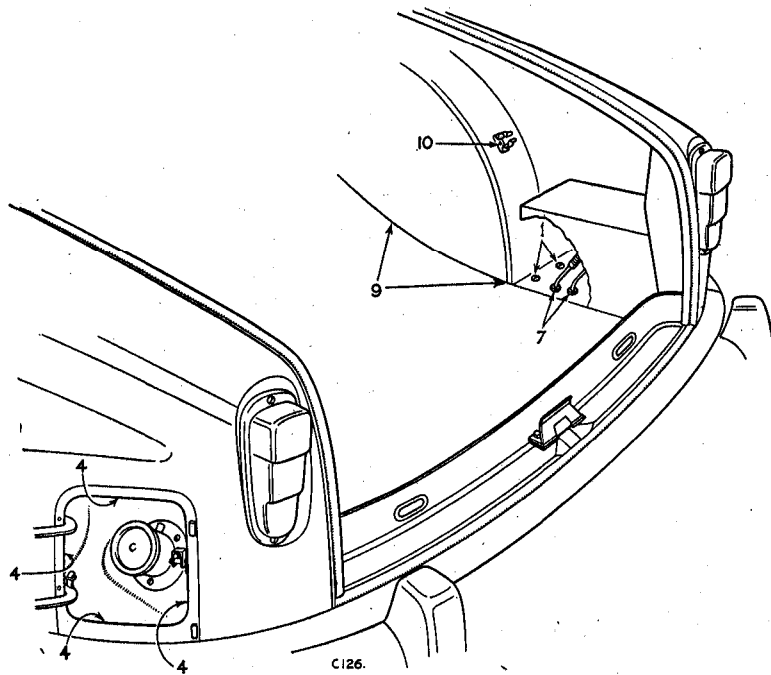
Fig. 4. Boot interior from left-hand side.

Holes for the clip securing the wheel brace on the right-hand wheelarch. Seal with Prestik. (See Fig. 4, Item 10.)

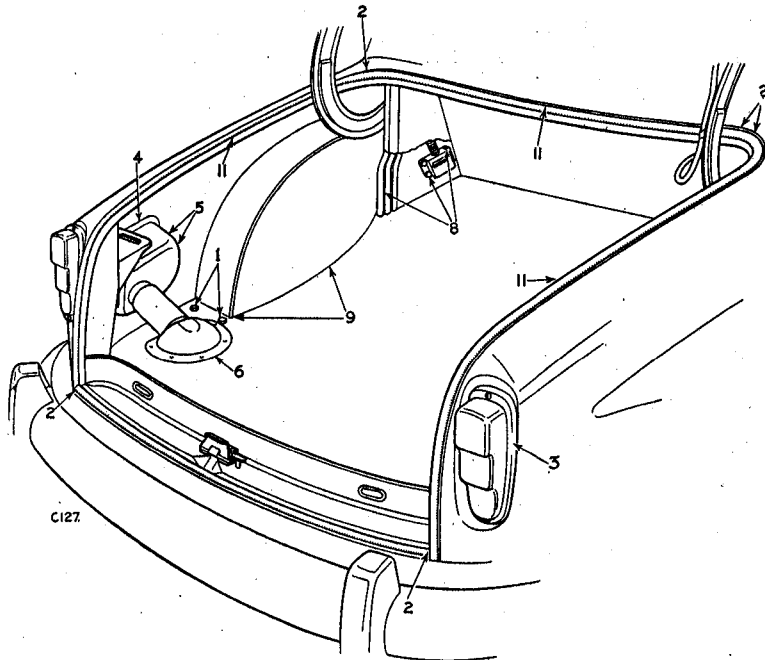
Fig. 5. Boot interior from right-hand side.

The body of the tail lamp, i.e., by-passing between the rubber seal and the wing panel. (See Fig. 5, Item 3.)

Remove the complete lamp and use a suitable compound to seal the rubber seal and wing. Seal between rubber and lamp bezel with Prestik. When replacing the lamp, do not tighten the nuts excessively, as this will distort the rubber seal.

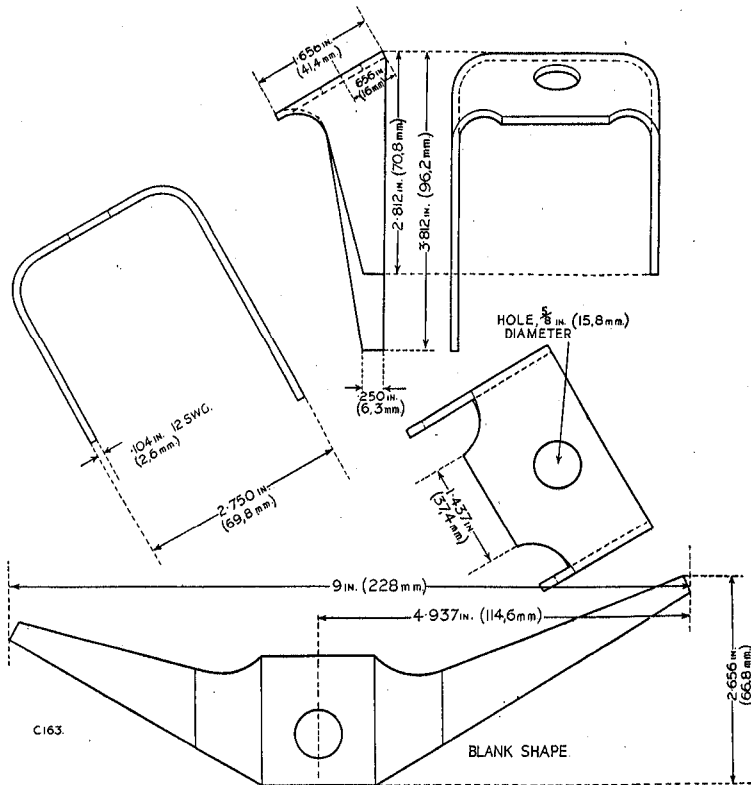
Fig. 1. Dimensions of support bracket.

Fracture of engine mounting bracket under severe service conditions.

Some cases have been reported of the L.H. front engine mounting bracket on the chassis frame fracturing when the vehicle is used under adverse conditions. It is recommended therefore, that when a vehicle is being used under conditions which may cause the above complaint, that a suitable support bracket is welded on to the existing bracket at the first opportunity.

1. Drain cooling system.
2. Remove bottom hose, pump elbow to radiator.
3. Remove oil filter.
4. Remove nut, spring and plain washer from top and bottom of engine suspension rubber (on both sides of engine to ensure there is no stress put on the R.H. suspension rubber).
5. Support engine under sump and lift engine slightly.
6. Remove bolts and lock washers from L.H. engine support foot and lift out engine foot complete with rubber.
7. Make the support bracket reinforcement from mild steel to the dimensions shown at Fig. 1.

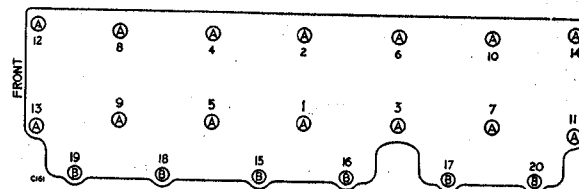
Fig. 3. Order of tightening cylinder head bolts. (“75” and “90” models with steel cylinder head gasket)

After tightening down the cylinder head bolts in the order and to the specified torque as shown at Fig. 3 a re-check of the torque figures must be made.

This operation is necessary to counteract reduction in torque of adjacent bolts during initial tightening owing to flattening out of the corrugations.

Bolts A to be tightened to 50 lbs./ft. (7 mKg.)  
 Bolts B to be tightened to 30 lbs./ft. (4 mKg.)

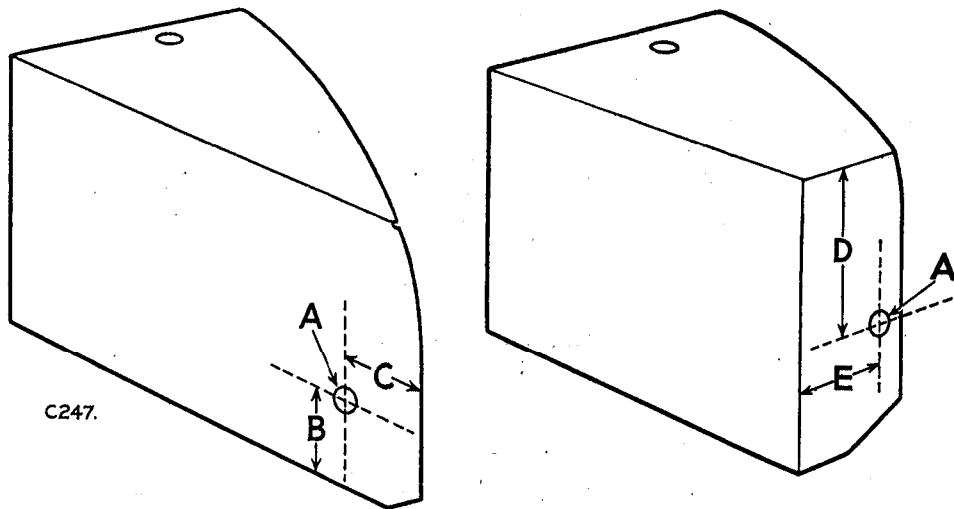
Fig. 2. Showing position of hole for rubber grommet in petrol pump cover.

**CAUSE:** Wire chafing between cover and body.

'A'— $\frac{1}{8}$ in. (16 mm) hole	} 1952-53 '75'	'A'— $\frac{1}{8}$ in. (16 mm) hole	} 1954-55 '60', '75' and '90'
'B'—2 in. (51 mm)		'D'— $3\frac{1}{4}$ in. (84 mm)	
'C'—2 in. (51 mm)		'E'— $2\frac{3}{8}$ in. (60 mm)
