TECHNICAL BULLETIN

MODEL/DERIVATIVE:
Discovery Series II
Defender

Bulletin N°: 0026
CDS. ref: L8616bu
Issue: 1
Date: 23.08.2000

ENGINE MISFIRE - ENGINE HARNESS OIL CONTAMINATION

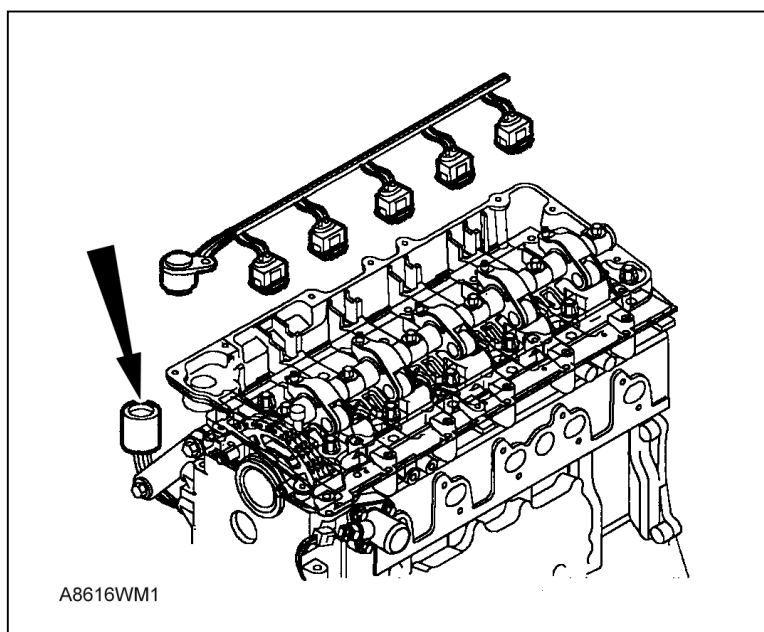
During investigation, oil contamination of the fuel injector harness to engine harness connector is identified.

Poor sealing in the injector harness connector, allowing engine oil to migrate through the connector and into the engine harness, resulting in poor electrical contact. It is possible that oil may reach the engine management ECU connector.

Upon customer complaint of engine misfire, poor performance or failure to start, disconnect the engine harness at the cylinder head multiplug, (arrowed in illustration) and inspect for evidence of engine oil.

If engine oil is present within the connector, renew the respective harnesses as detailed below.

Land Rover Parts now supply harnesses having improved internal sealing. There are no changes to part numbers, refer to *PARTS INFORMATION* for specific applications.

1. Renew the fuel injector harness, Workshop Manual repair number **86.70.22** refers.
2. Renew the engine harness, Workshop Manual repair number **86.70.17** refers.
3. When renewing the engine harness, inspect the ECU connector for evidence of engine oil. If oil is present, clean the ECU connectors with electrical contact cleaner before connecting the new harness. ***IT IS NOT NECESSARY TO RENEW THE ECU.***
4. Use TestBook to remove any fault codes stored in the ECU and to extinguish warning lights.
