TECHNICAL INFORMATION

Sealing Cam Bore and Galley Plugs

No: 12/01/02/NAS
 Replaces 12/01/01/NAS
 Ref: 12/02/02/NAS
 Issue: 1
 Date: 10/11/02

OIL LEAKAGE FROM THE CAM BORE AND GALLEY PLUGS

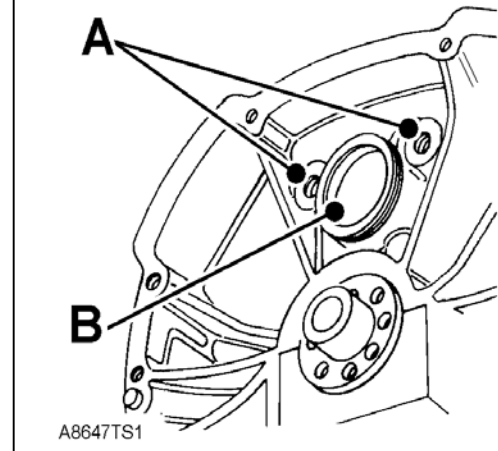
Figure 1

A customer may complain about oil seepage from the rear of the engine. The cam bore plug and cam galley plugs installed with early application technology may seep engine oil over the life of the vehicle.

1. If oil galley plugs have been determined to be the source of the oil leak, remove the old plug using an 8 mm Allen wrench. ("A" in Figure 1)
2. Clean all surfaces to ensure they are free of oil, old sealant and other contamination.
3. Apply Loctite® 243 to the threads of a galley plugs.
4. Install plugs and tighten to 55 Nm (40.5 lbf.ft.).
5. Allow Loctite to cure to manufacturer's specification.

6. If cam bore plug has been determined to be the source of the oil leak ("B" in Figure 1), access and remove the old plug as follows:
 - Position a sharp chisel at the center of the plug to maximize clearance to camshaft. ("A" and "B" in Figure 2)
 - Pierce the plug
 - Protect the engine block and pry out the old plug.
7. Clean all surfaces to ensure they are free of oil, sealant and other contamination.
8. Apply Loctite® 648 to the edges of a new bore plug (602146).
9. Install new plug until the edge of the plug is flush with the block casting ("C" in Figure 2).
10. Allow Loctite to cure to manufacturer's specification.
