TECHNICAL INFORMATION

No: 12/01/99/NAS
 Ref: Alert SA99 1201
 Issue: 2
 Date: 06/04/99

Sump Bolt Oil Seep

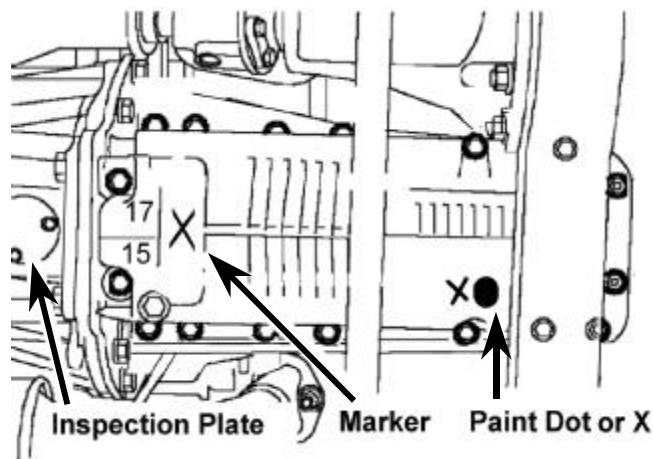
Figure 1

The two rear most structural sump bolts that thread into the rear main bearing cap may be the source of an oil leak on some 99 MY "THOR" V8 engines. (Positions 15 and 17 in Figure 1) Vehicles produced with engines after the above engine number, or vehicles marked by Land Rover on the engine sump, have had the condition corrected.

- At PDI inspect engine sump for any markings indicating that a prior repair has been completed on vehicles before the safe engine numbers. (Figure 1)
 - "X" with marker pen just in front of bolts 15 and 17 indicates a line repair.
 - A yellow or blue paint dot or "X" at the front of the sump indicates a repair completed at engine assembly.
- At PDI if the sump is *not* marked and the vehicle is before the safe VIN, perform the following procedure and claim SRO 12.60.89/36.
- If a leak from the specified sump bolts has been detected after vehicle delivery, perform the following procedure and claim SRO 12.60.89/34 which includes drive-in/drive-out plus diagnostic time.

- Remove **one** bolt (Figure 1 - #15 or #17) and clean thoroughly.
- Clean the bearing cap threads and the sump casting of all oil.

- Apply a small amount of Permatex/Loctite "THE RIGHT STUFF" ® to the underside of the bolt head.
- Install treated bolt and torque to **22 Nm (16 lbf. ft.)**.
- Remove second bolt and repeat steps 1 through 4 for that bolt.
- Verify that entire sump bolt area is clean and free of all oil and oil residue.
- Mark the sump with an "X" near the sealed bolts as indicated in Figure 1.
- Start engine and check for oil leaks.
