TECHNICAL INFORMATION

3rd Row Seat Linkage Improvements

No: 76/13/99/NAS
Ref:
Issue: 1
Date: 05/07/99

DISCOVERY Series II (LT)

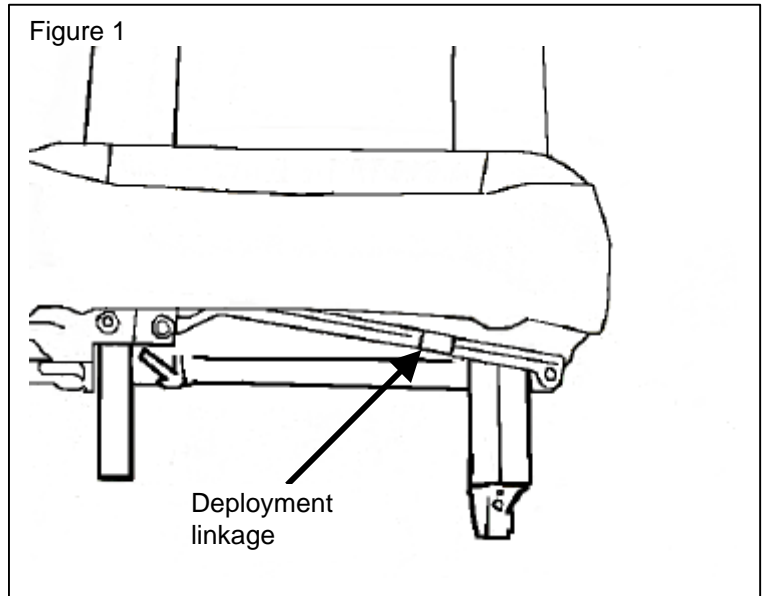
THIRD ROW SEAT LINKAGE PIVOT POINT WEAKNESS

Customer may experience difficult operation or jamming of the third row seat. Inspection may show a fracture of the deployment linkage. The seat cannot be folded or unfolded when the linkage has broken.

1. Fully store the second row seat.
2. Deploy the third row seat and verify that it is correctly latched to the floor.
3. Locate the failed deployment linkage (Figure 1).
4. Locate press-on multi-prong retaining clips at linkage pins.
5. Pry off press-on clips.
6. Remove broken deployment linkage.
