## REPAIR PROCEDURE

# TECHNICAL INFORMATION

No:RB149

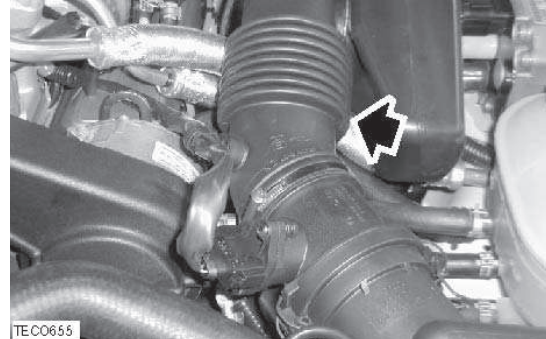
Figure 1

4. If a leak is *not* evident, perform the following:
  - Release jubilee clip and two spring clips securing air intake hose.
  - Release the hose and position aside. (Figure 1).

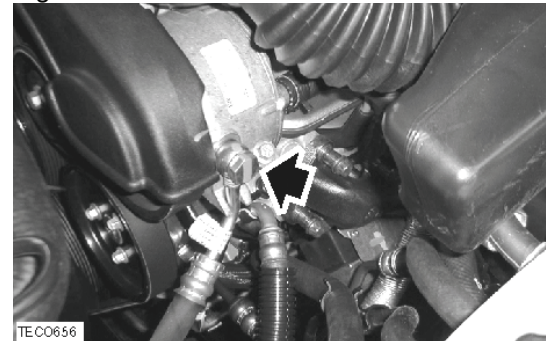
Figure 2

- Set a torque wrench to **33 Nm (24 lbf.ft)** and apply torque to the ACE pump banjo bolt (Arrowed in Figure 2) until the wrench indicates the set torque has been reached.

- ACE components are thoroughly cleaned externally before work commences.
  - All opened pipe and module ports are capped immediately.
  - All fluid is stored in, and administered through, clean containers.
2. Clean around the ACE pump banjo bolt and the surrounding area. (Arrowed in Figure 2)
  3. Position a container to collect fluid spillage.

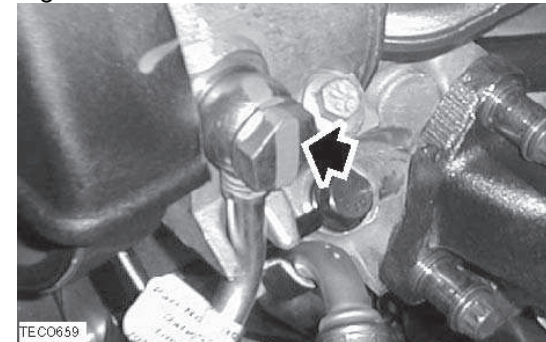
Figure 3

- Apply a yellow paint stripe across the bolt head and the top of the banjo (Arrowed in Figure 3).
  - Position air intake hose and secure with clips.

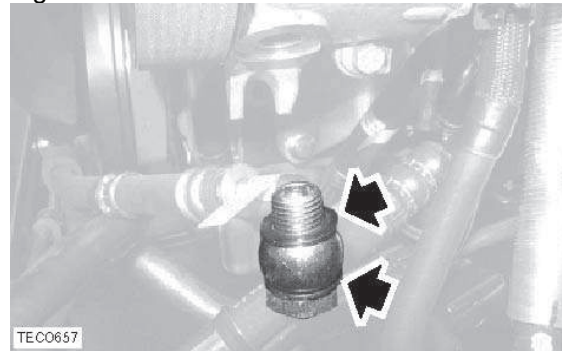
Figure 4

4. Remove the banjo bolt and disconnect the pressure pipe from the ACE pump.
5. Discard both sealing washers. (Figure 4)
6. Clean pressure pipe and ACE pump mating surfaces.
7. Clean the banjo bolt and new sealing washers to remove any dirt or debris.
8. Connect pressure pipe to ACE pump with banjo bolt and new sealing washers.
9. Tighten banjo bolt to **33 Nm (24 lbf.ft)**.
10. Apply a yellow paint stripe across the bolt head and the top of the banjo. (Figure 5)
11. Position air intake hose and secure with clips.
12. Connect battery ground cable.
13. Check and top-up the ACE system reservoir.
14. Start the engine and allow to idle for one minute.
15. Check for leaks in all areas of the ACE system.
