TECHNICAL INFORMATION

Alternator Cable Heat Shrink Replacement

No: 86/09/04/NAS
 FGN LT414
 Ref:
 Issue: 1
 Date: 20 December 2004

Discovery Series II (LT) 3A771323 to 4A870624

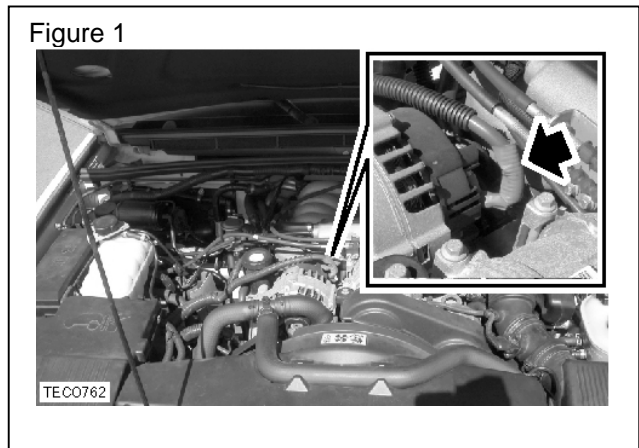
HEAT SHRINK SLEEVE ON ALTERNATOR CABLE - SPLITTING

Inadequate heat shrink sleeve thickness may contribute to the insulation cover of the main alternator cable deteriorating and splitting.

1. Disconnect the battery ground lead.
2. Remove the nut and disconnect the alternator cable from the alternator.
3. If required, remove the deteriorated heat shrink sleeve from alternator cable.
4. Install a new heat shrink sleeve onto the alternator cable. (Figure 1)
5. Shrink the sleeve to the cable using a hot air gun.
6. Connect the alternator cable to the alternator.
7. Install the nut and tighten to **15 Nm (11 lbf.ft)**.
8. Connect the battery ground lead.
