TECHNICAL ALERT

TA00 4402

AT Breather Repositioning and Fluid Check

TRANSMISSION WATER INGRESS THROUGH BREATHER

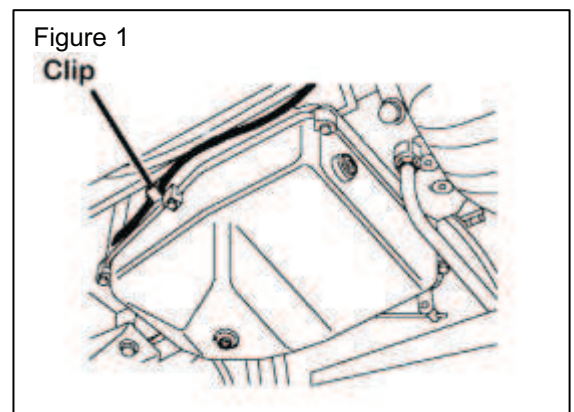
Condensation from Air Conditioning and water from a “deep wading” event can flow over the transmission and collect on the transmission breather tube on Range Rover and Discovery Series II vehicles. It can then migrate up the transmission tube. Over time these small water droplets can cause an accumulation of water in the transmission causing problems associated with water contamination – harsh gear changes, poor gear selection, gear slip or loss of drive and intermittent failure of the park lock function. Inspections and resolution for these faults will be addressed by the formal Recall.

1. Raise vehicle on lift.
2. Locate end of transmission breather tube clipped to the edge of the transmission pan.(Figure 1)
3. Inspect the end of the tube for blockage or damage.
4. Unfasten clip from transmission and remove the clip from the tube. Discard the clip.
5. Guide the end of the breather tube up over the top of the transmission housing.
6. Locate the white three-hole tube-locating clip near the top of the transmission housing.
7. Spray a small amount of silicon lubricant on the breather tubing near the locating clip.
