TECHNICAL INFORMATION

No: 86/05/02/NAS
 Ref:
 Issue: 1
 Date: 08/09/02

Battery Clamp Bolt Availability

Range Rover (LP)	All
Discovery (LJ)	All
Discovery (LT)	All
Freelander (LN)	All

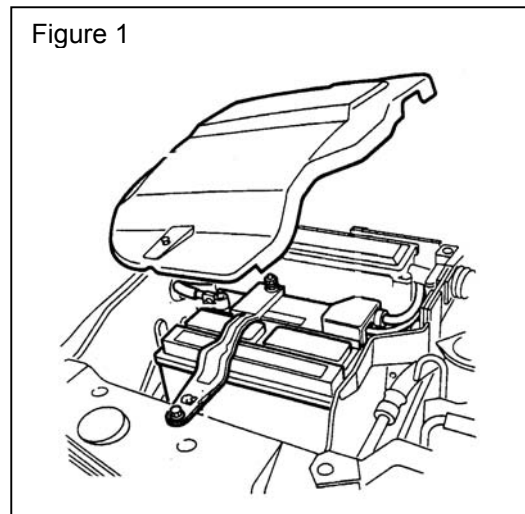
Figure 1

BATTERY CLAMP BOLT MAY SHEAR

The customer may complain of non-starting or intermittent electrical problems. The root cause of these symptoms may be a broken battery clamp bolt on either the positive or negative cable clamp.

1. Disconnect battery and extract damaged bolt .
2. Install new bolt and nut (YTJ000010) detailed in parts information.
3. Tighten the new bolt to between **4 and 6 Nm (35.5 – 53 lbf.in.)** on all vehicles.
