TECHNICAL INFORMATION

No: 76/02/03/NAS
Ref:
Issue: 1
Date: 02/28/03

Cargo Blind Snap Replacement

Discovery Series II (LT)

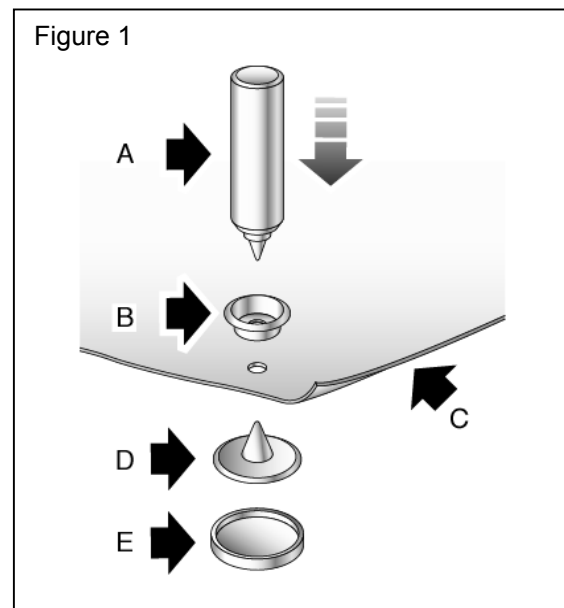
LOAD SPACE ROLLER BLIND SNAP BROKEN

The snap that secures the load space roller blind to the rear seat may break under excessive force.

1. Release and remove the load space roller blind from the vehicle.
2. Position the load space roller blind on a clean flat bench and remove the broken "female" snap.
3. Refer to Figure 1 and from the underside of the load space roller blind, locate the stemmed snap head (D), through the roller blind fabric (C).
4. Position the die (E) under the stemmed button.
5. From the top of the load space roller blind, locate the female snap (B) over the stemmed button.
6. From the top of the load space roller blind, position the punch (A) to the top of the stemmed button.
7. Strike the punch firmly with a hammer.
8. Remove the die (E) from the stemmed snap head.
9. Fit the load space roller blind and secure in retainers.
10. Secure load space roller blind to the rear seat using the snap.

**NOTE: If the press stud rotates in the fabric repeat step 5 until the press stud is secure.**
