TECHNICAL INFORMATION

No: 86/05/04/NAS
Ref:
Issue: 1
Date: 04 June 2004

Correct Headlight Cover Installation

Discovery Series II (LT)

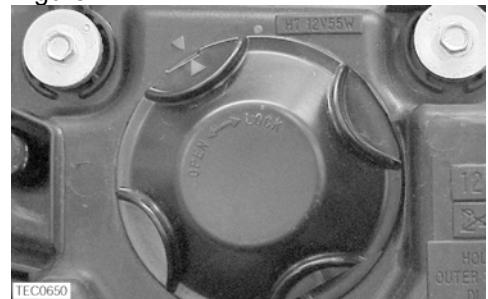
Figure 1

Incorrectly installed or incompletely tightened headlight bulb access covers permit moisture into the headlight assembly. The customer may complain of condensation in the lamp, or of deteriorating headlight performance.

1. Position the cover for installation and align arrowheads on the cover with the arrowhead on the housing. (Figure 1).
2. Push the cover into the housing.
3. Rotate the cover clockwise until the arrowhead on the cover aligns with the dot on the housing and the positive stop restricts any further clockwise motion. (Figure 2)
