# TECHNICAL ALERT

TA00 D203

## D203 Inspection Information

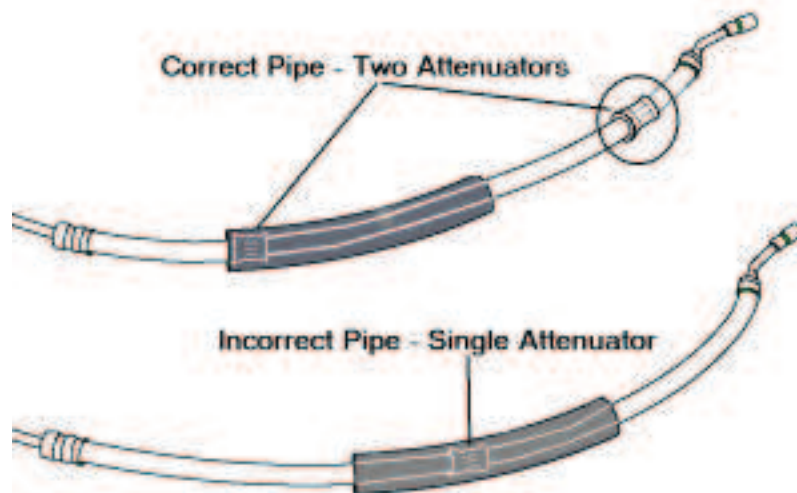
For inspection purposes a correct pipe can most easily be identified by the attenuator located on the flexible hose portion of the pipe a few inches downstream of the pump banjo fitting. Refer to Figure 1 and note the circled attenuator. If this attenuator is present the plumbing is the correct specification.

The revised Figure 1 more accurately shows the position of the attenuators. This illustration will be inserted into the bulletin “D203” on the InfoTrail.
