TECHNICAL ALERT

TA99 1901

Discovery Series II Fuel Gauge Inoperative

DISCOVERY (LT) All

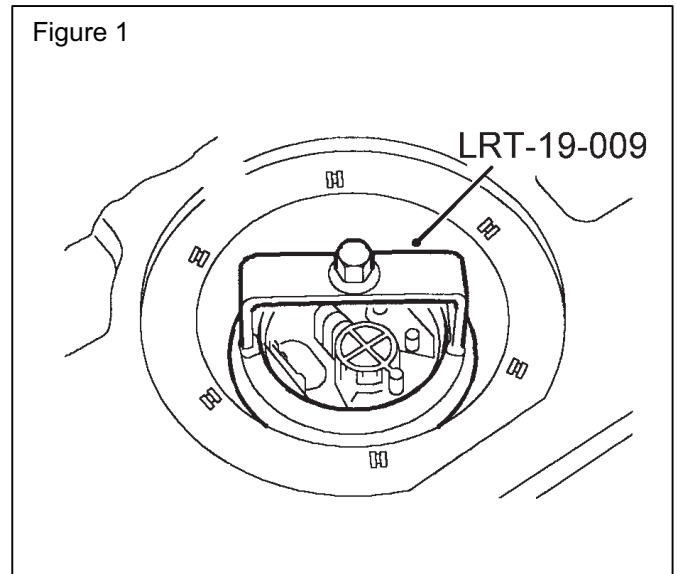
Figure 1

Some Discovery Series II vehicle owners have encountered fuel gauges which either do not indicate above half a tank or are stuck at one reading. The root cause of this is incorrect positioning of the fuel pump in the tank, causing the float arm to foul.

1. Refer to Section 19.45.08 of the Workshop Manual and remove the fuel pump assembly using special tool LRT-19-009. (Figure 1)
2. Refer to the resistance chart on Fuel System REPAIR page 19-2-8.
3. Connect an ohm meter and check the resistance of the fuel gauge through the float arm full range of motion against the values in the WSM chart.

1. Place a **new** fuel pump seal (ESR3806) in the tank opening.
2. If the resistance of the sending unit is within specification and no damage is observed, position the original pump in the tank.
3. If the resistance measurement was out specification, or the pump assembly is damaged, position a new pump assembly (WFX101070) in the tank.
4. Verify that the pump is oriented properly in the indentation in the base of the tank.
5. Refer to the Workshop Manual and complete fuel pump installation.
