TECHNICAL INFORMATION

No: 76/21/99/NAS
 Ref:
 Issue: 1
 Date: 07/16/99

Front Seat Recline Trim Piece loose

DISCOVERY Series II (LT) Up To XA902786
 Up To XA206760

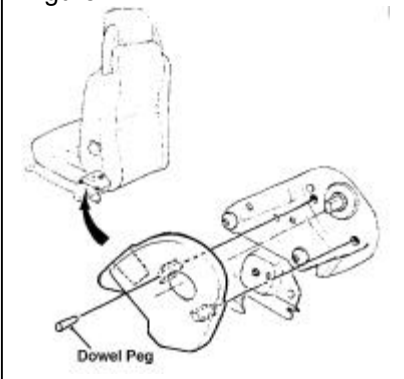
Figure 1

FRONT SEAT RECLINE MECHANISM TRIM PIECE EXHIBITS POOR FIT.

A customer may complain of a loose or misaligned trim piece on the seat recline mechanism. This may be due to insufficient fastening of the trim piece to the seat frame.

1. Adjust the seat to its rear-most position.
2. Remove the recline mechanism trim piece by pulling it away from the two stud locations in the seat frame.
3. Install the new specification trim piece as follows:
 - Locate the trim piece retaining studs.
 - Push the trim piece into the seat frame.
 - Insert the tapered dowel peg into the forward retaining stud, and press firmly.
