TECHNICAL INFORMATION

Headlight Condensation Resolution

No: 86/04/05/NAS
FGN LT417-01
Ref:
Issue: 1
Date: 23 June 2005

Discovery Series II (LT)

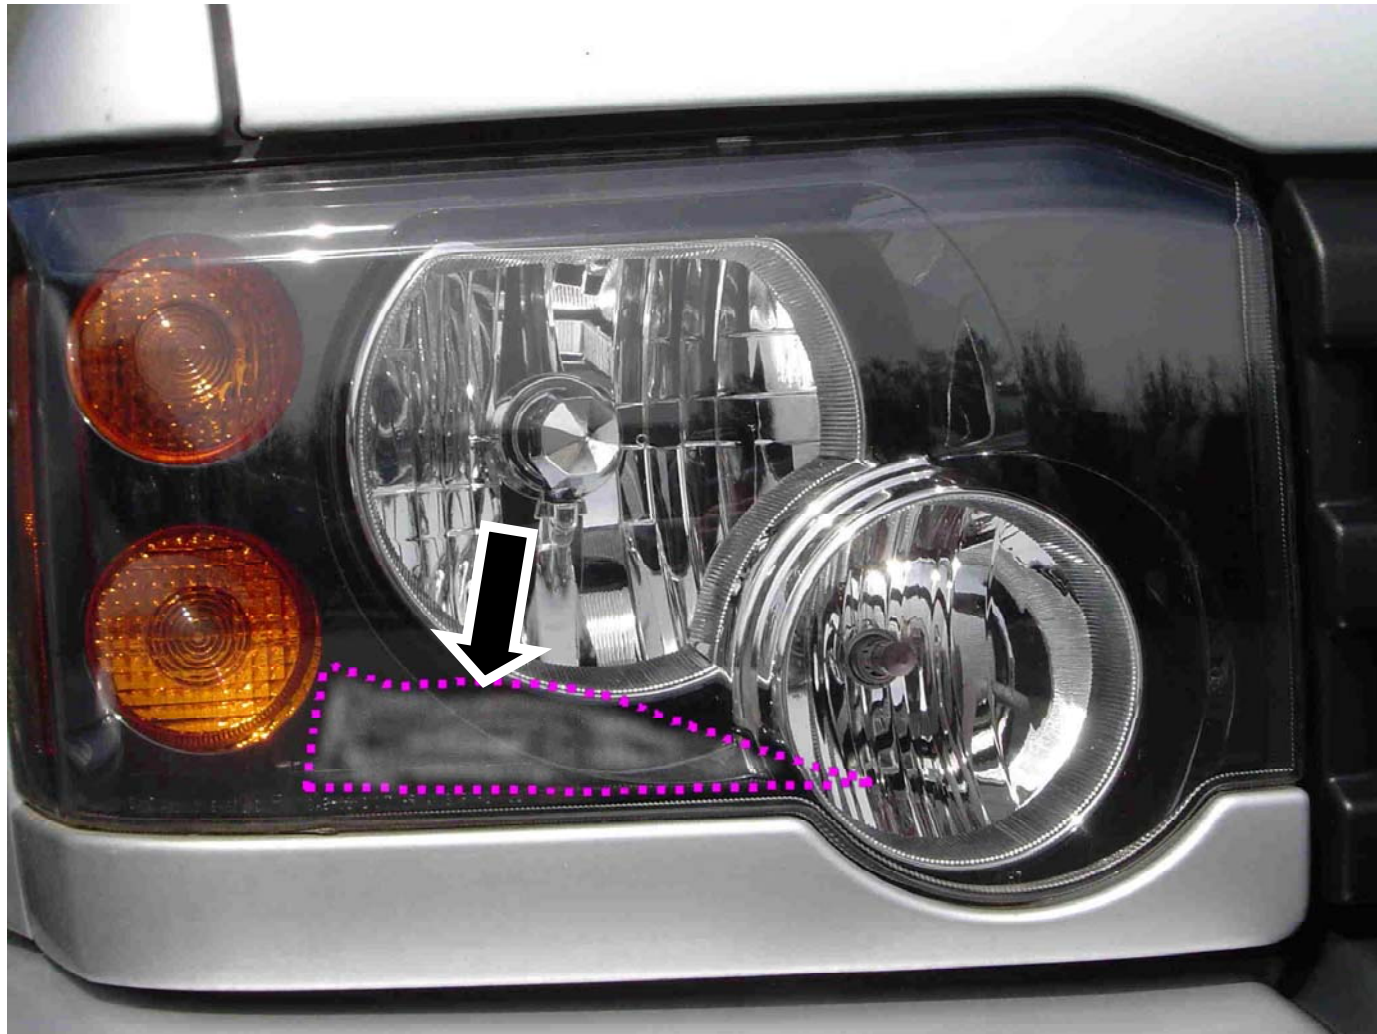
Attachment 4 Headlamp Condensation NOT Covered by Warranty - 1

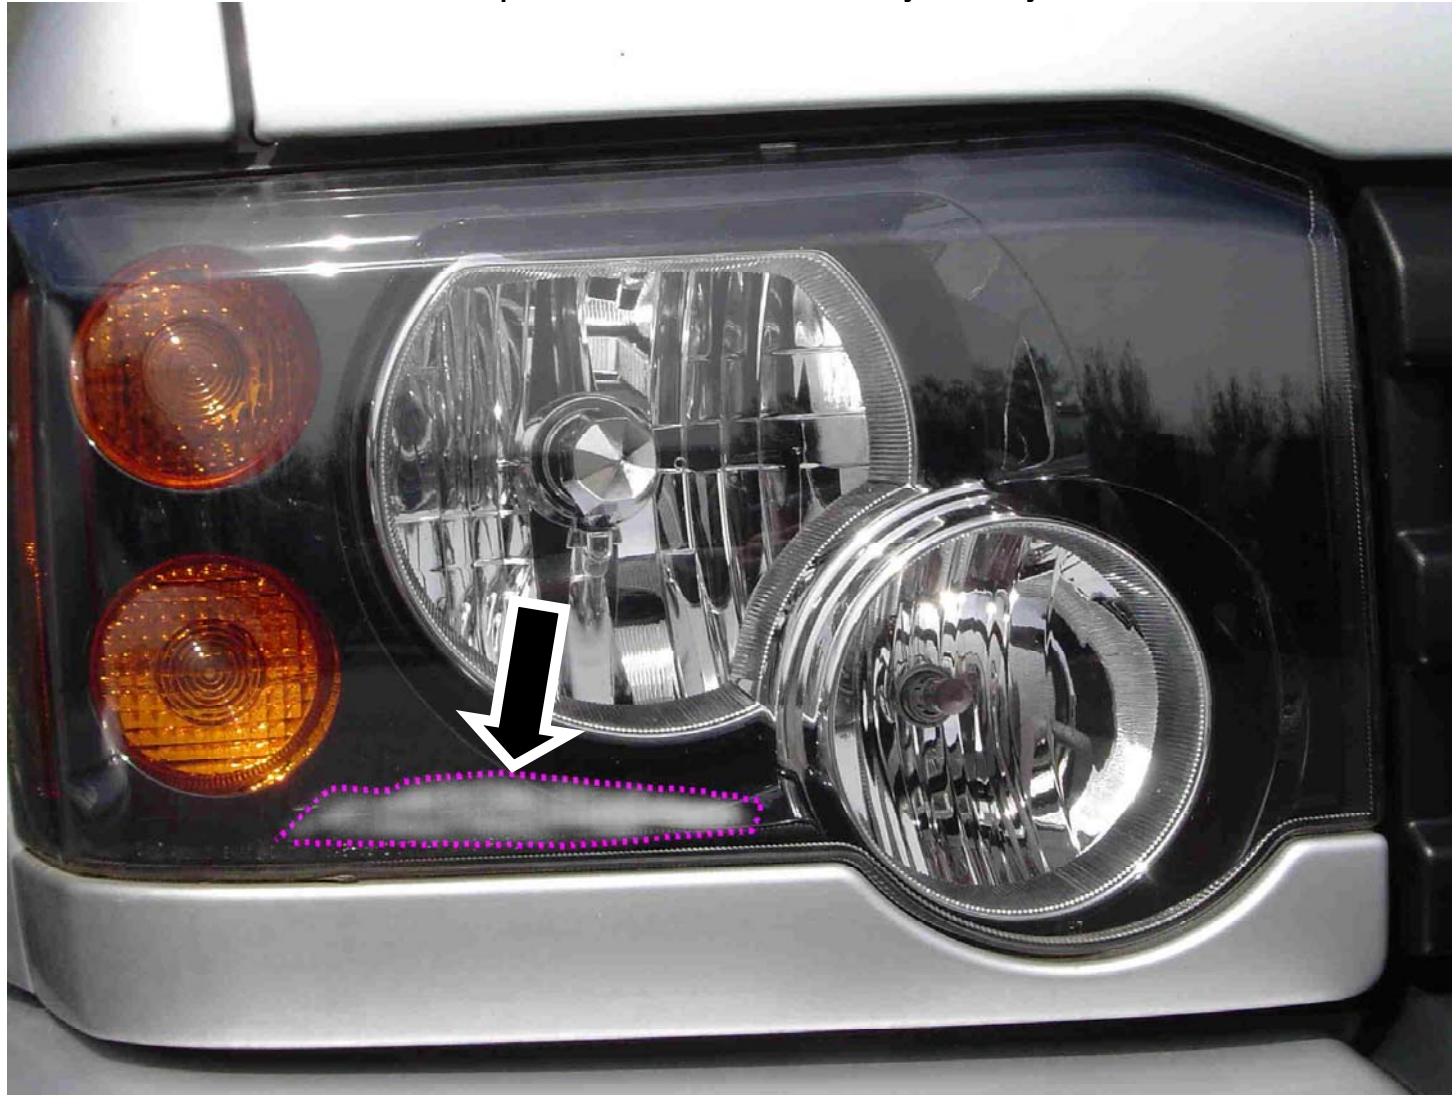
Attachment 5 Headlamp Condensation NOT Covered by Warranty – 2

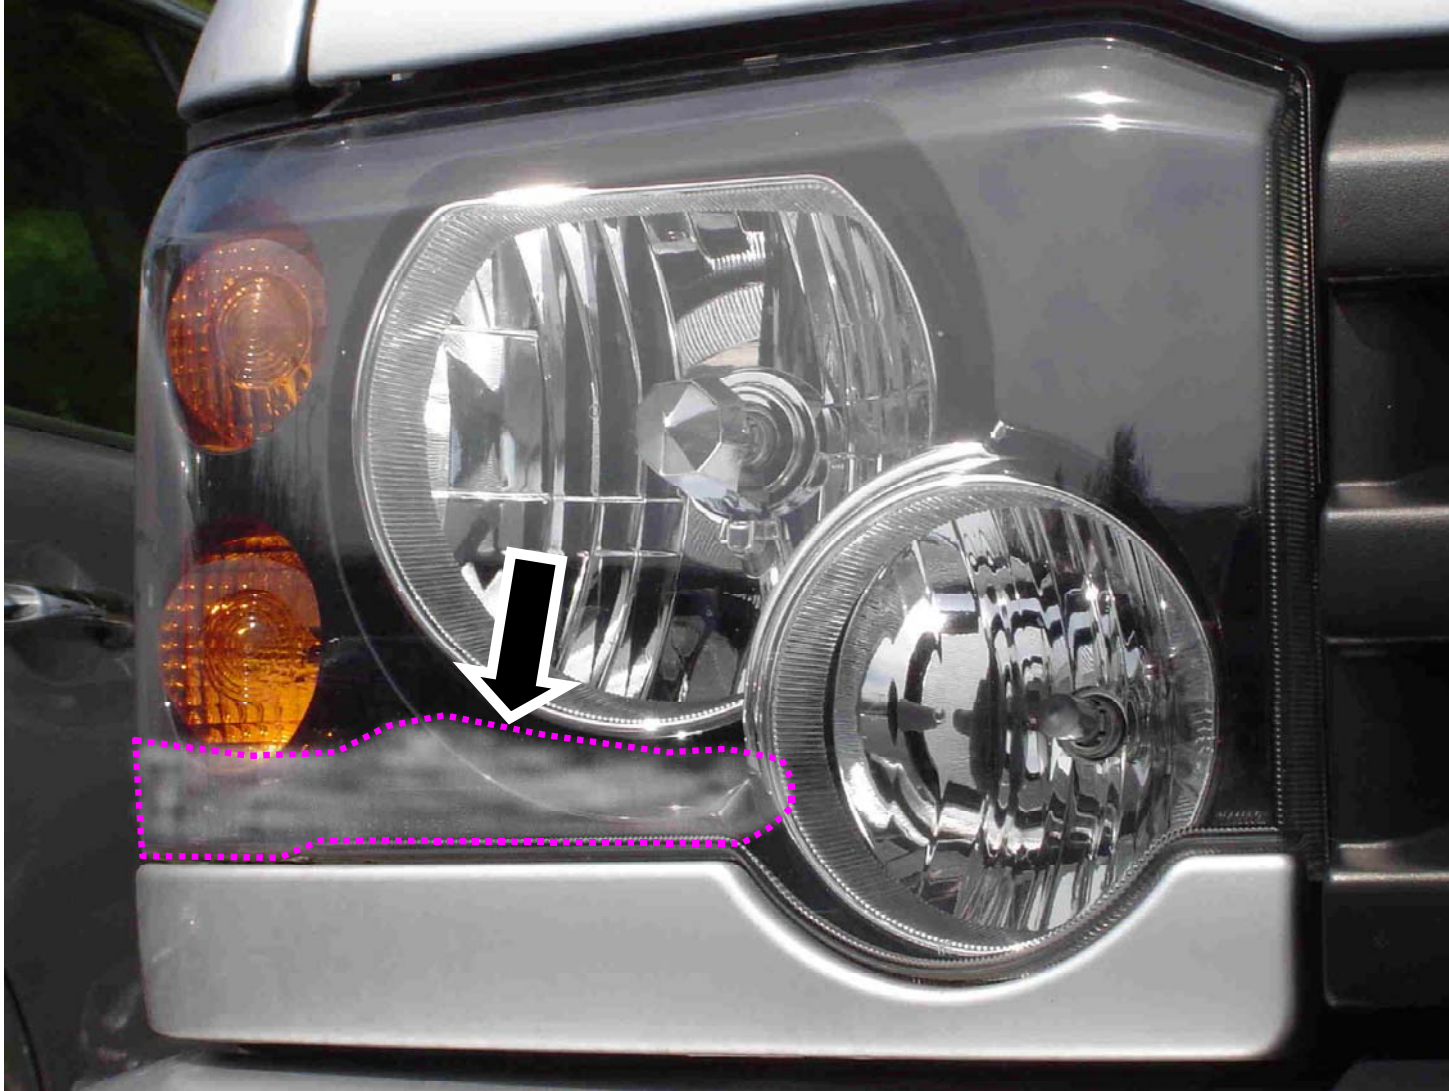
Attachment 6

Headlamp Condensation NOT Covered by Warranty - 3 (Mist does not obstruct the view of the lamp's interior)

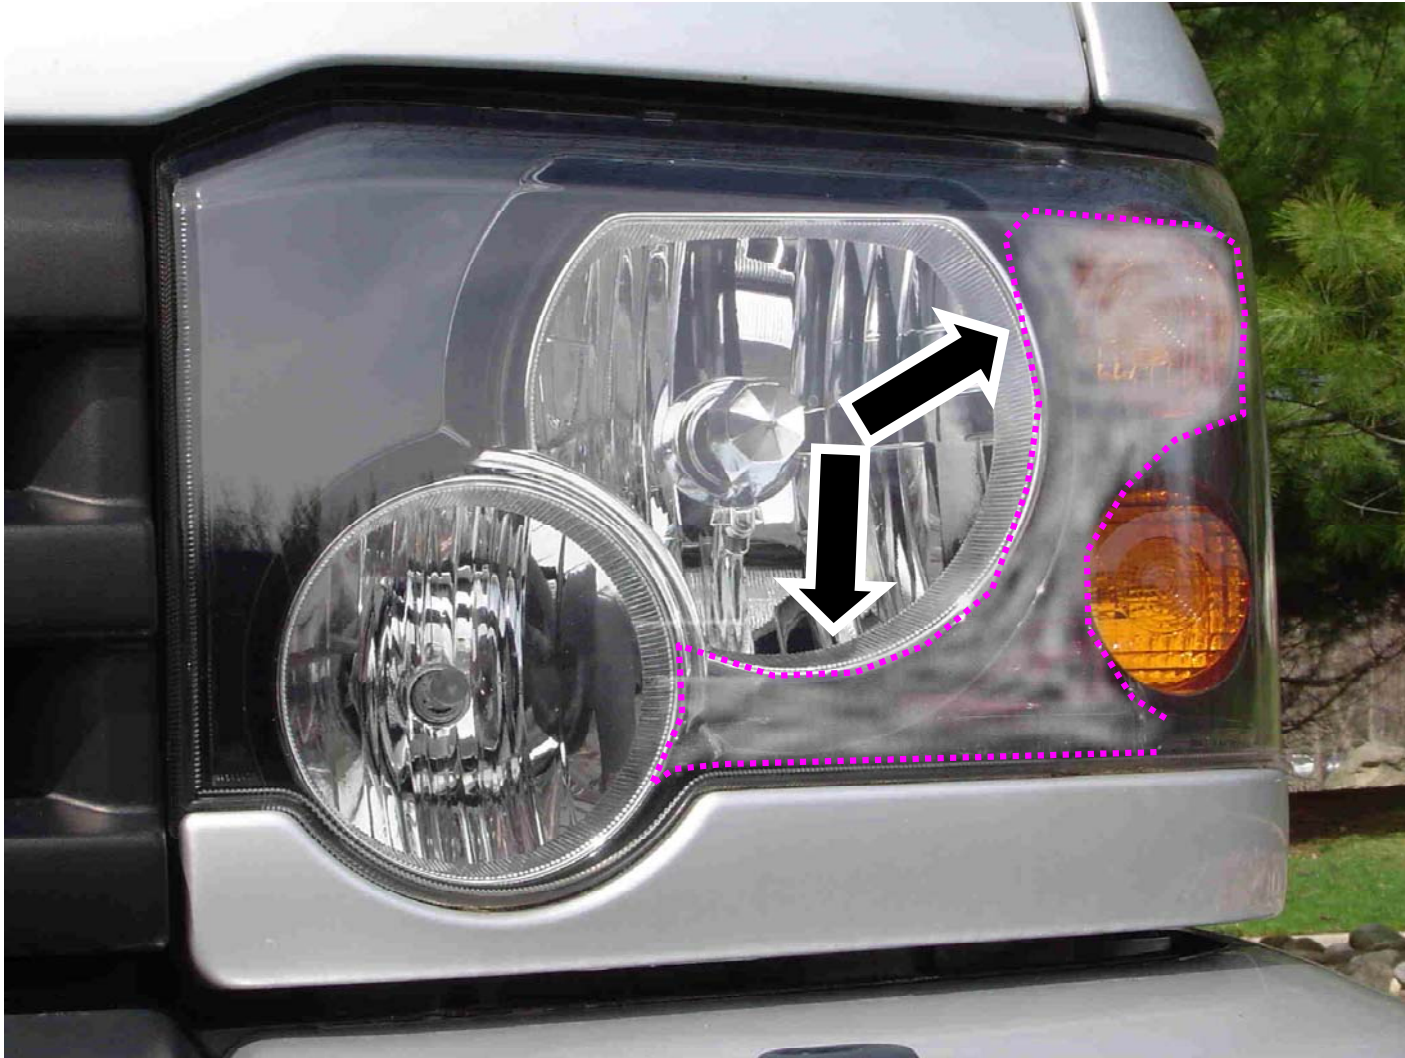
Attachment 7

Headlamp Condensation NOT Covered by Warranty - 4 (Fine mist covers less than 50% of the lens)
