# TECHNICAL INFORMATION

## License Plate Lamp Water Ingress

No: 86/01/05/NAS  
FGN LT417  
Ref:  
Issue: 1  
Date: 07 March 2005

Discovery Series II (LT)

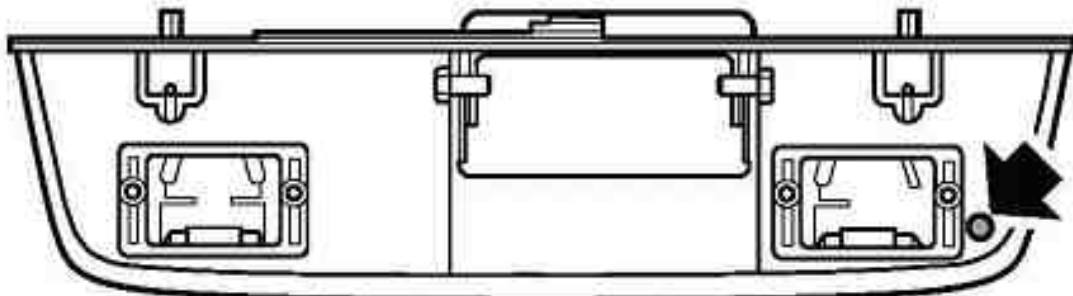
Figure 1

**Shown upside down. The hole is on vehicle left side.**

2. Refer to GTR Workshop Manual section 86.40.98 and remove the number plate lamp housing.
3. Remove and discard the discolored or water damaged lamp lens, lens securing, lens, gasket and bulb.
4. Remove the two spring retaining clips and discard.
5. Visually inspect the electrical wiring connections on the number plate lamp housing harness for evidence of corrosion to the wiring or connectors.
6. Clean or repair electrical connections as necessary.
7. Clean the number plate housing assembly to remove any corrosion deposits.
8. Drill a 6mm (1/4 in) drain hole in the underside of the handle assembly to allow further water to drain. (Figure 1)
9. Install the new lamp into the left-hand door handle lamp location.
10. Refer to GTR Workshop Manual Section 86.40.98 and install the door handle assembly into the tailgate.
