TECHNICAL INFORMATION

No: 76/03/01/NAS
Ref:
Issue: 1
Date: 06/01/01

Loose Armrest Bolts

| Discovery Series II (LT) | XA900012 | to | XA907212 |

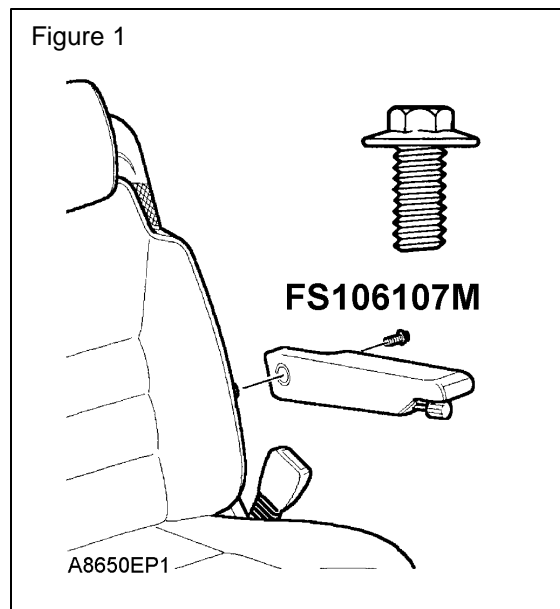
The customer may complain that the front armrest has come adrift or is loose on its fastening bolt. Incorrect armrest securing bolts may have been fitted during manufacture. Some bolts lack the correct patchlock material

1. Remove existing attachment bolts.
2. Install patchlock attachment bolts (FS106107M) in both armrest anchor locations.
3. Tighten each bolt to 10 Nm (88.5 lbf. in.).
