TECHNICAL INFORMATION

Loose Starter Cable Connection

No: 86/04/00/NAS
Ref: 86/08/01/NAS
Issue: 2
Date: 07/27/01

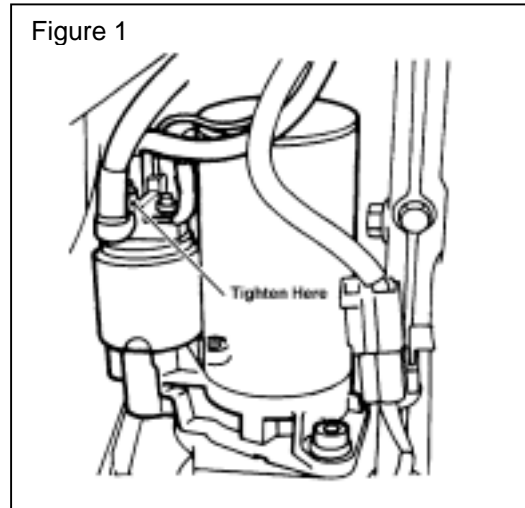
Figure 1

The primary electrical connection between the starter and the battery may not be adequately tightened on vehicles exhibiting these symptoms. A low torque condition will not provide a solid electrical connection.

1. Disconnect battery ground terminal.
2. Slacken and remove the battery-lead-to-starter-solenoid-securing nut at the starter solenoid.
3. Clean all connection surfaces.
4. Install a star washer on the solenoid stud.
5. Install and tighten the nut to **18 Nm (13 lbf.in.)**. (Figure 1)
6. Clean and install battery ground terminal.
7. Start vehicle to verify repair.
