TECHNICAL INFORMATION

No: 76/19/99/NAS
Ref:
Issue: 1
Date: 07/09/99

Play in Second Row Seat Back Hinge

DISCOVERY Series II (LT)

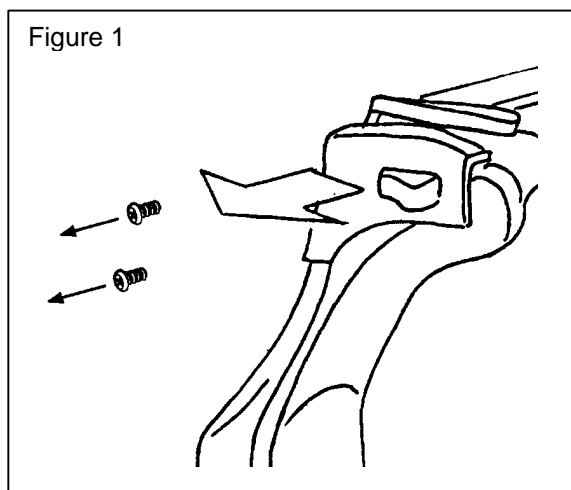
Figure 1

Customers may experience a rattle from the second row seat hinge (both 40% and 60% sides). Excessive play in the hinge may cause the rattle.

1. Fold both second seats fully forward.
2. Prepare each of the two outboard hinge assemblies as follows:
 - Remove the two trim cover securing screws and remove the trim piece from the seat (Figure 1).
 - Mask the area around the over-travel stop pin (Figure 2).
 - Using sand paper, remove the paint from the stop pin.
 - Place one offset drilled collar onto the stop pin and ensure that the collar can rotate freely 360° (Figure 3).
 - Remove the collar from the stop pin.
3. Go to step 2 and repeat for the alternate side.
