TECHNICAL INFORMATION

No: 76/18/99/NAS
Ref:
Issue: 1
Date: 06/18/99

Rattle In Center Console

Discovery Series II (LT)

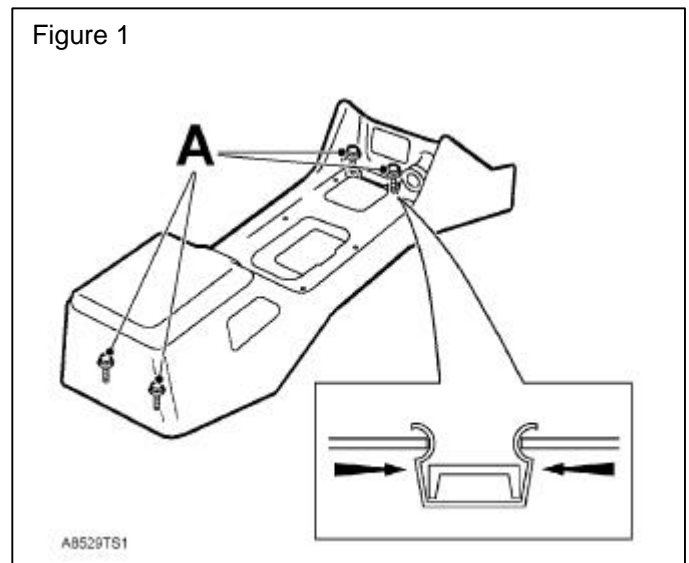
Figure 1

EXCESSIVE MOVEMENT AND RATTLES IN THE CENTER CONSOLE

The customer may complain of rattling or knocking noises as a result of side to side movement of the center console. Free-play in the securing cage nuts, may be the cause of up to 4mm of console travel.

1. Refer to WSM 76.25.01 and remove center console.
2. Replace each cage nut as follows:
 - Compress side retainer clips of original cage nut. (Figure 1)
 - Remove and discard cage nut.
 - Install new cage nut (NK106061L) into bracket opening.
3. When all four cage nuts are replaced, refer to WSM 76.25.01 and install center console.
