TECHNICAL INFORMATION

No: 76/02/01/NAS
Ref:
Issue: 1
Date: 03/02/01

Rear Center Seat Belt Escutcheon

Discovery Series II (LT)

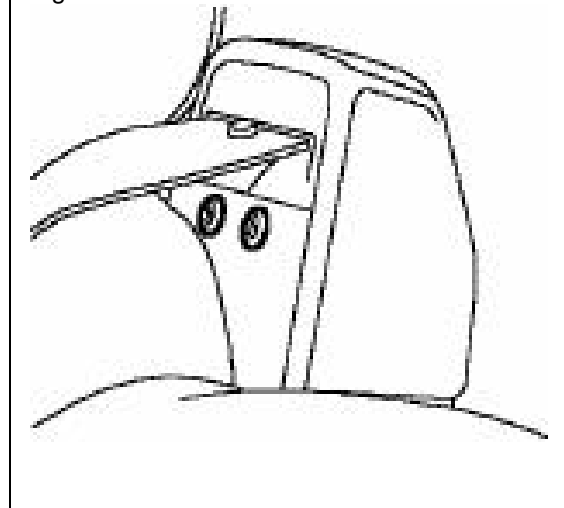
Figure 1

If allowed to return too quickly, the rear center seat belt "stop button" can pass through the opening of the escutcheon. Should the seat then be folded forward it is possible that the belt will jam requiring disassembly of the seat to release it from the folded position.

1. Release the seat belt escutcheon from the center belt cover. (Figure 1)
2. Slide escutcheon off of the belt through the slot
3. Install new escutcheon onto the belt
4. Insert the escutcheon into the center belt cover.
