# TECHNICAL INFORMATION

## Remote Handset Function/Alarm Module Troubleshooting and Upgrade

No: 86/10/01/NAS  
 Ref: Replaces  
 86/01/01/NAS  
 Issue: 1  
 Date: 10/19/01

Discovery Series II (LT)

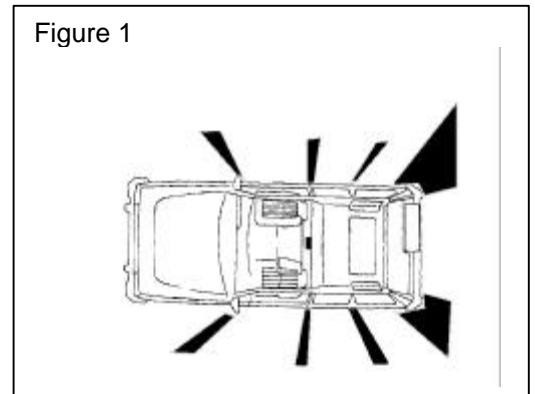
Figure 1

5. If intermittent operation is experienced in any areas other than known weak reception areas (Figure 1) or if the range is poor, the fault lies in the alarm receiver.

6. If the above checks do not reveal a cause, or if the alarms system consistently enters sleep mode, replace the receiver.
