TECHNICAL INFORMATION

Right 'A' Pillar Wind Noise Correction

No: 76/11/03/NAS
Ref:
Issue: 1
Date: 04/25/03

Discovery Series II (LT)

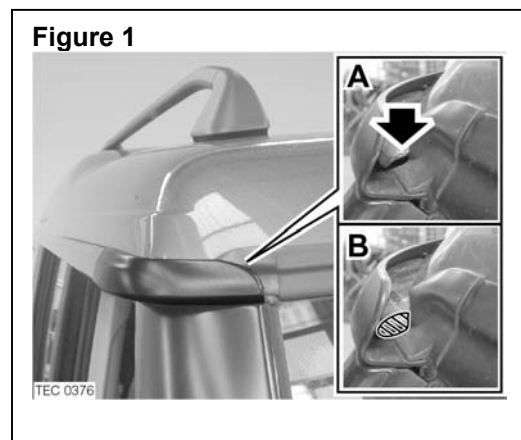
The customer may complain of a wind noise at speeds above 32 km/h (20 mph) coming from around the top of the right-hand 'A' pillar. A gap in the body sealant on the right hand drip rail is the probably cause.

1. Clean around the area to be sealed on right hand drip rail (Inset 'A' Figure 1).
2. Apply sealant to fill the gap in the body sealant (Inset 'B' Figure 1).
3. Remove any excess sealant.
