TECHNICAL INFORMATION

No: 86/02/03/NAS
 Ref:
 Issue: 3
 Date: 05/23/03

Serpentine Belt Idler Pulley Noise

Range Rover (LP)	XA410504 and up
Discovery Series II	XA200419 – 1A299999 1A700000 – 3A781991

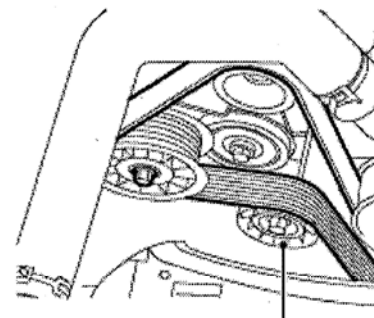
Figure 1

The customer may complain of a chirp or excessive belt noise. The plastic idler pulley may be deformed causing uneven loads on the serpentine belt.

Idler Pulley (Range Rover shown)

1. Refer to RAVE section 86.10.03 for affected vehicle and remove the auxiliary drive belt.
2. Remove bolt securing the RH idler pulley below the tensioner assembly.
3. Remove and discard the idler pulley.
4. Clean area around pulley mount and ensure mounting threads are clear of debris.
5. Install the new idler pulley and tighten the bolt to **50 Nm (37 lbf.ft)**.
6. Install the auxiliary drive belt following RAVE procedures.
