# TECHNICAL INFORMATION

No: 76/02/00/NAS  
Ref:  
Issue: 1  
Date: 04/07/00

## Tightening Support Strut Fasteners

Discovery Series II (LT)

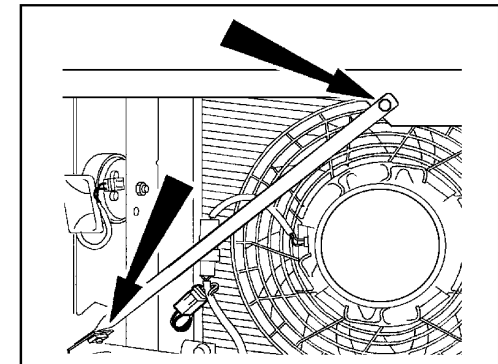
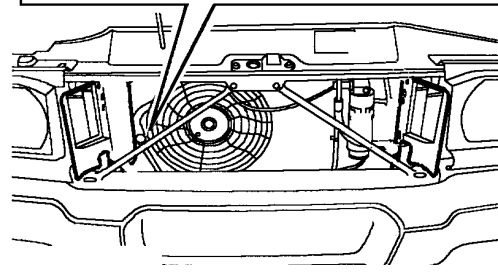
The customer may notice an intermittent knock from the front of the vehicle when driving over uneven surfaces. Insufficient torque on the support strut fasteners can permit movement of the struts causing the knock.

**NOTE: The Figure 1 illustration arrows the upper and lower fastener locations for the right side.**

2. Carefully hold grille forward just enough to gain access to both lower support strut fixing bolts.
3. Torque support strut fasteners on both sides as follows:
  - Using a suitably long extension and 10mm socket, apply a torque of **9Nm (80 lbf.in.)** to both lower support strut bolts.
  - Remove the extension and torque the upper strut bolts to **9Nm (80 lbf.in.)**.
4. Reposition grille and tighten the 3 grille quick screws.
