TECHNICAL INFORMATION

Troubleshooting ABS/HDC/TC Warning Lamp Illumination

No: 70/07/04/NAS
Ref:
Issue: 1
Date: 28 October 2004

Discovery Series II

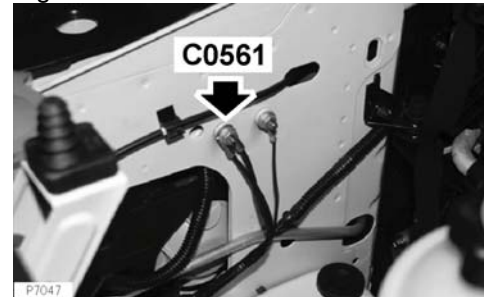
Figure 1

1. Connect T4 to the vehicle and check for any logged fault codes.
2. Locate the ground stud connection (C0561-1) located on the radiator support behind the LH headlamp assembly. (Figure 1)
3. Check that C0561-1 is undamaged and free of corrosion.
4. If the ground stud is damaged or corroded, clean the eyelet and stud and tighten the nut to **10 Nm (7.5 lbf.ft.)**.
5. Check for continuity between the ground stud (C0561-1) and C0500 connector on the ABS modulator body.
6. Move and flex the wire between C0561-1 and C0500 to verify that there is no interruption in continuity.

LOCATION: Behind LH Headlamp
Air intake box removed for visibility

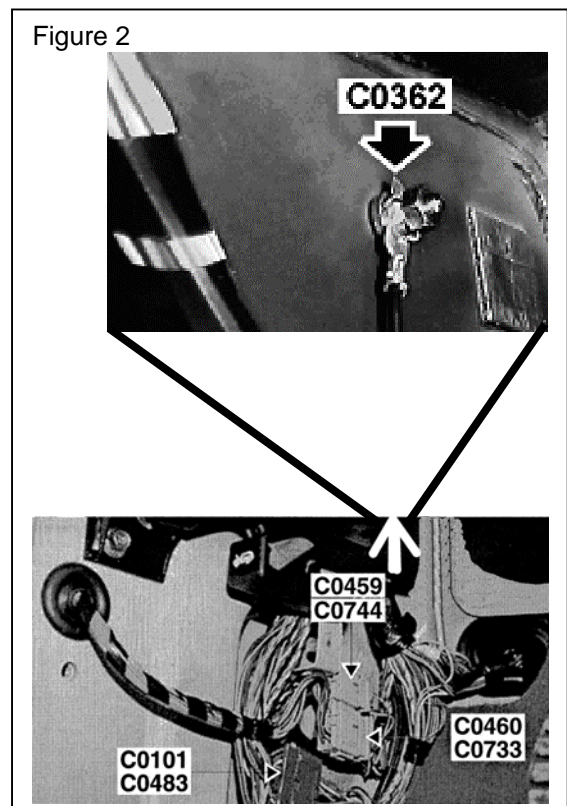
Figure 2

19. If there is no continuity or intermittent continuity when the wire is flexed, repair or replace the damaged wire.
20. If the resistance is between the minimum and maximum values, check for continuity between pin 12 of the 18-pin SLABS ECU connector (C0504-12 - black wire) and ground C0362-1 located high on the LH inner fender within the passenger compartment. (Figure 2)

21. If there is no continuity or intermittent continuity when the wire is flexed, repair or replace the damaged wire.
22. Check for continuity between pin 3 of the 15-pin SLABS ECU connector (C0506-3 black/slate wire) and ground.
