# TECHNICAL ALERT

TA03 1202

## Land Rover V8 Manifold Bolt Re-Use

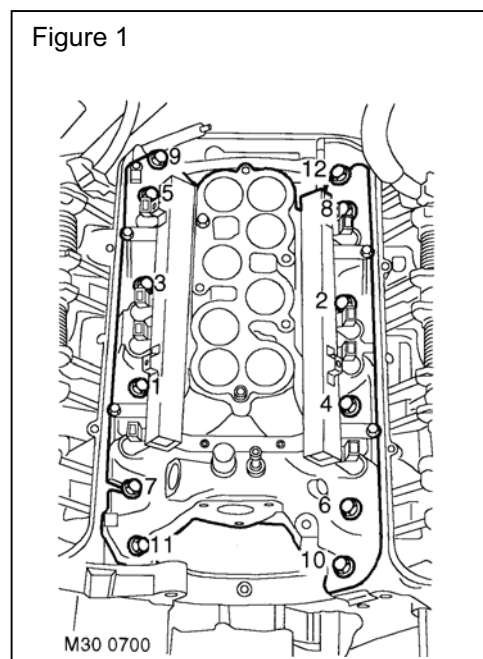
Figure 1

**Manifolds secured by "V" grade bolts may have those bolts re-used.** The new specification bolts announced in TIB 12/02/99/NAS (LYG101450 and LYG101440) are identified by a "V" on the bolt head. They will not experience the "stretching" that was the root cause of some manifold leaks. The only requirement for reuse is that a thread sealant be applied to the threads before installation and performance of the torque procedures.

1. Refer to WSM 12-2-43 and install "V" specification bolts taking note of the following care points:
  - If old "V" grade bolts are to be reused, clean and remove oil and sealant residue from bolts
  - Apply sealant to bolt threads
  - Install long bolts (LYG101450) in the two front-most locations (Positions 10 and 11, Figure 1).
  - Install shorter bolts (LYG101440) in the remaining locations.
  - Refer to the Workshop Manual and follow the proper torque sequence and value when installing the bolts.
