TECHNICAL INFORMATION

No: 84/02/03/NAS	
Ref:	
Issue: 1	
Date: 04/11/03

Washer Jets Weep

AFFECTED VEHICLE RANGE:
Discovery Series II (LT) Up to 3A777039

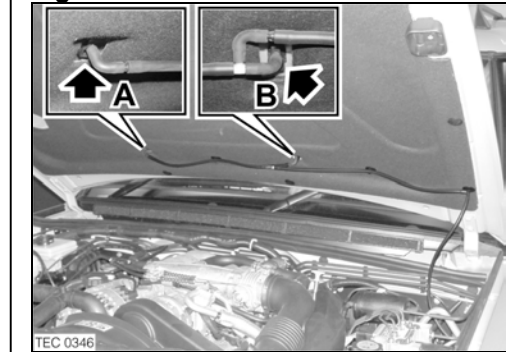
Figure 1

SITUATION:
FRONT WASHER JETS LEAK
 The owner may complain that the front washer jets weep and leave fluid on the hood surface. This symptom may be caused by the check valve location being too far removed from the jet. Washer fluid trapped between the check valve and the jet can expand due to engine compartment temperatures and weep onto the hood.

1. Disconnect the washer hose assembly from the washer jets. (A and B in Figure 1)
2. Release the 90° hose connector from the hood. (C in Figure 2)
3. Disconnect the supply hose from the connector (B in Figure 2).
4. Release the washer hose assembly from the clips on the hood (A in Figure 2)
5. Remove the old washer hose assembly.
6. Connect the new washer hose assembly to the washer jets.
7. Connect the supply hose to the new 90° connector.
8. Install the 90° connector onto the hood.
9. Install the washer hose assembly into the clips on the hood.
10. Operate the windscreen washers to verify correct operation.
11. Verify there are no leaks in the washer system.
12. Top up the windscreen washer reservoir.
