TECHNICAL INFORMATION

Wind Noise Correction

No: 80/02/03/NAS
Ref:
Issue: 1
Date: 09/12/03

Discovery Series II (LT)

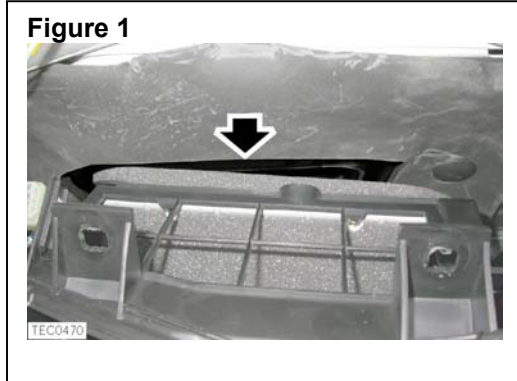
Interference between the sound deadening material and the air intake duct may prevent a proper seating of the duct to the bulkhead. Follow the procedures in this bulletin to correct the alignment and fit of the duct into the bulkhead.

5. Mark out and remove the surplus NVH insulation pad to allow the air intake duct to fit correctly to the plastic intake duct in the bulkhead (Figure 1).
