# TECHNICAL INFORMATION

No: 84/01/00/NAS  
Ref:  
Issue: 1  
Date: 04/21/00

## Wiper Mechanism Washer Corrosion

Discovery Series II (LT)

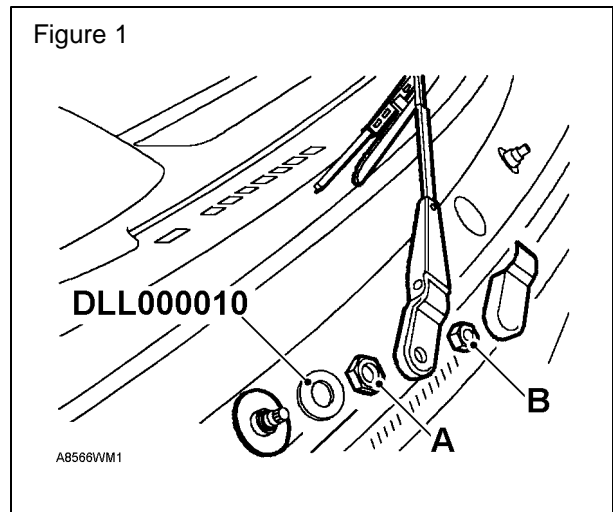
Poor finish durability may cause a customer complaint regarding deteriorating appearance of the washers behind the wiper arms on the windshield wiper mechanism.

1. Refer to Figure 1 and remove the original washers as follows:
  - Remove wiper arm nut (B) and the arm.
  - Remove wiper assembly nut (A).
  - Remove and discard the deteriorated washer.
2. Install the new washers, (DLL000010) as follows:
  - Position the new washer and install the mechanism nut (A).
  - Tighten the wiper mechanism nut (A) to **7Nm (62 lbf.in.)**.
  - Install the wiper arm and tighten the wiper arm nut (B) to **15Nm (133 lbf.in.)**.
3. Go to Step 1 and repeat procedure for the alternate side.
