# PHILIPS

OSC 216

OSCILLOSCOPE PM3219/04

Subject : 1. Supplementary information to Service manual 9499 445 01911  
2. Modifications during production of the /04-version  
3. Possible storage problem

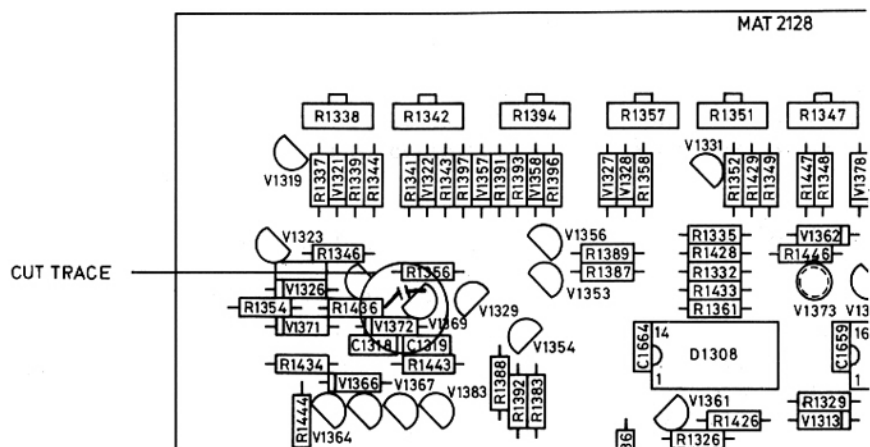
Fig.1 Part of Storage unit p.c.b.

A problem has occurred in several storage boards that may be particularly difficult to track down. A method of checking to see if you have this problem, as well as a procedure to resolve this problem, is given below.

Symptom: The symptom for this problem is that the storage function can not be turned off. In addition, if you measure the voltage on storage mesh "G9" on the CRT, it remains at approximately +110 volts, regardless of whether the memory is switched on, or off.

1. Remove transistor V1369.
2. Cut the trace on the conductor side of the P.C. board that connects the emitter of V1369 with R1436.
3. Replace transistor V1369, however instead of inserting the emitter lead in the P.C. board, connect it directly to R1436. Insulate the lead to prevent shorting.
4. Check the unit for proper operation, allowing at least a 48 hour burn-in period to insure proper operation.
