SERVICE SUPPORT DOCUMENT

Program Type	SERVICE UPDATE PLAN #3010
Product Type	2213,2215
Service Support Group	BEAVERTON SERVICE SUPPORT

SERVICE UPDATE PROGRAM 3010I. PROGRAM OVERVIEW

2213/2215 CRT FILAMENT VOLTAGE

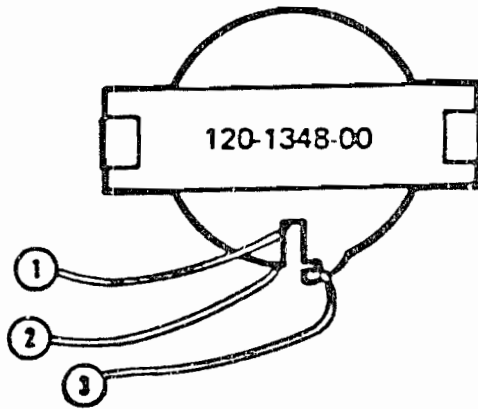
FIG 1

- () 17. Locate the lead of T940 labeled (3) in Fig. 1. Unsolder this lead from the Main circuit board, noting location for later reassembling.
- () 18. Unhook wire (3) from small retaining clip in transformer bobbin and unwind one complete turn. Refer to Fig. 2.
- () 19. Snap wire back into the retaining clip and pull tight.
- () 20. Cut off 3 inches of lead. Trim 3/16 inch insulation off remaining lead. Take care not to nick or cut the wires.
- () 21. Dress wire (3) back through the transformer core as indicated in Fig. 3.
- () 22. Tin the stripped lead and resolder it to the Main circuit board pad, noted previously. The dress of the wire is not critical except it should not be pulled tight against the edge of the transformer core.
- () 23. Change the part number on top of the transformer from 120-1340-00 to 120-1348-01.

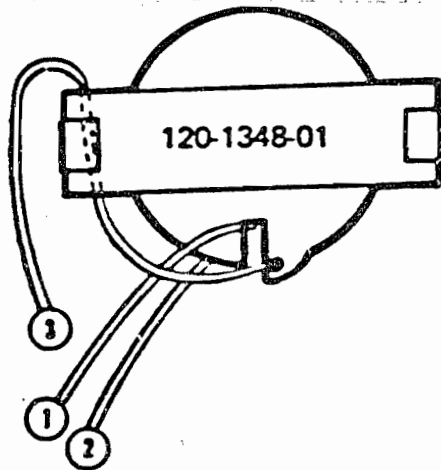
FIG 3

T940 Heater Voltage Winding Modification.

The customer letter and instructions will not include this label. Therefore, each customer unit coming through the service center must be examined to verify whether or not it needs to be modified. Identification can be made either by the transformer part number upgraded to 120-1348-01 or the transformer lead being redressed as per Figure 3 of the mod instructions.

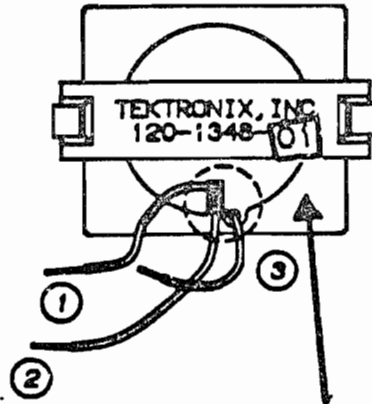
A few modified units had the wire redressed as the original part after being moded. Look for the "01" part number.

The "00" was changed to "01" with a white stick on label.

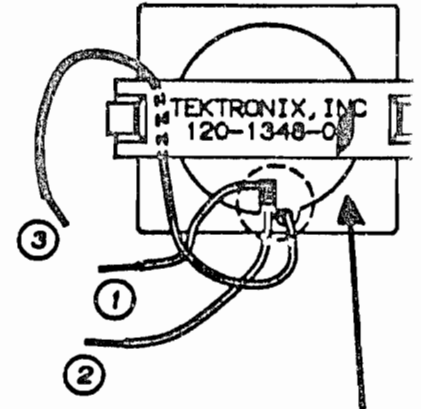
The last "0" in the P was changed to a "1" with a black felt tip marker.

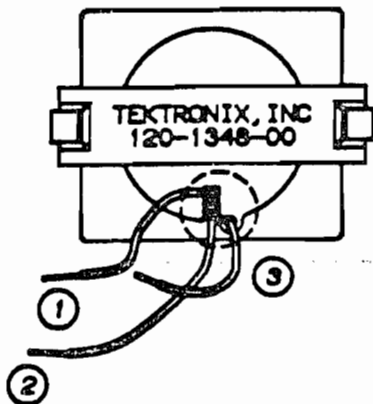
Wire # 3 in UNMODIFIED units goes directly from the notch to the circuit board connection.

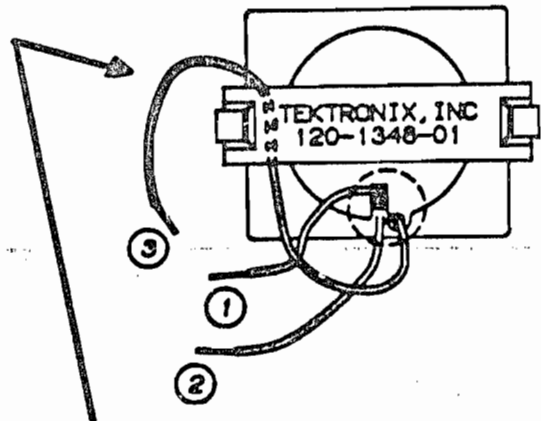
Wire # 3 in a MODIFIED unit is looped through the transformer bobbin and then resoldered to the same circuit board connection point.

Wires # 1 and 2 are not changed. They remain connected as before the mod.

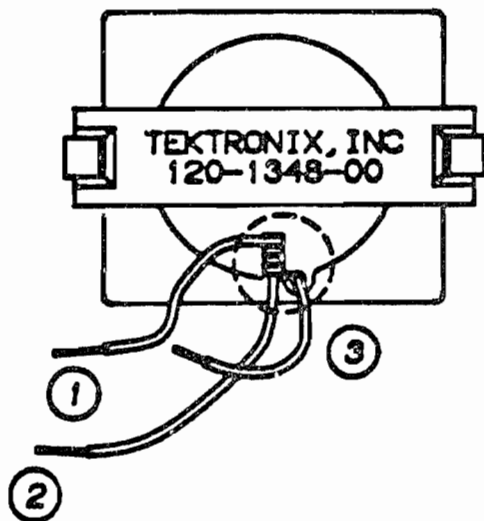
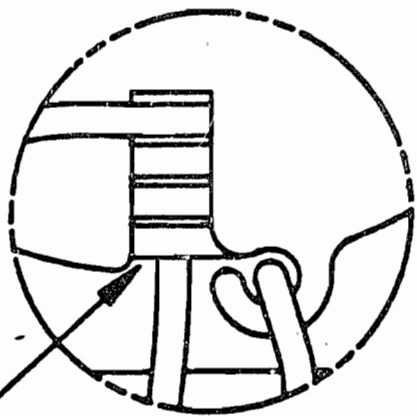
FIGURE 1
(BEFORE MODIFICATION)

Close examination of the notch in the top of the transformer should show the space left when the first wrap is unwound during implementation of the modification. (FIG 2) An unmodified transformer will show the wires all the way out to the edge as in FIGURE 1.
