Tektronix 7603 mainframe repair

In today's episode I'm going to describe briefly the repair process of the TEK 7603.

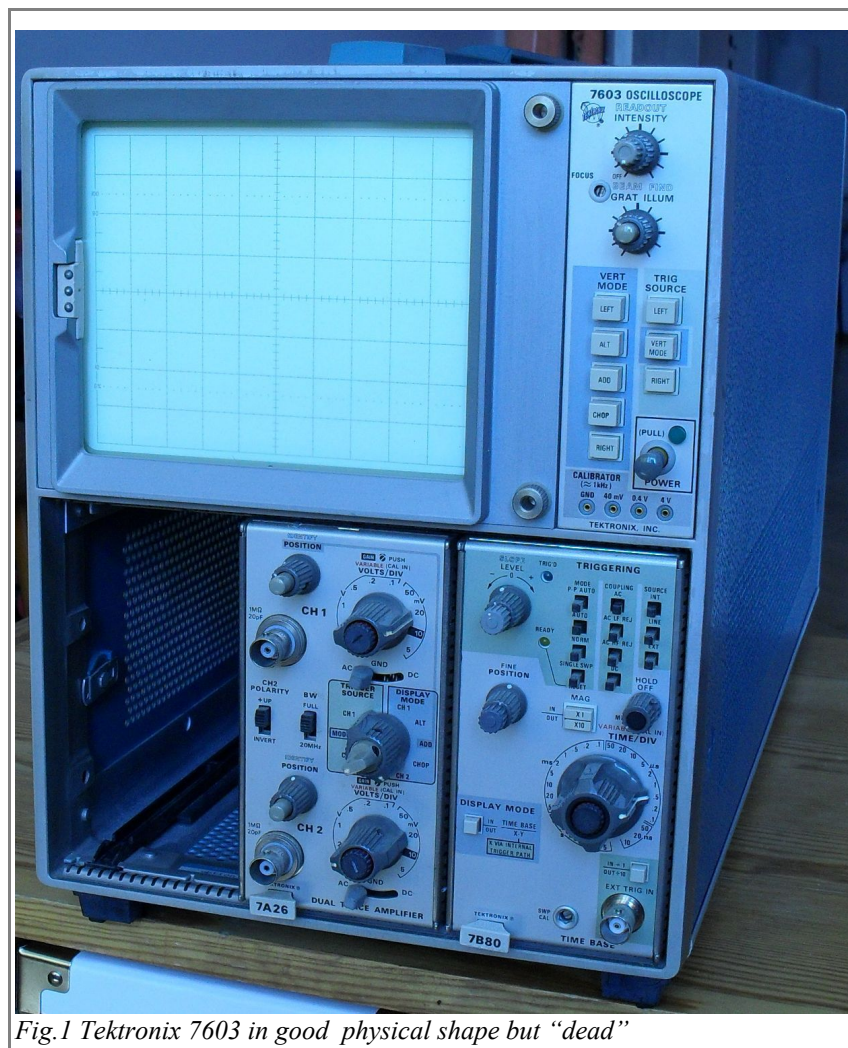
Fig.1 Tektronix 7603 in good physical shape but "dead"

Completely NO reactions after powering the unit: no fan hum, no scale illumination, blanked CRT, "POWER ON" lamp on the front panel was off.

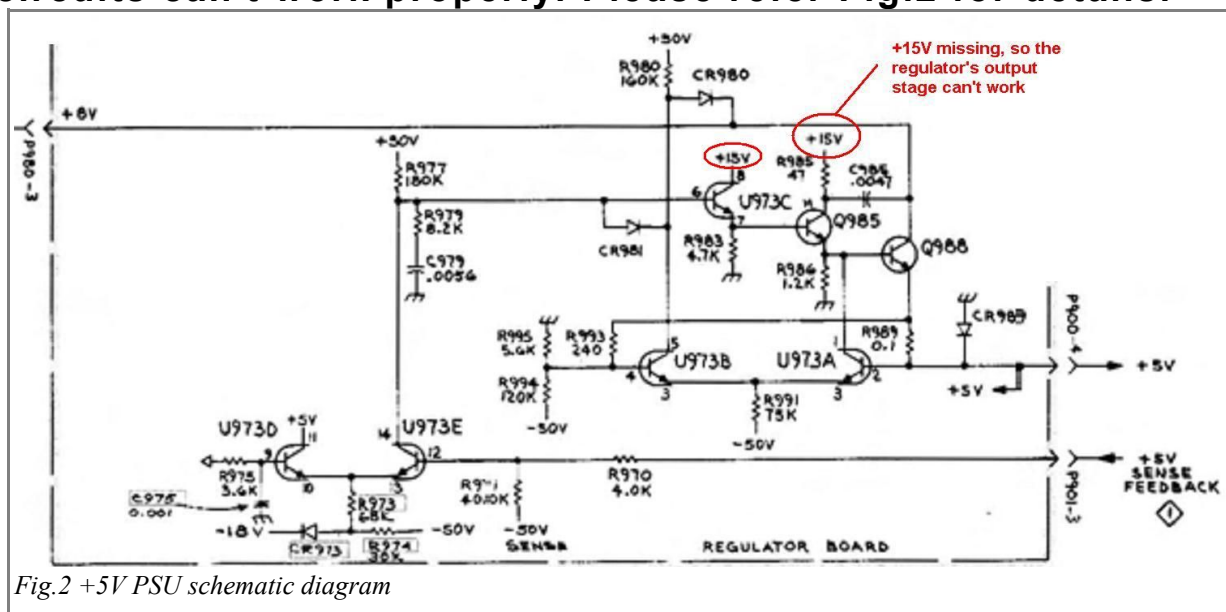
Fig.2 +5V PSU schematic diagram

It was found that the +5V and +15V voltages were missing, they even went 0,6V negative. I started tracking, which voltages in the power supply section are +15V dependent. I have disconnected supply cables from every board in the scope EXCLUDING the main board. Why? Because the main board provides all "SENSE" feedback connections and without these feedbacks most of the PSU circuits can't work properly. Please refer Fig.2 for details.

As You can see, the +5V can't work until the +15V supply is provided. To ensure my thesis I connected external bench power supply set for 15V and 1A of current limit. The CRT turned on and the scope was brought back to life.

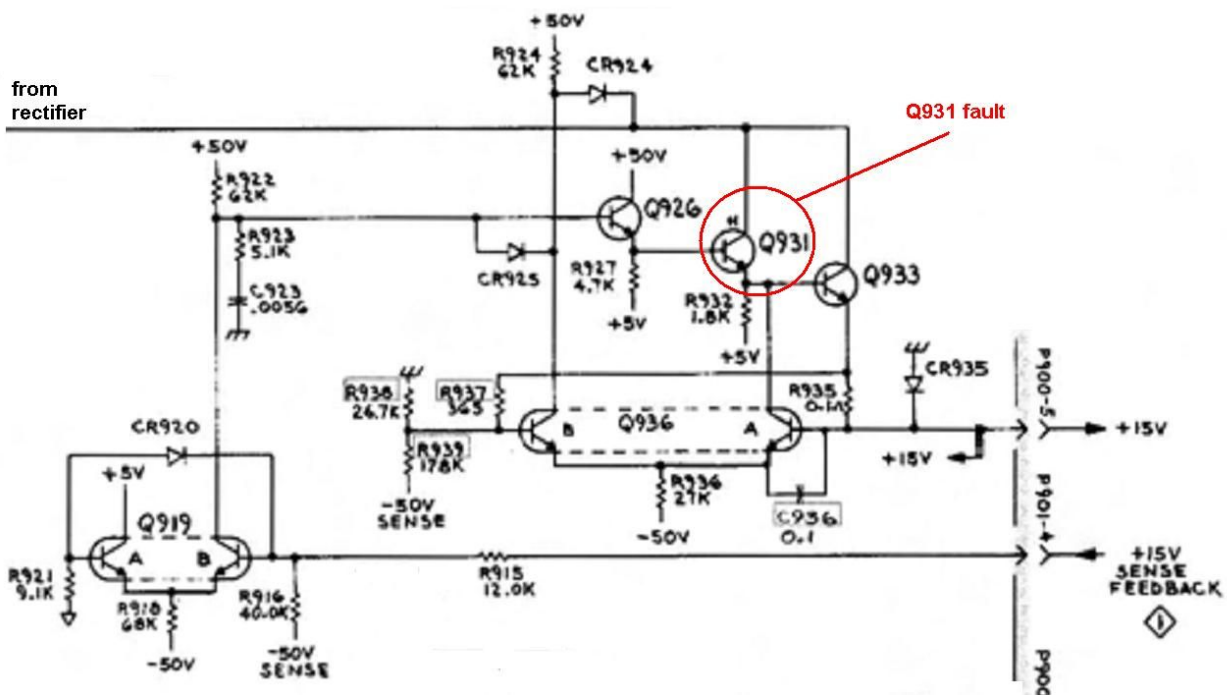
Fig.3 +15V PSU schematic diagram

It was a time to find the cause of +15V PSU failure. After few minutes of measuring few potentials the diagnosis was : Q931 fault (Fig.3). I found it's parameters on the web and the closest equivalent I had was BSX61 (fT doesn't matter in this circuit, voltage and current ratings are important).

I checked everything once again and it worked stable and properly. All voltages coming out from the PSU unit had less than 2% tolerances, so I could go further with checking. I connected all boards' supply connectors back on their places.

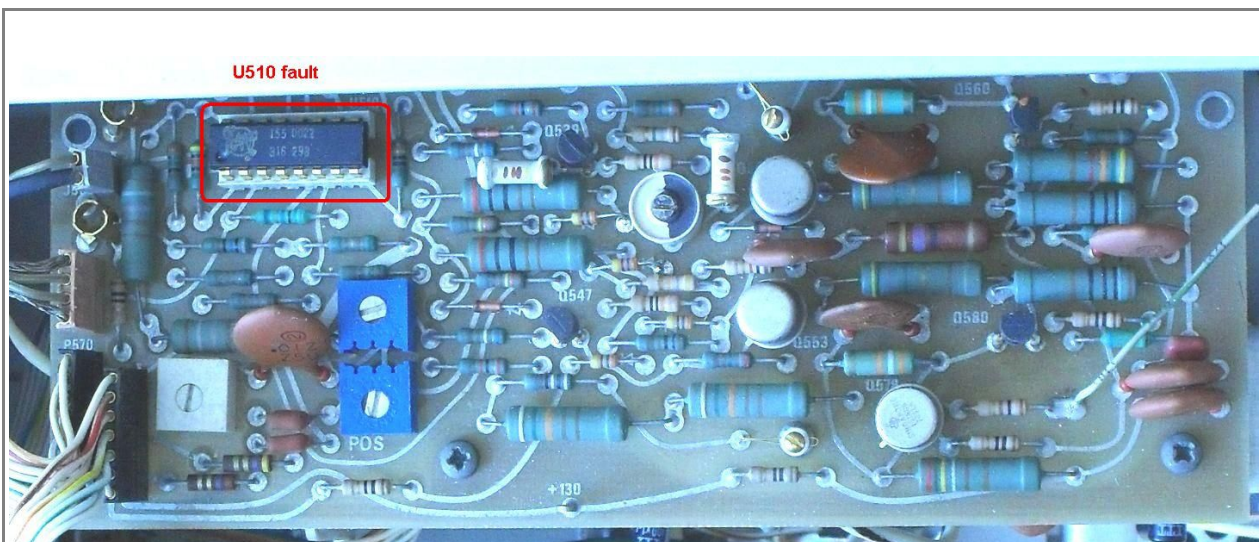
Fig.4 Horizontal amplifier and switch PCB

Then I used two TEK plug-ins I was sure to work fine: vertical amplifier 7A26 and time base 7T80. I also applied 1kHz 1V test signal to the vertical plug-in input. I tried to obtain the correct view, but I couldn't. What I've seen was only bright, VERTICAL trace. I've presumed that the horizontal part was faulty. I checked the timebase and all signals produced by 7T80 plug-in were correct (Fig.5). Using the second oscilloscope I found, that signals coming into U510 were correct, but there was no signal at the output of this IC switch. Rotating the "LIMIT CENTERING" potentiometer resulted in moving of the X position of displayed trace, so I assumed that following horizontal amplifier was OK. I needed to ensure, that the U510 was faulty so I put out the same type from working 7613 scope. The scope showed a proper sinewave on the screen. Fortunately the custom TEK IC's were available on eBay for about 10 Euro so I've bought one.

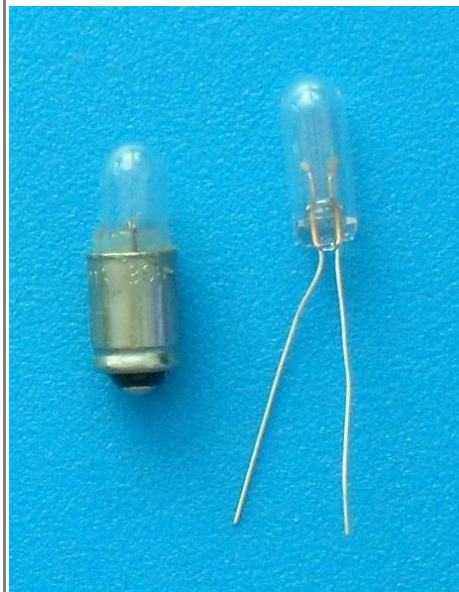
Fig.6 Scale illumination bulb reconstruction

The next thing - let's say less important - was no reaction on rotating the "GRAT ILLUM" knob. Soon it was clear that ALL three 6V bulbs were burned out. I checked few shops to find bulbs with the same bulb holder but it was impossible to buy them. I decided to crash the glass of the TEK bulbs and I prepared my own bulbs using the POXIPOL and bulbs rated at 6V/ 40mA which I've bought earlier. The results are shown on the Fig.6.

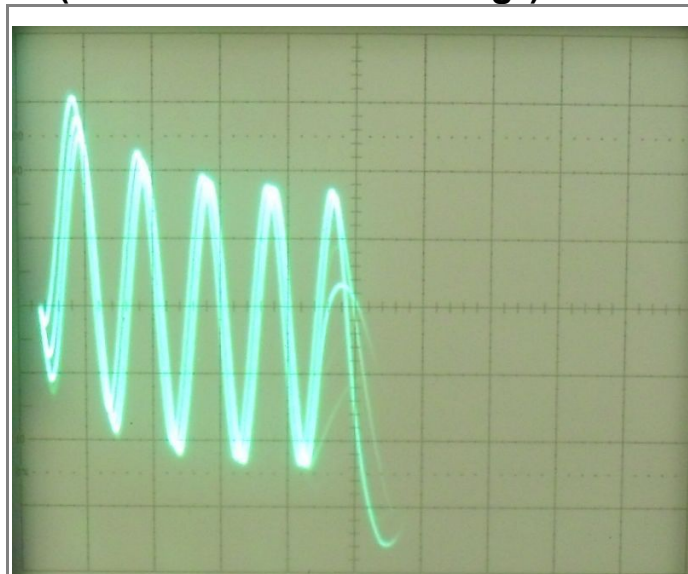
Everything was fine until one day I've seen something as on the photo below (the trace was shaking).

Fig.7 Strange traces on the display (1kHz 1V test sinewave applied)

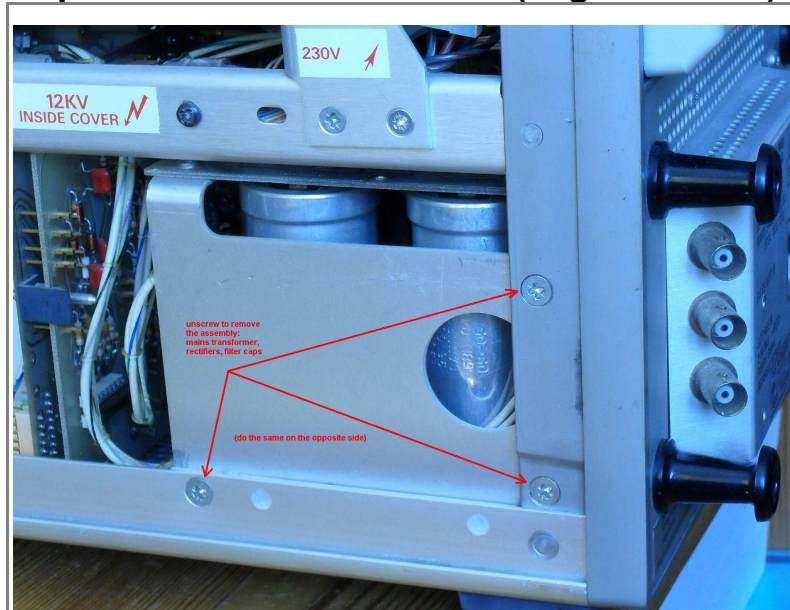
Fig.8 Removing the PSU assembly

Once again I've checked the PSU for the AC ripple using an external oscilloscope. The transformer/ rectifier/ filter module needed to be pulled out to do further inspection. After removing 6 screws I pulled the module out (Fig.8 and 9)

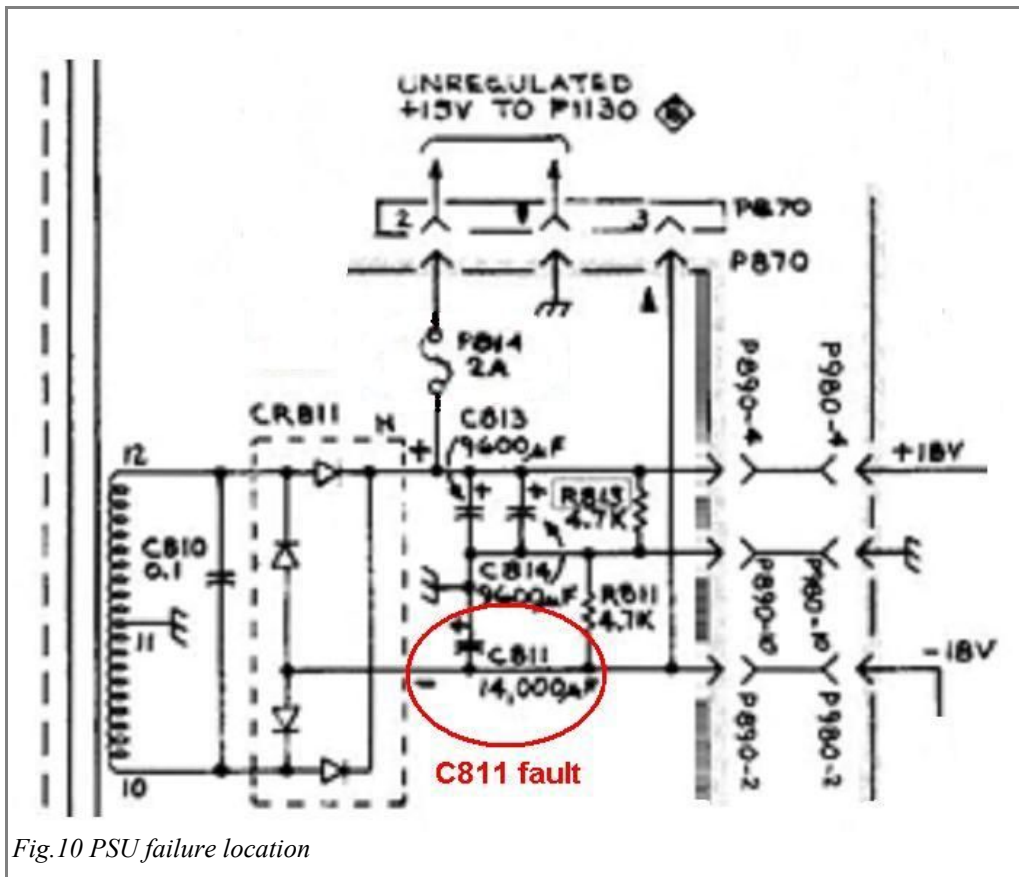
Fig.10 PSU failure location

I turned out that the capacitor C811 in the -18V PSU was dry.

The C811 was 14000uF but I had only 10000uF/ 25V so I used one :)
