# Icom IC-765 Notes

Don Stalkowski, VE3HUR

June 10, 2003

Version 1.03

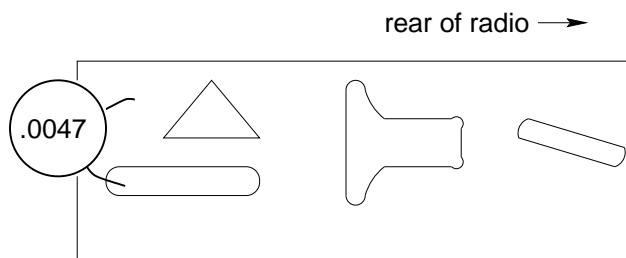
Figure 2: Rear of antenna switch circuit board.

1. Remove top cover
2. Locate antenna switch unit at right rear of radio (at antenna jack).
3. Solder a 0.0047 uF, 500V ceramic capacitor to back side of pc board as shown. (Board removal is not necessary). The capacitor is effectively installed between ground and the junction of R1 and L1.
4. Reinstall top cover and check for proper transmitter operation. This modification prevents failure of R1, R2, D1 and L1.
